## Item #13810767 - 2017 JLG 4069LE Electric Scissor Lift

- Features: 40 ft Max Platform Height, 800 lb Max Weight Capacity, Platform Extension, Power to Platform, Foam Filled Tires, Upper Control Box
- Meter Reading: 365 Hours
- Serial # : 0200264451
- Inspection Completed: 8/21/25

# Inspection Report

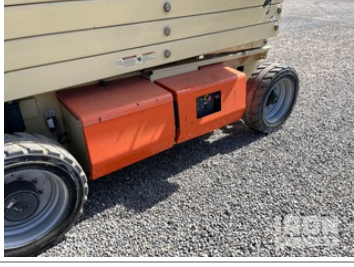
| Body Panels | No visible damage or missing components | |

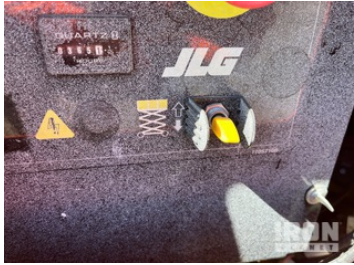
| Control Station Ground | | |
|---|---|---|
| Function Controls | ★★★★☆ | |

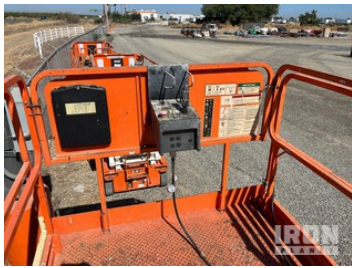
| Item | Assessment | Photo |
|---|---|---|
| Control Console | No visible damage or missing components | |

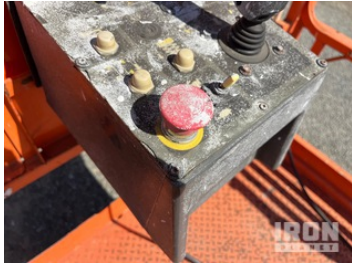
| Item | Assessment | Photo |
|---|---|---|
| Emergency Shut Off Switch | Operational | |

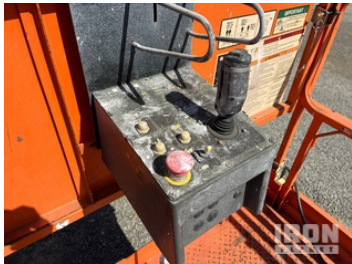
| Item | Assessment | Photo |
|---|---|---|
| Upper Function Controls | ★★★★☆ | |

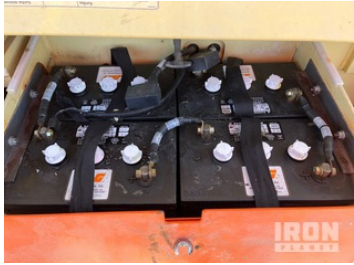
| Electrical Operating System | | |
|---|---|---|
| Cables and Connections | No visible damage or missing components | |

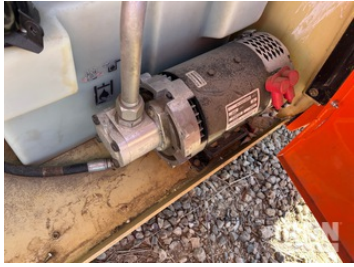
| Hydraulics | | |
|---|---|---|
| Pumps (Hydraulics) | ★★★★☆ | |

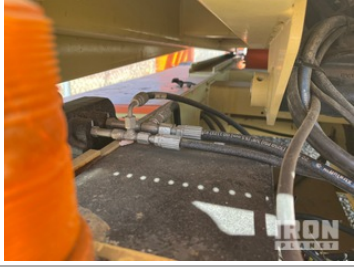
| Hydraulics | | |
|---|---|---|
| Valves | ★★★★☆ | |

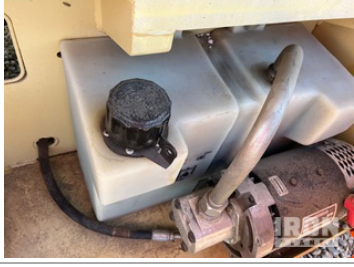
| Hydraulics | | |
|---|---|---|
| Hydraulic Tank | ★★★★☆ | |

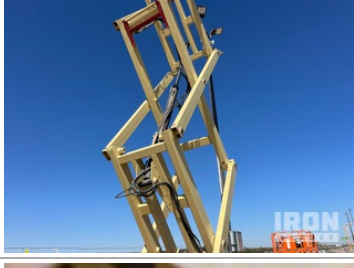
| Hydraulics | | |
|---|---|---|
| Lift Cylinders | ★★★★☆ | |

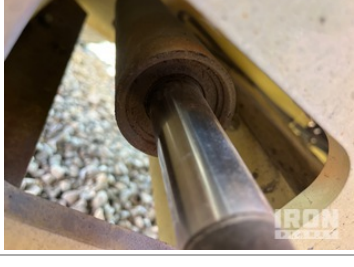
| Hydraulics | | |
|---|---|---|
| Steering Cylinder | ★★★★☆ | |

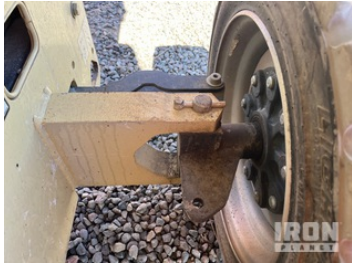
| Item | Assessment | Photo |
|---|---|---|
| Steering Linkage | ★★☆☆ | |

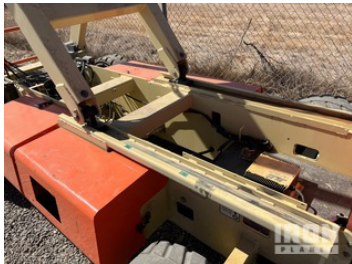
| Item | Assessment | Photo |
|---|---|---|
| Frame Condition | ★★☆☆ | |

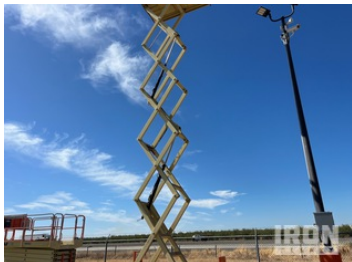
| Item | Assessment | Photo |
|---|---|---|
| Scissor Linkage | ★★☆☆ | |

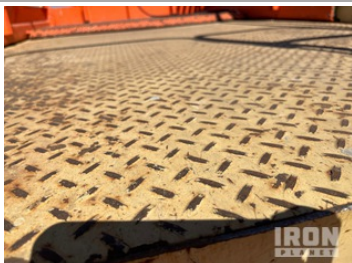
| Item | Assessment | Photo |
|---|---|---|
| Platform Condition | ★★☆☆ | |

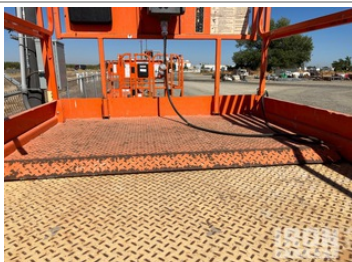
| Item | Assessment | Photo |
|---|---|---|
| Platform Extension | ★★☆☆ | |

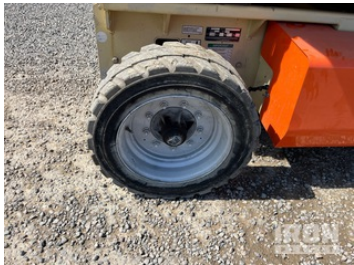
| Left Front Tire | Cracks | |

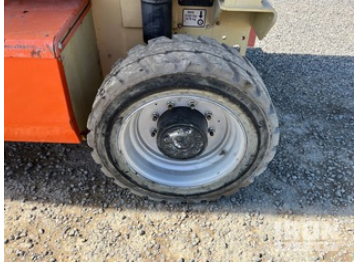
| Left Rear Tire | Cracks | |

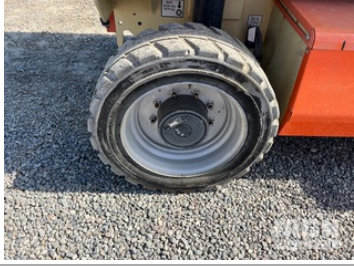
| Right Rear Tire | Cracks | |

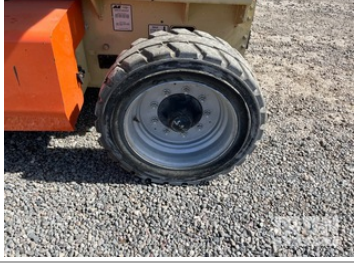
| Right Front Tire | Cracks | |

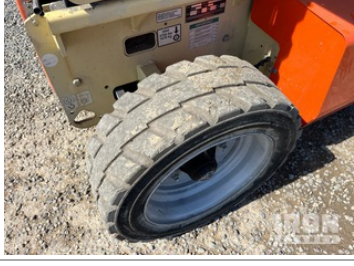
| Wheel Condition | No visible damage or missing components | |
