## Item #13811301 - 2016 JLG 4069LE Electric Scissor Lift

## Inspection Report

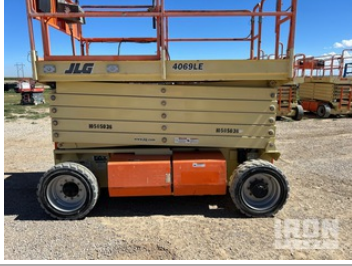
| Paint | Other unknown material | |

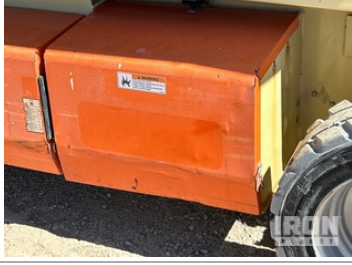
| Body Panels | Battery compartment door damaged | |

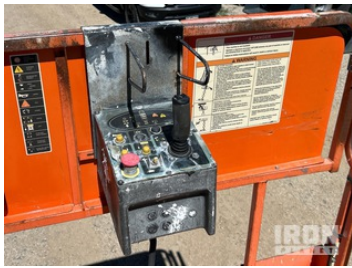
| Item | Assessment | Photo |
|---|---|---|
| Control Console | Material buildup | |

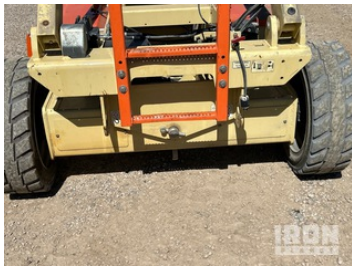
| Item | Assessment | Photo |
|---|---|---|
| Brake System | ★★☆☆<br>The brake system functioned, stopping and holding the machine. | |

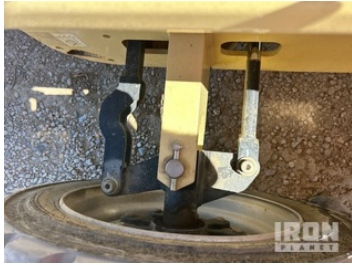
| Item | Assessment | Photo |
|---|---|---|
| Steering Linkage | ★★☆☆ | |

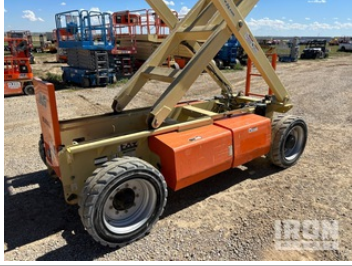
| Item | Assessment | Photo |
|---|---|---|
| Frame Condition | ★★☆☆ | |

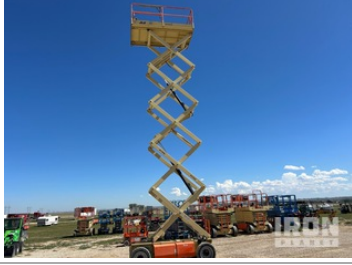
| Item | Assessment | Photo |
|---|---|---|
| Scissor Linkage | ★★☆☆ | |

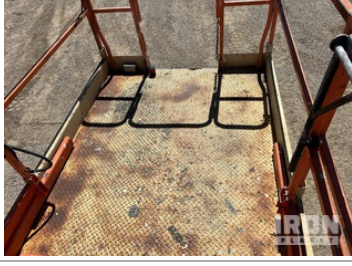
| Item | Assessment | Photo |
|---|---|---|
| Platform Condition | ★★☆☆<br>Dented flooring by stair | |
