## Item #13810745 - 2016 JLG 4069LE Electric Scissor Lift

# Inspection Report

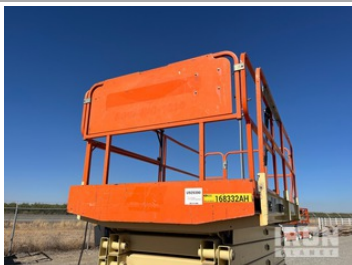
| Paint | No visible damage | |

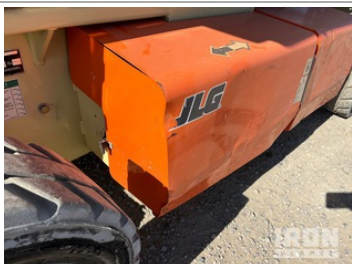
| Body Panels | Battery compartment door damaged | |

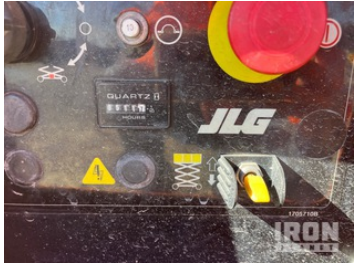
| Control Station Ground | | |
|---|---|---|
| Function Controls | ★ ★ ★ ☆ | |

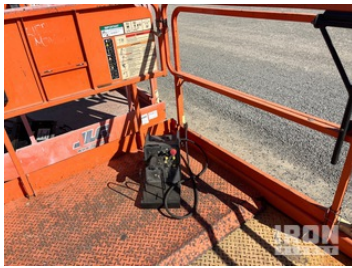
| Item | Assessment | Photo |
|---|---|---|
| Control Console | No visible damage or missing components | |

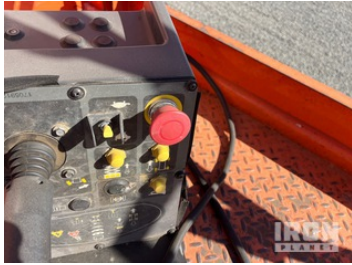
| Item | Assessment | Photo |
|---|---|---|
| Emergency Shut Off Switch | Operational | |

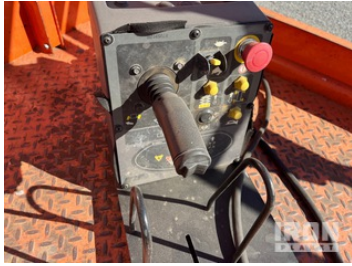
| Item | Assessment | Photo |
|---|---|---|
| Upper Function Controls | ★★★★☆ | |

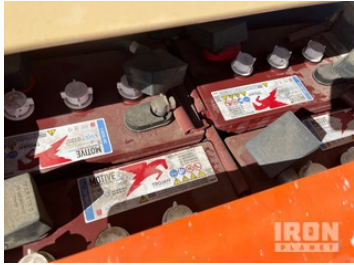
| Electrical Operating System | | |
|---|---|---|
| Cables and Connections | No visible damage or missing components | |

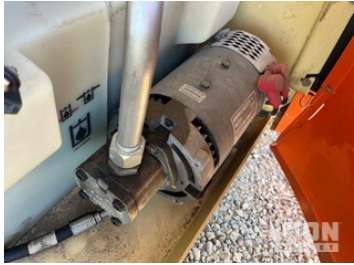
| Hydraulics | | |
|---|---|---|
| Pumps (Hydraulics) | ★★★★☆ | |

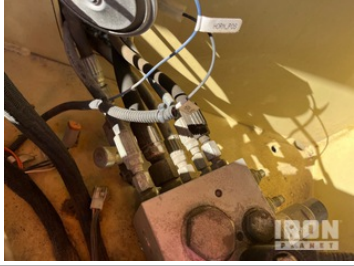
| Hydraulics | | |
|---|---|---|
| Valves | ★★★★☆ | |

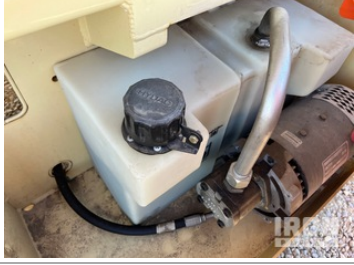
| Hydraulics | | |
|---|---|---|
| Hydraulic Tank | ★★★★☆ | |

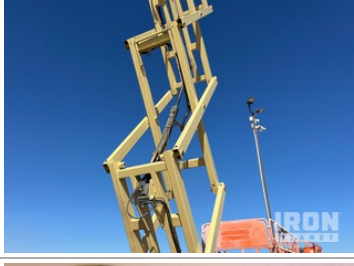
| Hydraulics | | |
|---|---|---|
| Lift Cylinders | ★★★★☆ | |

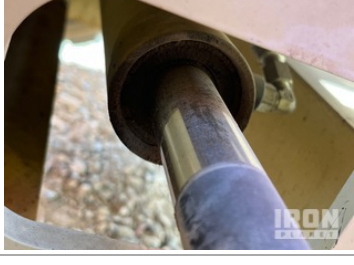
| Hydraulics | | |
|---|---|---|
| Steering Cylinder | ★★★★☆ | |

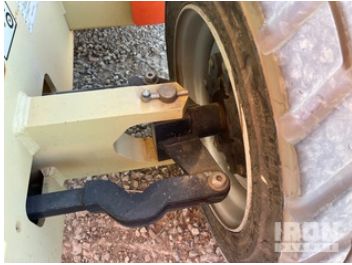
| Item | Assessment | Photo |
|---|---|---|
| Steering Linkage | ★★☆☆ | |

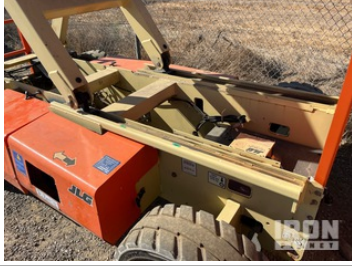
| Item | Assessment | Photo |
|---|---|---|
| Frame Condition | ★★☆☆ | |

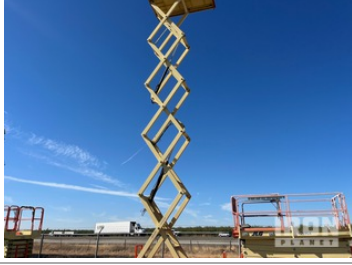
| Item | Assessment | Photo |
|---|---|---|
| Scissor Linkage | ★★☆☆ | |

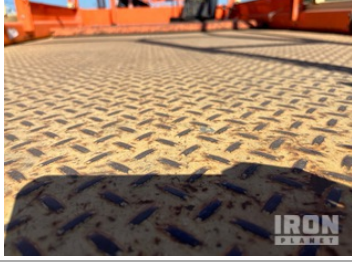
| Item | Assessment | Photo |
|---|---|---|
| Platform Condition | ★★☆☆ | |

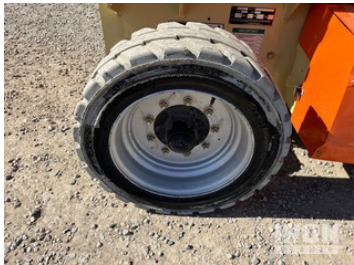
| Left Front Tire | Cracks | |

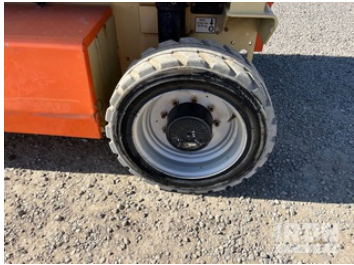
| Left Rear Tire | Cracks | |

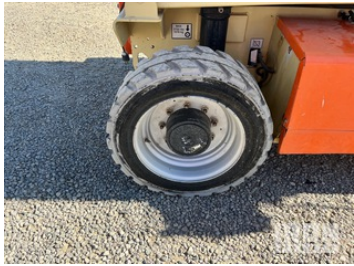
| Right Rear Tire | Cracks | |

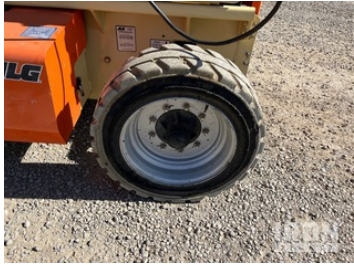
| Right Front Tire | Cracks | |

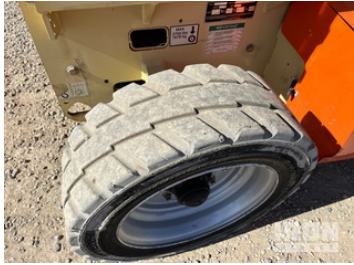
| Wheel Condition | No visible damage or missing components | |
