## Item #13811435 - 2016 JLG 4069LE Electric Scissor Lift

# Inspection Report

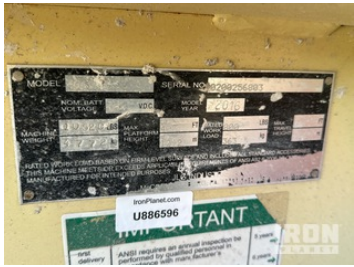
| Serial Number / VIN | 0200256803 | |

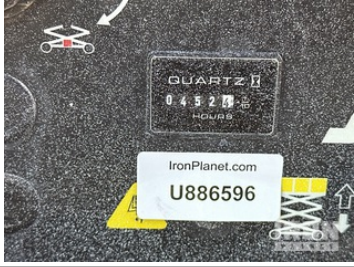
| Hour Meter / Odometer | 452 hrs | |

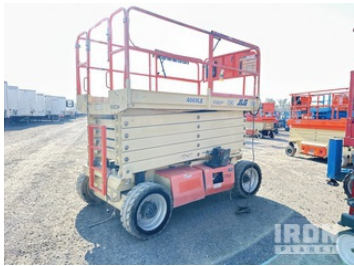
| Body Panels | No visible damage or missing components | |

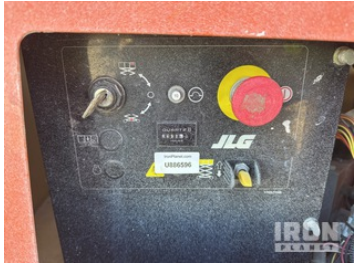
| Control Station Ground | | |
|---|---|---|
| Function Controls | ☆☆☆☆ | |

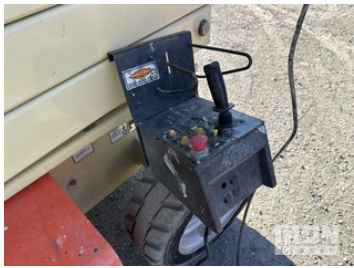
| Item | Assessment | Photo |
|---|---|---|
| Control Console | No visible damage or missing components | |

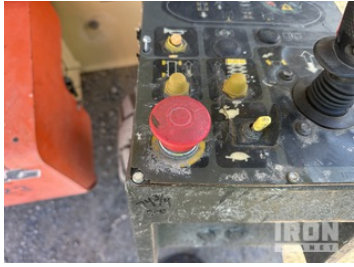
| Item | Assessment | Photo |
|---|---|---|
| Emergency Shut Off Switch | Operational | |

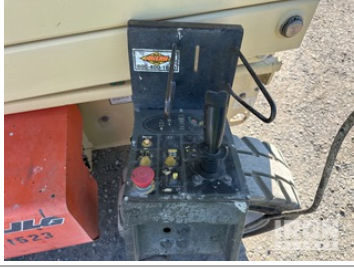
| Item | Assessment | Photo |
|---|---|---|
| Upper Function Controls | ☆☆☆☆ | |

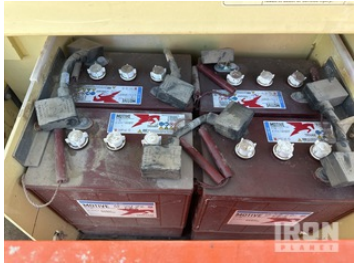
| Electrical Operating System | | |
|---|---|---|
| Cables and Connections | No visible damage or missing components | |

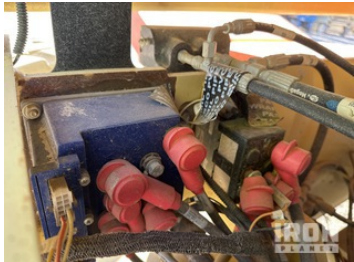
| Electrical Operating System | | |
|---|---|---|
| Battery Charger | Included Appears normal - Not operationally checked, 120 Volt, Single Phase | |

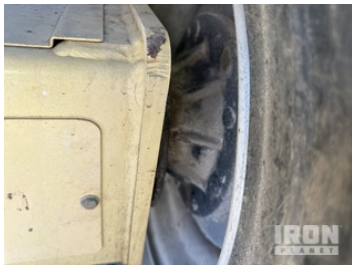
| Item | Assessment | Photo |
|---|---|---|
| Drive Motors | ★★★★☆ | |

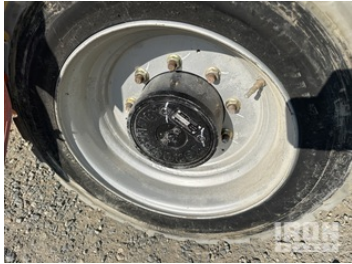
| Item | Assessment | Photo |
|---|---|---|
| Final Drives | ★★★★☆ | |

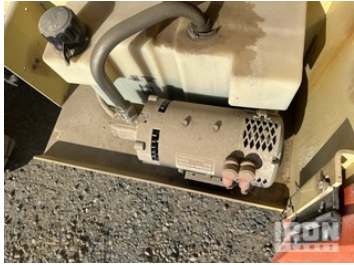
| Hydraulics | | |
|---|---|---|
| Pumps (Hydraulics) | ★★★★☆ | A close-up photograph of a yellow hydraulic pump assembly mounted on a metal frame. The pump is connected to various hoses and has a black filter on top. The background shows a gravel surface. |

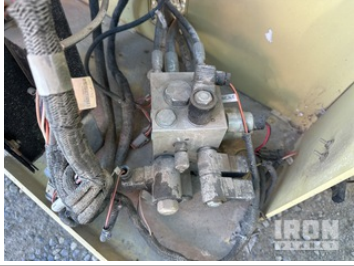
| Hydraulics | | |
|---|---|---|
| Valves | ★★★★☆ | A close-up photograph of a hydraulic valve block with several ports and hoses connected. The block is mounted on a metal frame, and the background shows a gravel surface. |

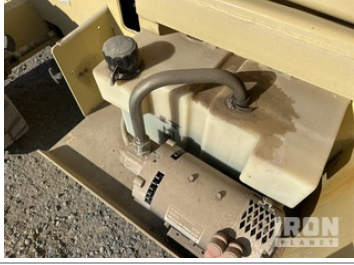
| Hydraulics | | |
|---|---|---|
| Hydraulic Tank | ★★★★☆ | A close-up photograph of a yellow hydraulic tank with a black filter on top. The tank is mounted on a metal frame, and the background shows a gravel surface. |

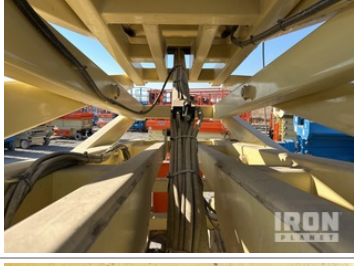
| Hydraulics | | |
|---|---|---|
| Lift Cylinders | ★★★★☆ | A photograph showing the lift cylinders of the scissor lift. The cylinders are yellow and extend upwards, supporting the platform. The background shows a clear blue sky. |

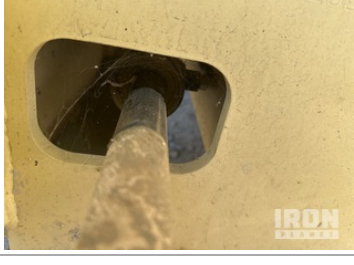
| Hydraulics | | |
|---|---|---|
| Steering Cylinder | ★★★★☆ | A close-up photograph of a steering cylinder. The cylinder is black and has a metal rod extending from it. The background is a yellow metal surface. |

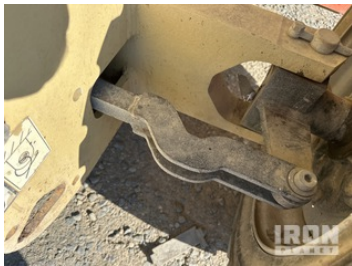
| Item | Assessment | Photo |
|---|---|---|
| Steering Linkage | ★★★★☆ | |

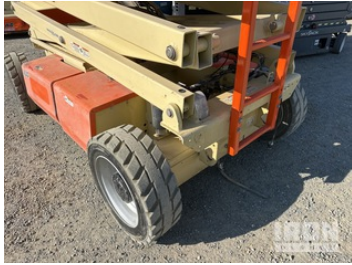
| Item | Assessment | Photo |
|---|---|---|
| Frame Condition | ★★★★☆ | |

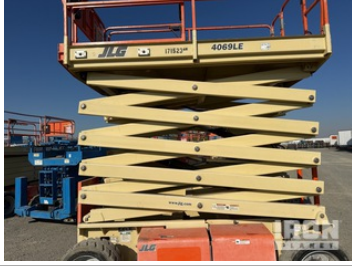
| Item | Assessment | Photo |
|---|---|---|
| Scissor Linkage | ★★★★☆ | |

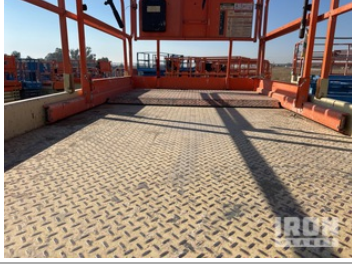
| Item | Assessment | Photo |
|---|---|---|
| Platform Condition | ★★★★☆ | |

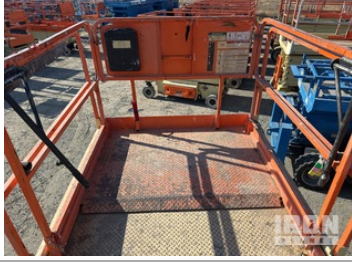
| Item | Assessment | Photo |
|---|---|---|
| Platform Extension | ★★★★☆ | |

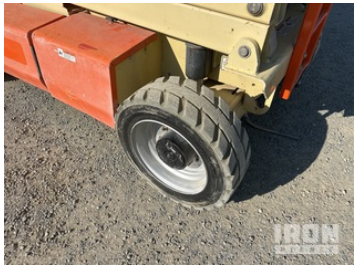
| Left Rear Tire | No visible defects | |

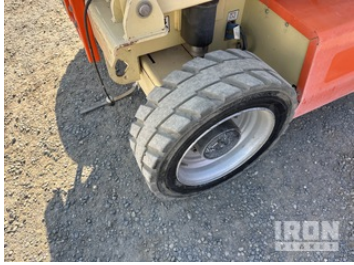
| Right Rear Tire | No visible defects | |

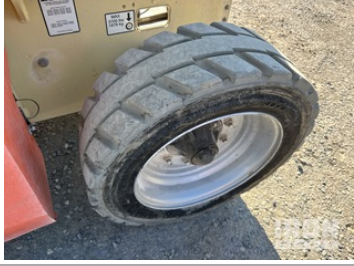
| Right Front Tire | No visible defects | |

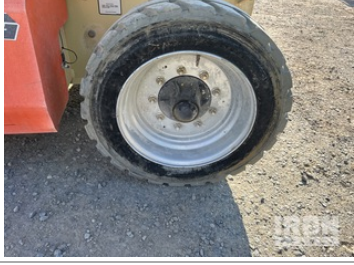
| Wheel Condition | No visible damage or missing components | |
