## Item #13869131 - 2017 Genie GTH-636 Telehandler

- Features: Open Operator Station, 6000 lb Max Lift Capacity, 2017 US EPA Label, CARB Compliant, 47.5 in Forks
- Meter Reading: 1,667 Hours
- Serial # : GTH06E-11473
- Inspection Completed: 8/23/25

# Inspection Report

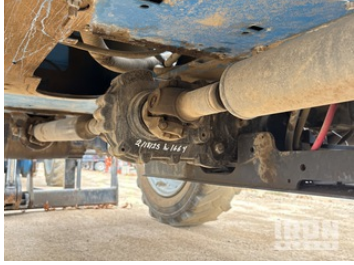
| Item | Assessment | Photo |
|---|---|---|
| Transfer Case / Drop Box | ★★★★☆ | |

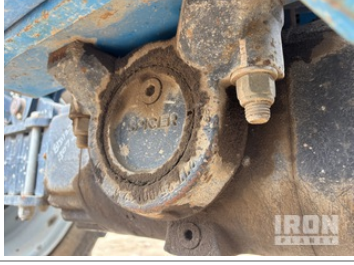
| Item | Assessment | Photo |
|---|---|---|
| Front Axle Oscillating Pin | ★★★★☆<br>Build up | |

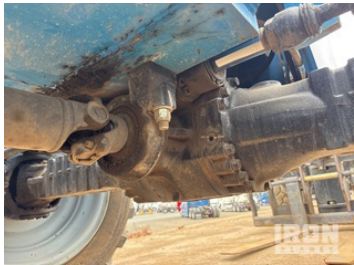
| Rear Drive Axle | <div> <div> <div>★</div> <div>★</div> <div>★</div> <div>★</div> <div>☆</div> </div> <div>Build up</div> </div> | |

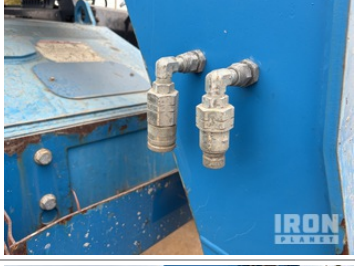
| Hydraulics | | |
|---|---|---|
| Auxiliary Hydraulic Plumbing | Capped off, Front | |

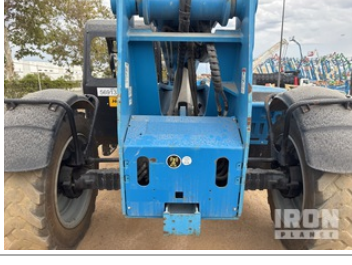
| General Appearance | | |
|---|---|---|
| Paint | Damage | |

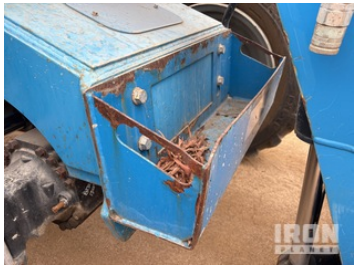
| Body Panels | Damage | |

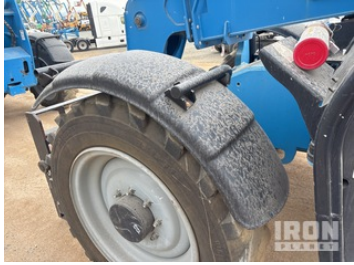
| Fenders | All have damage | |

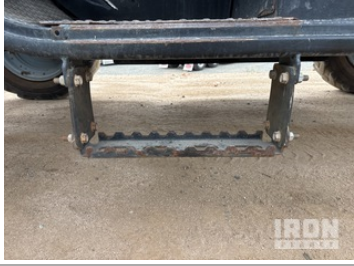
| Steps | Rust damage | |

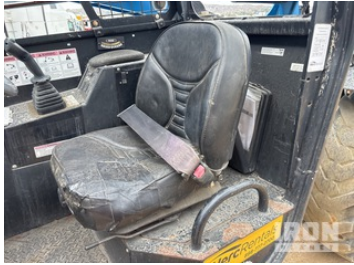
| Control Station | | |
|---|---|---|
| Seat/Armrests | Operator seat cover torn | |

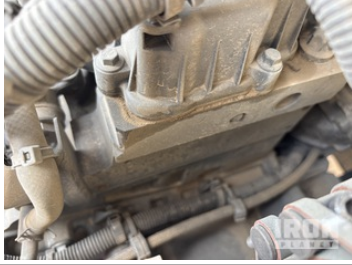
| Engine | | |
|---|---|---|
| Oil Leaks | Residue by gasket | |

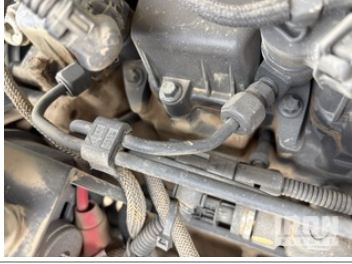
| Engine | | |
|---|---|---|
| Fuel Leaks | Possible seep by injectors | |

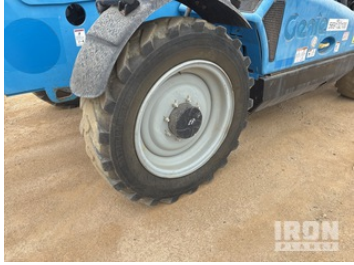
| Right Rear Tire | Tread Depth: 9/32 | |

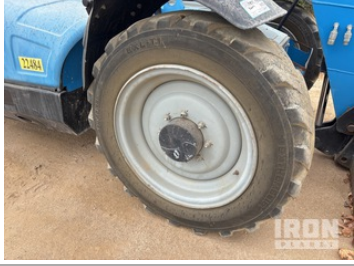
| Right Front Tire | Tread Depth: 2/32 | |
