## Item #13810722 - 2019 Skyjack SJ6832 RT Dual Fuel 4x4 Scissor Lift

- Features: 32 ft Max Platform Height, 1000 lb Max Weight Capacity, Platform Extension, Power to Platform, Stabilizers, Solid Non-Marking Tires, Upper Control Box, 2018 US EPA Label, CARB Compliant, Kubota 3 Cylinder Dual Fuel Engine
- Meter Reading: 1,193 Miles
- Serial # : 37014715
- Inspection Completed: 8/27/25

## Inspection Report

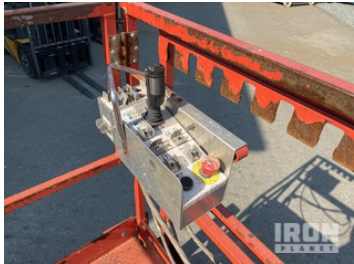
| Item | Assessment | Photo |
|---|---|---|
| Control Console | No visible damage or missing components | |

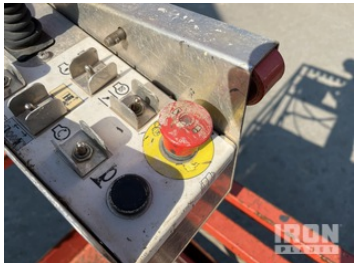
| Item | Assessment | Photo |
|---|---|---|
| Emergency Shut Off Switch | Operational | |

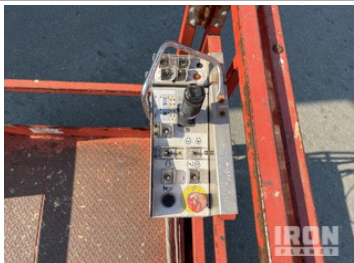
| Item | Assessment | Photo |
|---|---|---|
| Upper Function Controls | ★★★★☆ | |

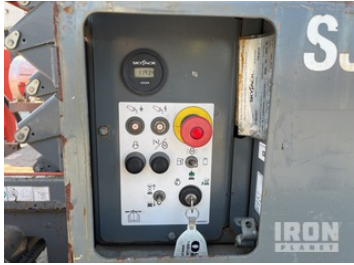
| Control Station Ground | | |
|---|---|---|
| Gauges | Operational | |

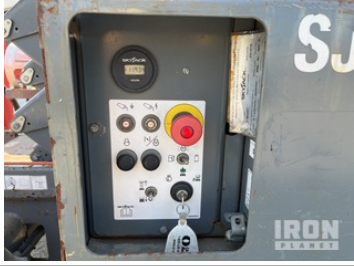
| Control Station Ground | | |
|---|---|---|
| Function Controls | ★★★★☆ | |

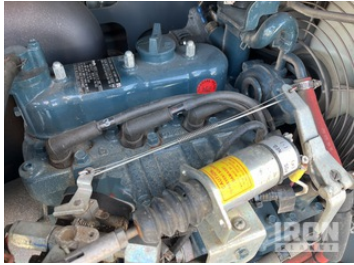
| Engine | | |
|---|---|---|
| Fuel System | Operational | |

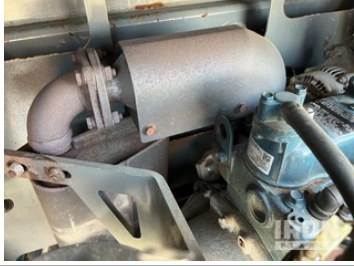
| Engine | | |
|---|---|---|
| Exhaust System | No visible damage or missing components | |

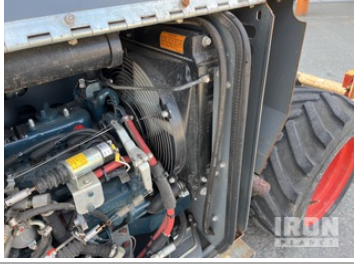
| Engine | | |
|---|---|---|
| Radiator | ★★★★☆ | |

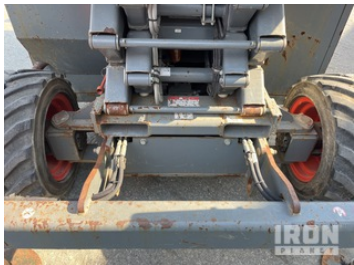
| Item | Assessment | Photo |
|---|---|---|
| Front Drive Axle | ★★★★☆ | A close-up photograph of the front drive axle assembly, showing the axle, suspension components, and the red-painted wheel hub. The IronPlanet logo is visible in the bottom right corner. |

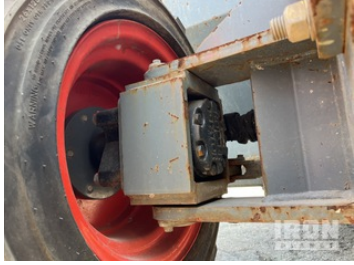
| Item | Assessment | Photo |
|---|---|---|
| Final Drives | ★★★★☆ | A close-up photograph of the final drive assembly, showing the housing and the red-painted wheel hub. The IronPlanet logo is visible in the bottom right corner. |

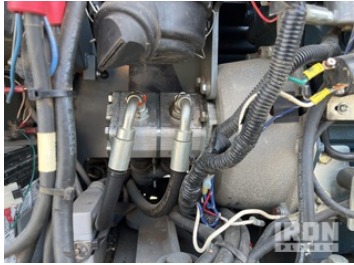
| Hydraulics | | |
|---|---|---|
| Pumps (Hydraulics) | ★★★★☆ | |

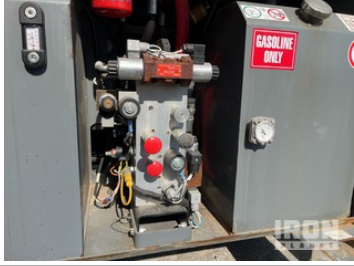
| Hydraulics | | |
|---|---|---|
| Valves | ★★★★☆ | |

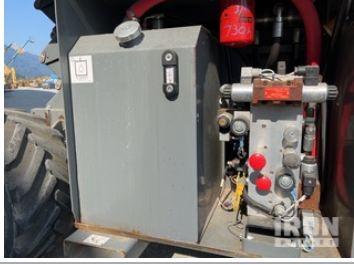
| Hydraulics | | |
|---|---|---|
| Hydraulic Tank | ★★★★☆ | |

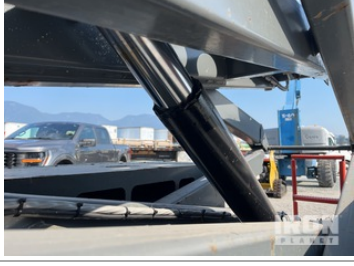
| Hydraulics | | |
|---|---|---|
| Lift Cylinders | ★★★★☆ | |

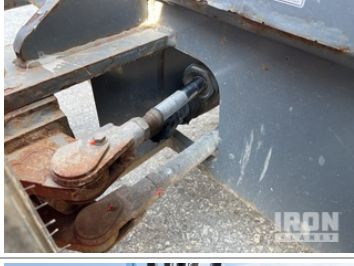
| Hydraulics | | |
|---|---|---|
| Steering Cylinder | ★★★★☆ | |

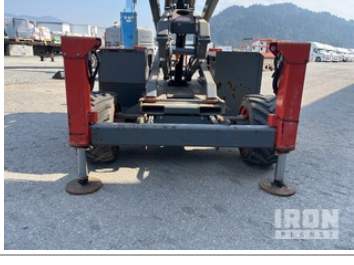
| Hydraulics | | |
|---|---|---|
| Outrigger Cylinders | ★★★★☆ | |

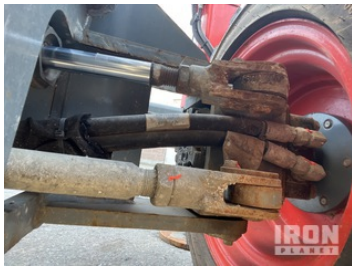
| Item | Assessment | Photo |
|---|---|---|
| Steering Linkage | ★★★★☆ | |

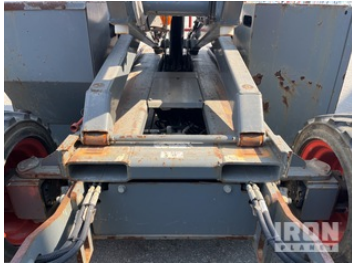
| Item | Assessment | Photo |
|---|---|---|
| Frame Condition | ★★★★☆ | |

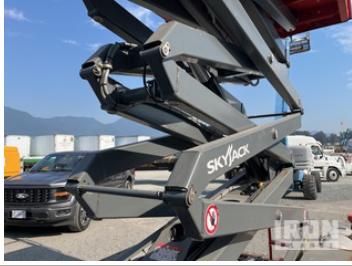
| Item | Assessment | Photo |
|---|---|---|
| Scissor Linkage | ★★★★☆ | |

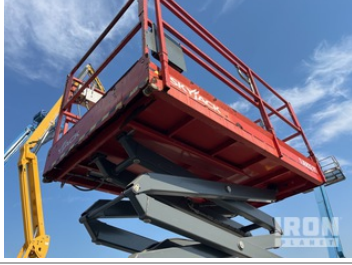
| Item | Assessment | Photo |
|---|---|---|
| Platform Condition | ★★★★☆ | |

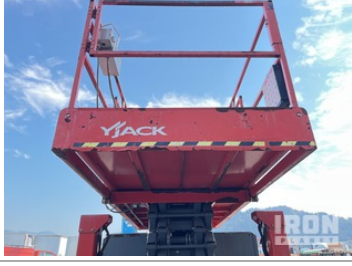
| Item | Assessment | Photo |
|---|---|---|
| Platform Extension | ★★★★☆ | |

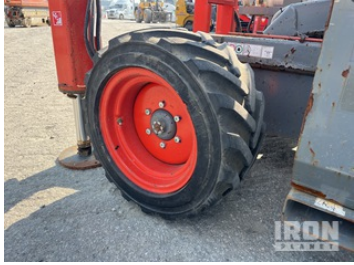
| Right Rear Tire | Screws | |

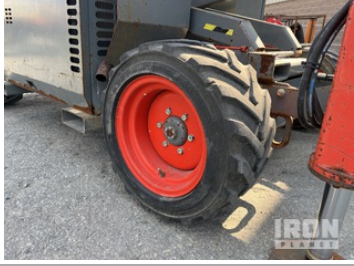
| Right Front Tire | Screws | |

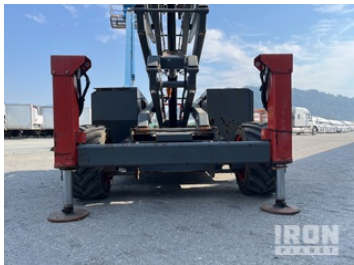
| Outriggers / Stabilizers | ★★★★☆ | |
