## Item #13689559 - 2012 Genie GS3232 Electric Scissor Lift

- Features: 32 ft Max Platform Height, 500 lb Max Weight Capacity, Platform Extension, Power to Platform, Upper Control Box
- Meter Reading: 241 Hours
- Serial # : GS3212A-112447
- Inspection Completed: 7/15/25

# Inspection Report

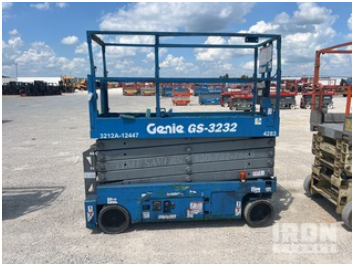
| Paint | No visible damage | |

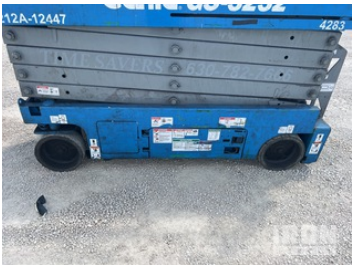
| Body Panels | No visible damage or missing components | |

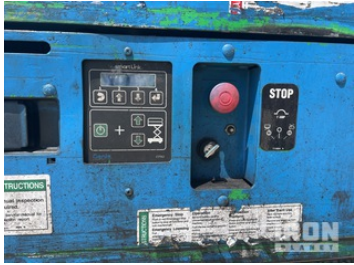
| Item | Assessment | Photo |
|---|---|---|
| Function Controls | ☆☆☆☆ | |

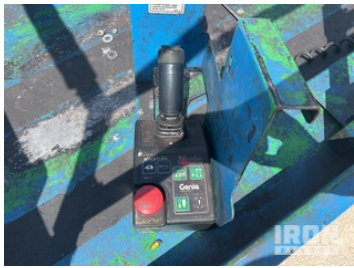
| Item | Assessment | Photo |
|---|---|---|
| Control Console | No visible damage or missing components | |

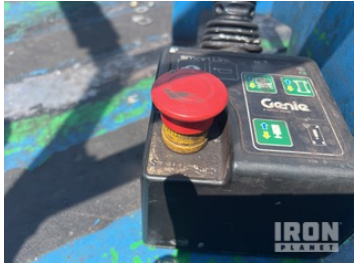
| Item | Assessment | Photo |
|---|---|---|
| Emergency Shut Off Switch | Operational | |

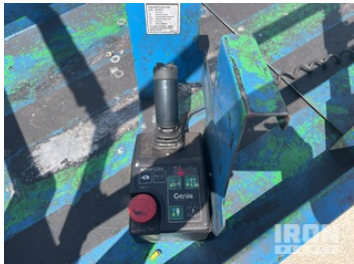
| Item | Assessment | Photo |
|---|---|---|
| Upper Function Controls | ★★★★☆ | |

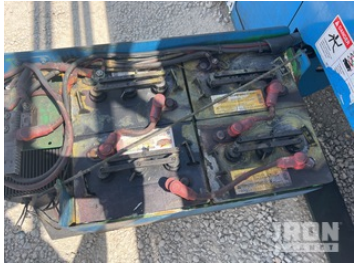
| Item | Assessment | Photo |
|---|---|---|
| Cables and Connections | No visible damage or missing components | |

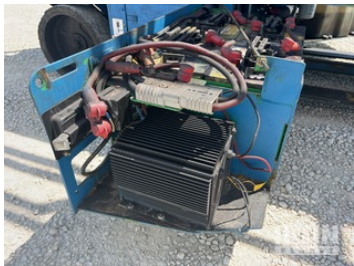
| Item | Assessment | Photo |
|---|---|---|
| Battery Charger | Included Appears normal - Not operationally checked, 24 Volt, Single Phase | |

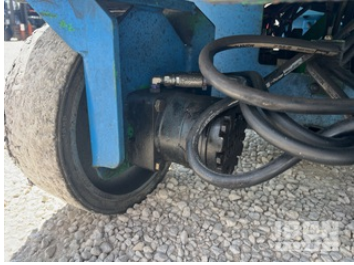
| Item | Assessment | Photo |
|---|---|---|
| Drive Motors | ★★★★☆ | |

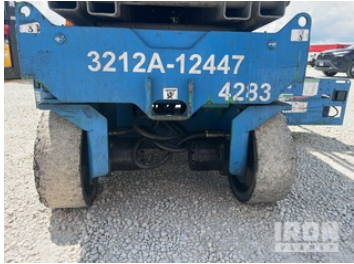
| Item | Assessment | Photo |
|---|---|---|
| Front Drive Axle | ★★★★☆ | |

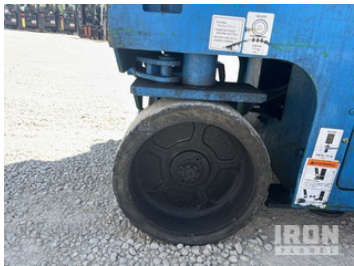
| Item | Assessment | Photo |
|---|---|---|
| Final Drives | ★★★★☆ | |

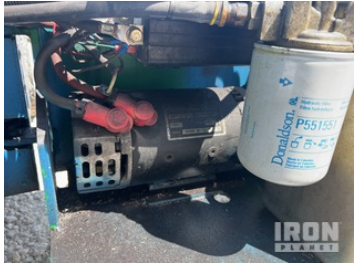
| Item | Assessment | Photo |
|---|---|---|
| Pumps (Hydraulics) | ★★★★☆ | |

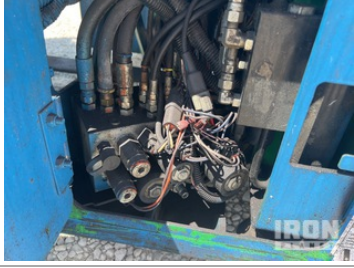
| Item | Assessment | Photo |
|---|---|---|
| Valves | ★★★★☆ | |

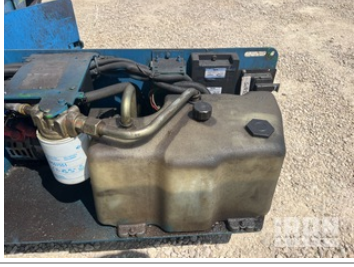
| Item | Assessment | Photo |
|---|---|---|
| Hydraulic Tank | ★★★★☆ | |

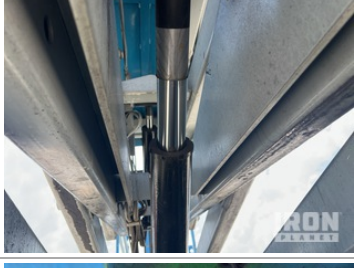
| Item | Assessment | Photo |
|---|---|---|
| Lift Cylinders | ★★★★☆ | |

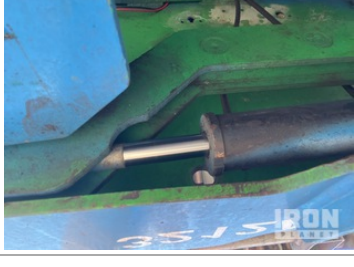
| Item | Assessment | Photo |
|---|---|---|
| Steering Cylinder | ★★★★☆ | |

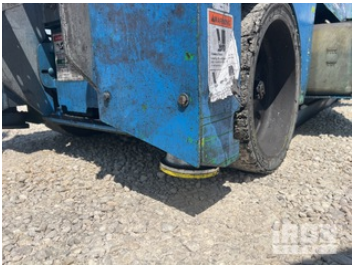
| Outrigger Cylinders | ☆☆☆☆ | |

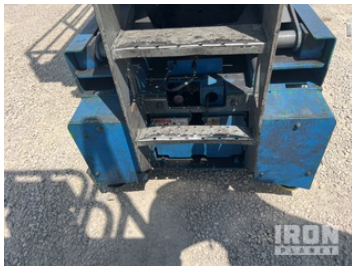
| Item | Assessment | Photo |
|---|---|---|
| Brake System | <p>★★★★☆</p> <p>The brake system functioned, stopping and holding the machine.</p> | |

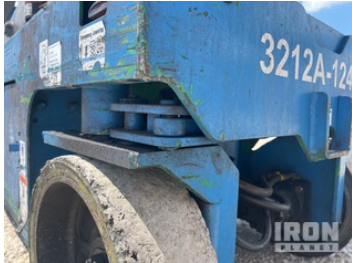
| Item | Assessment | Photo |
|---|---|---|
| Steering Linkage | <p>★★★★☆</p> | |

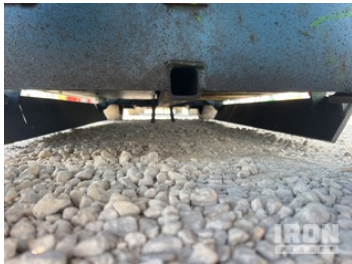
| Item | Assessment | Photo |
|---|---|---|
| Frame Condition | <p>★★★★☆</p> | |

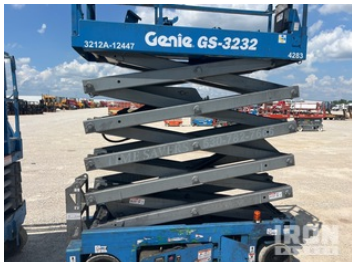
| Item | Assessment | Photo |
|---|---|---|
| Scissor Linkage | <p>★★★★☆</p> | |

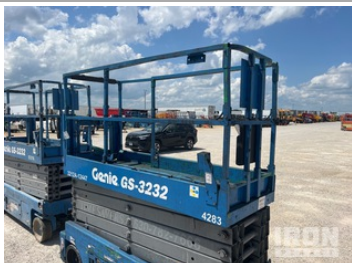
| Item | Assessment | Photo |
|---|---|---|
| Platform Condition | <p>★★★★☆</p> | |

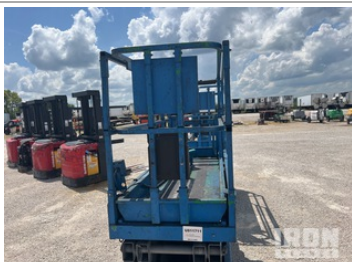
| Item | Assessment | Photo |
|---|---|---|
| Platform Extension | <p>★★★★☆</p> | |

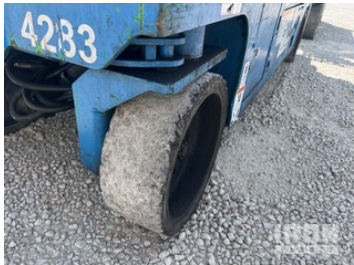
| Left Front Tire | Chunks missing | |

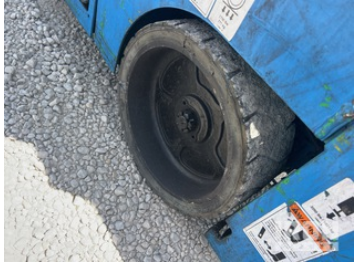
| Left Rear Tire | Chunks missing | |

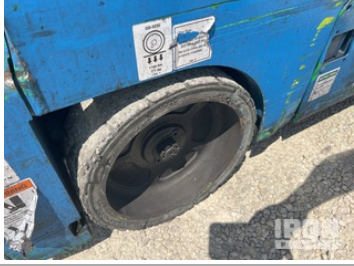
| Right Rear Tire | Chunks missing | |

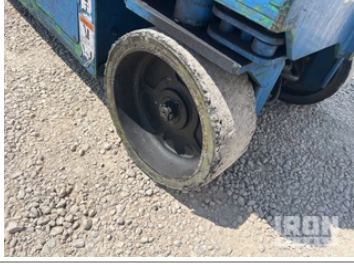
| Right Front Tire | Chunks missing | |

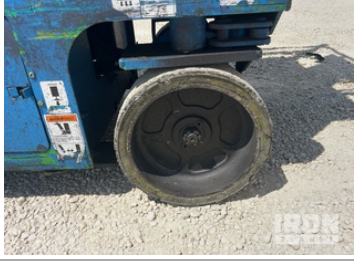
| Wheel Condition | No visible damage or missing components | |

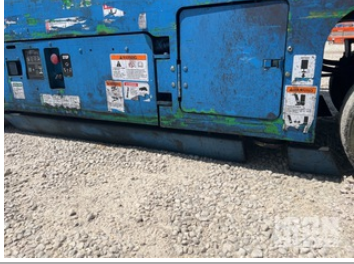
| Pothole Protection Bars | ★★★★☆<br>Functional | |

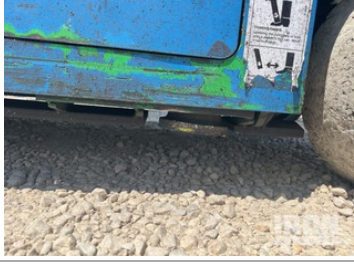
| Outriggers / Stabilizers | ★★★★☆ | |
