## Item #13810893 - 2016 Skyjack SJ4626 Electric Scissor Lift

# Inspection Report

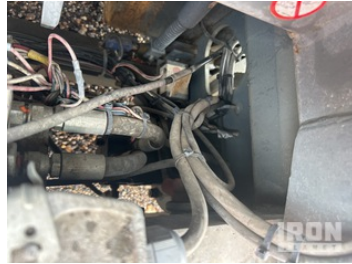
| Item | Assessment | Photo |
|---|---|---|
| Drive Motors | ★★★★ | |

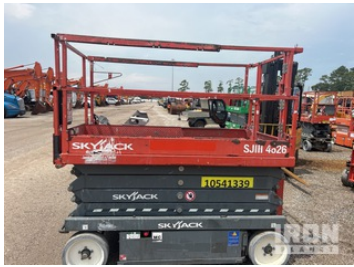
| Paint | Other unknown material Has scratches and rust all over it. | |

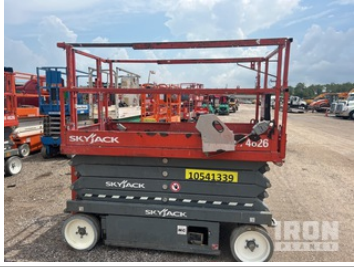
| Body Panels | No visible damage or missing components | |

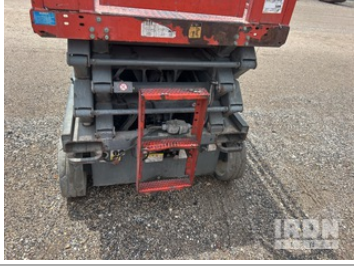
| Steps/Ladders | Bent. | |

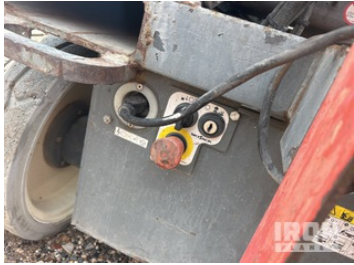
| Control Station Ground | | |
|---|---|---|
| Function Controls | ☆☆☆☆ | |

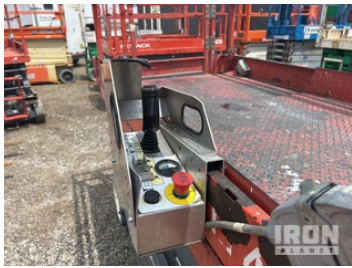
| Item | Assessment | Photo |
|---|---|---|
| Control Console | No visible damage or missing components | |

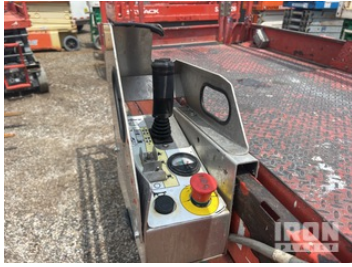
| Item | Assessment | Photo |
|---|---|---|
| Emergency Shut Off Switch | Operational | |

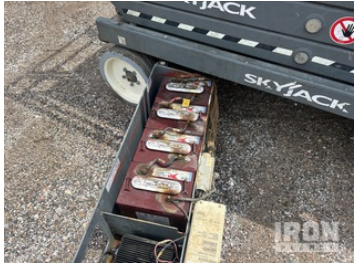
| Electrical Operating System | | |
|---|---|---|
| Cables and Connections | No visible damage or missing components | |

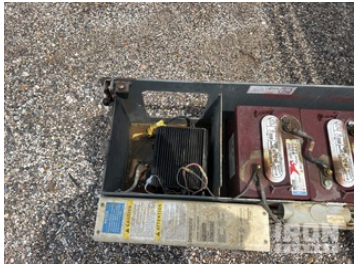
| Electrical Operating System | | |
|---|---|---|
| Battery Charger | Included 120 Volt, Single Phase | |

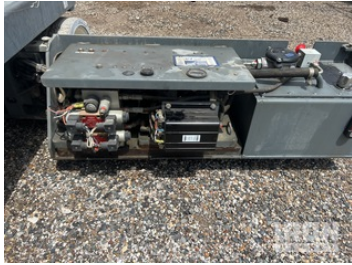
| Hydraulics | | |
|---|---|---|
| Pumps (Hydraulics) | ★★★★☆ | |

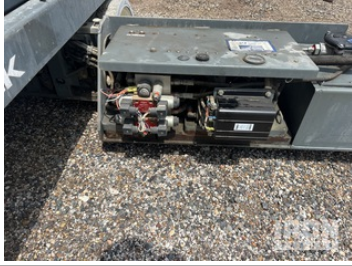
| Hydraulics | | |
|---|---|---|
| Valves | ★★★★☆ | |

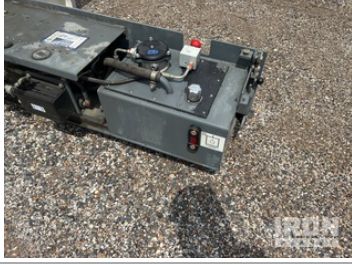
| Hydraulics | | |
|---|---|---|
| Hydraulic Tank | ★★★★☆ | |

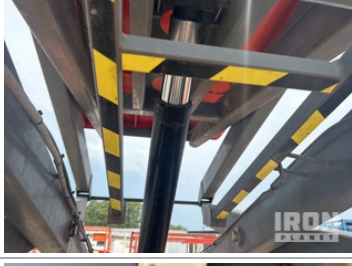
| Hydraulics | | |
|---|---|---|
| Lift Cylinders | ★★★★☆ | |

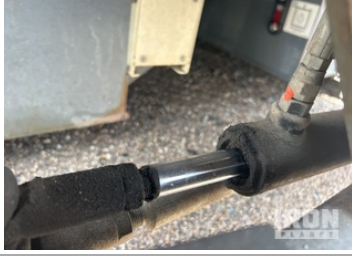
| Hydraulics | | |
|---|---|---|
| Steering Cylinder | ★★★★☆ | |

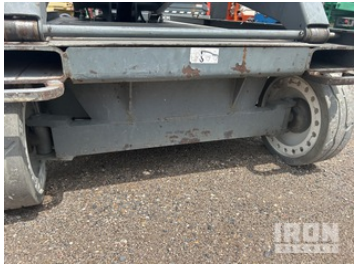
| Item | Assessment | Photo |
|---|---|---|
| Steering Linkage | ★★★★☆ | |

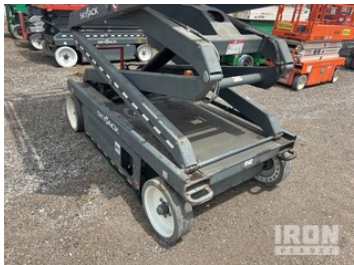
| Item | Assessment | Photo |
|---|---|---|
| Frame Condition | ★★★★☆ | |

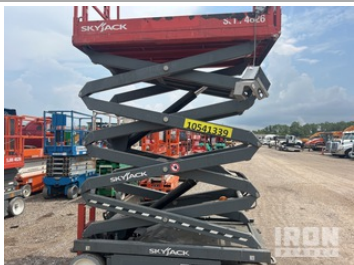
| Item | Assessment | Photo |
|---|---|---|
| Scissor Linkage | ★★★★☆ | |

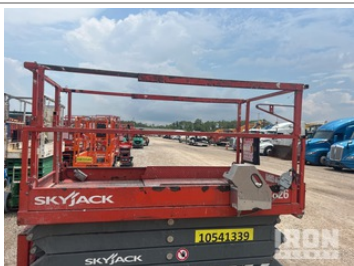
| Item | Assessment | Photo |
|---|---|---|
| Platform Condition | ★★★★☆ | |

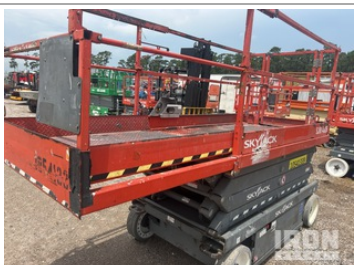
| Item | Assessment | Photo |
|---|---|---|
| Platform Extension | ★★★★☆ | |

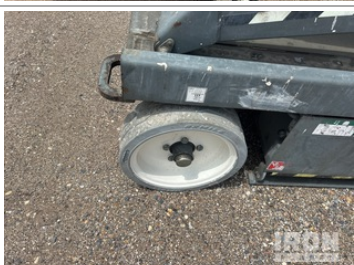
| Item | Assessment | Photo |
|---|---|---|
| Left Front Tire | Cracks | |

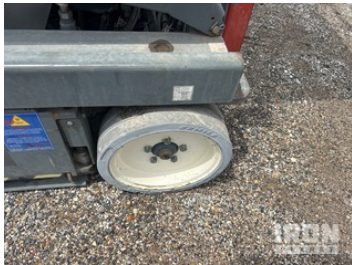
| Left Rear Tire | Cracks | |

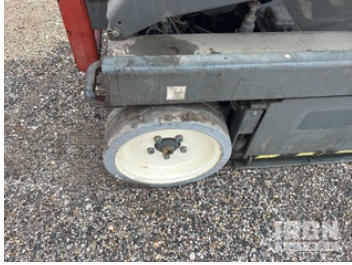
| Right Rear Tire | Cracks | |

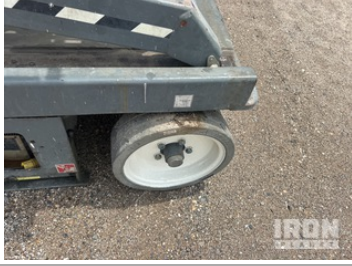
| Right Front Tire | Cracks | |

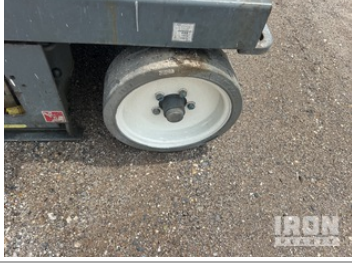
| Wheel Condition | No visible damage or missing components | |

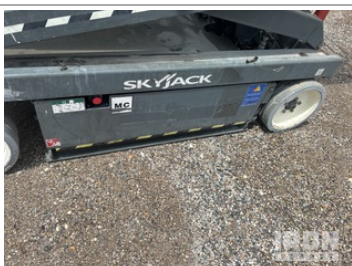
| Pothole Protection Bars | ★★★★☆<br>Functional | |
