Item #13445322 - 2024 Skyjack SJ3219 Electric Scissor Lift

Inspection Report

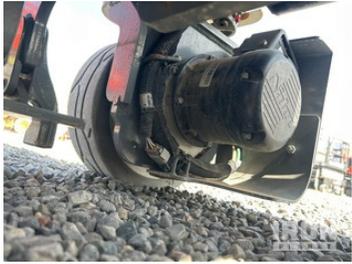
Drivetrain		
Operational test is limited to low speed in a confined flat area without load. Differential interlocks, full transmission shifting and functionality of all drive axles cannot be fully verified. Inspector listens for abnormal noises, observes leaks and notes physical damage.		
Item	Assessment	Photo
Drive Motors	★★★☆☆

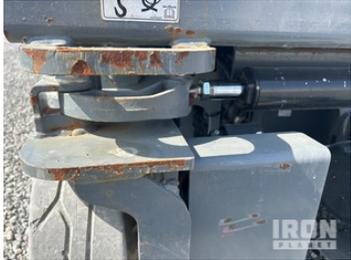
Chassis		
IronPlanet pin connection pivot point wear inspections are limited to sound, sight and feel observations. Dial indicator testing is not performed.		
Item	Assessment	Photo
Brake System	★★☆☆ The brake system functioned, stopping and holding the machine.	
Steering Linkage	★★☆☆

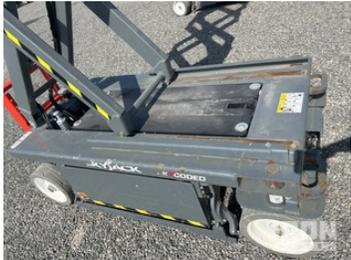
Frame Condition	★★☆☆

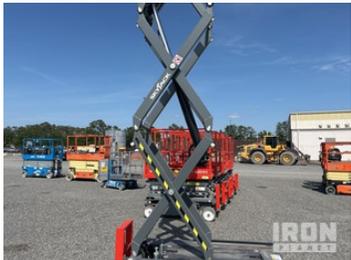
Scissor Linkage	★★☆☆

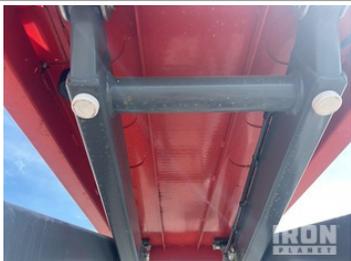
Platform Condition	★★☆☆

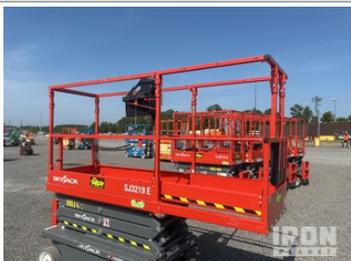
Platform Extension	★★☆☆

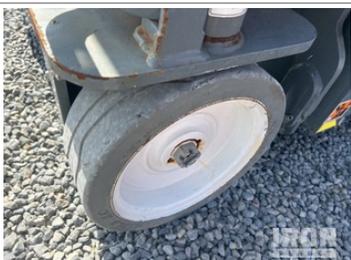
Left Front Tire	Chunks missing

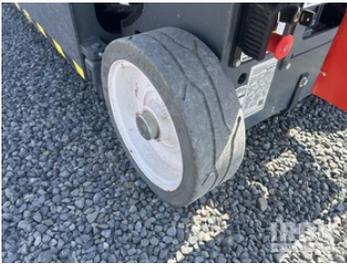
Left Rear Tire	Cracks

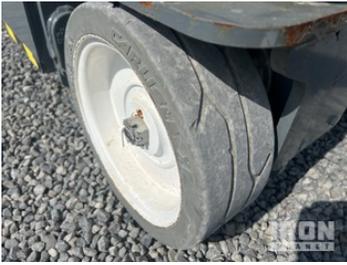
Right Front Tire	Cracks
