Item #13445339 - 2024 Skyjack SJ3219 Electric Scissor Lift

Inspection Report

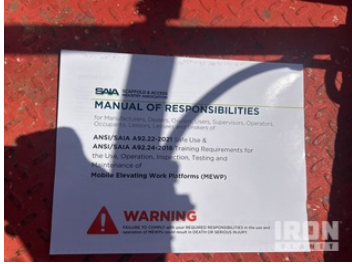
Safety		
Item	Assessment	Photo
Travel Alarm	Inoperable	
Horn	Operational	
Current Safety Manual	Yes	
Current Operator/Maintenance Manual	Yes	
ANSI Guidelines	Yes

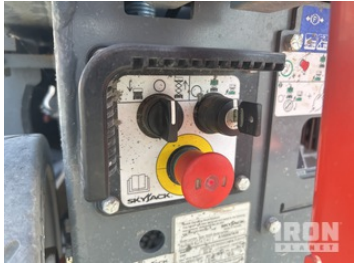
Control Station Ground		
Item	Assessment	Photo
Function Controls	★ ★ ★ ☆

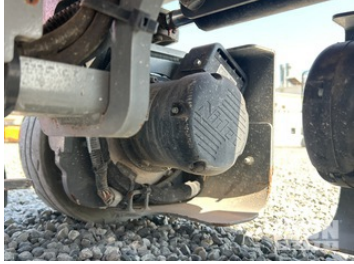
Drivetrain		
Operational test is limited to low speed in a confined flat area without load. Differential interlocks, full transmission shifting and functionality of all drive axles cannot be fully verified. Inspector listens for abnormal noises, observes leaks and notes physical damage.		
Item	Assessment	Photo
Drive Motors	★★★☆☆

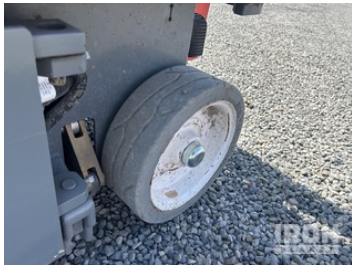
Left Rear Tire	Cracks, Chunks missing

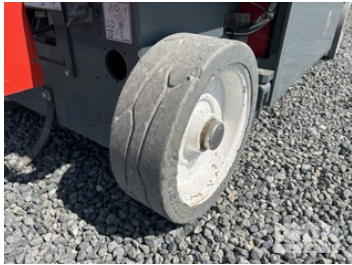
Right Rear Tire	Cracks, Chunks missing

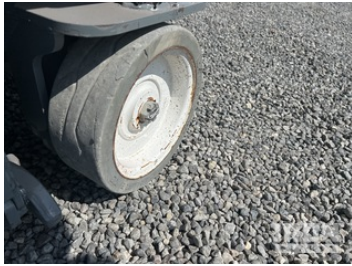
Right Front Tire	Cracks, Chunks missing
