## Item #13811392 - 2017 Skyjack SJ4626 Electric Scissor Lift

# Inspection Report

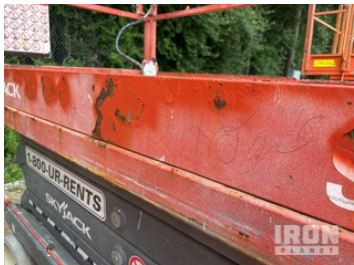
| Paint | No visible damage | |

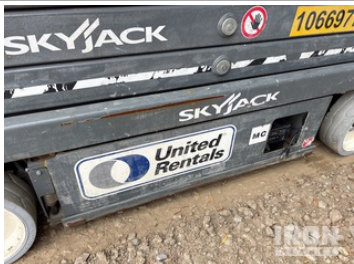
| Body Panels | No visible damage or missing components | |

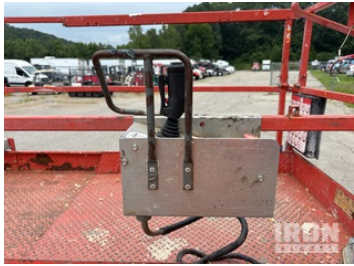
| Item | Assessment | Photo |
|---|---|---|
| Control Console | No visible damage or missing components | A photograph of the control console, a metal box mounted on a red metal frame. It has a black handle and a black cable connected to it. The background shows a parking lot with other vehicles. |

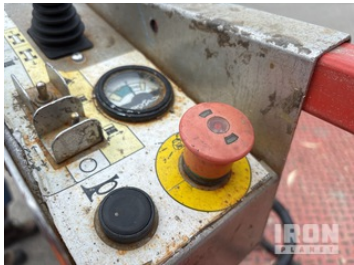
| Item | Assessment | Photo |
|---|---|---|
| Emergency Shut Off Switch | Operational | A close-up photograph of the emergency shut off switch, which is a red button with a black label, mounted on a metal plate. There is also a black dial indicator and a black cable connected to it. |

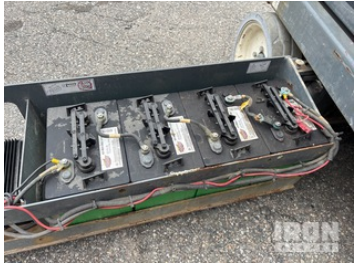
| Item | Assessment | Photo |
|---|---|---|
| Cables and Connections | No visible damage or missing components | |

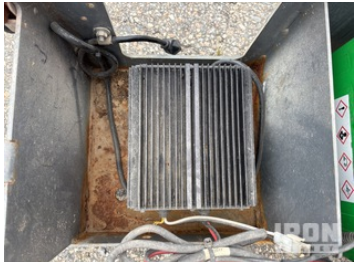
| Item | Assessment | Photo |
|---|---|---|
| Battery Charger | Included Appears normal - Not operationally checked, 120 Volt, Single Phase | |

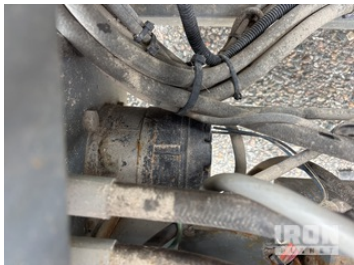
| Item | Assessment | Photo |
|---|---|---|
| Drive Motors | ★★★☆☆ | |

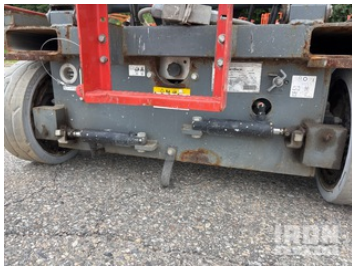
| Item | Assessment | Photo |
|---|---|---|
| Brake System | <p>★★★★☆</p> <p>The brake system functioned, stopping and holding the machine.</p> | |

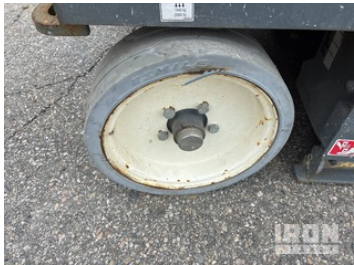
| Left Front Tire | Chunks missing, Tears | |

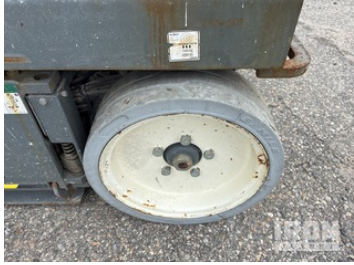
| Left Rear Tire | Chunks missing, Tears | |

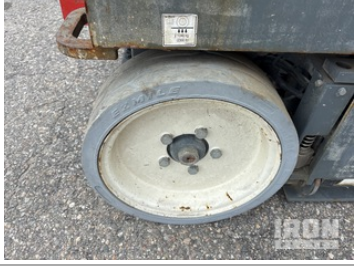
| Right Rear Tire | Tears | |

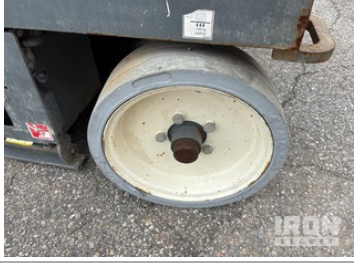
| Right Front Tire | Tears | |

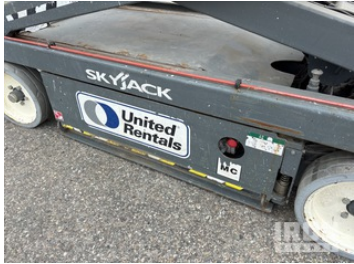
| Pothole Protection Bars | ★★★★☆<br>Functional | |
