## Item #13689579 - 2013 Genie GS3232 Electric Scissor Lift

# Inspection Report

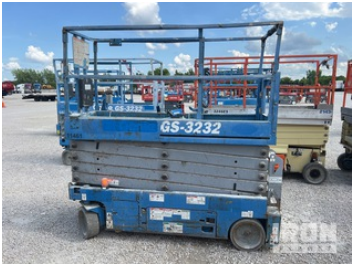
| Paint | No visible damage | |

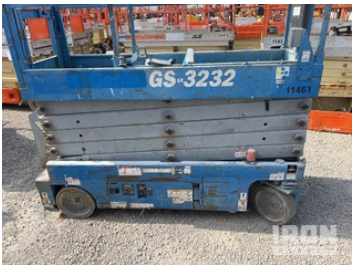
| Body Panels | No visible damage or missing components | |

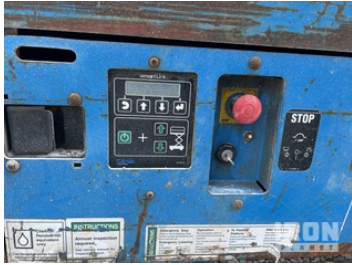
| Control Station Ground | | |
|---|---|---|
| Function Controls | ☆☆☆☆ | |

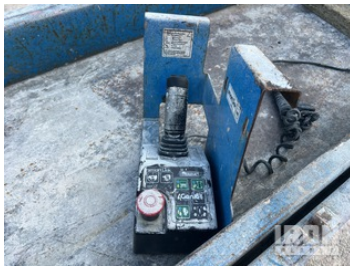
| Item | Assessment | Photo |
|---|---|---|
| Control Console | No visible damage or missing components | |

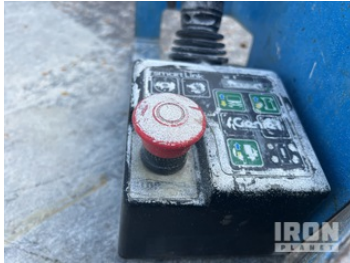
| Item | Assessment | Photo |
|---|---|---|
| Emergency Shut Off Switch | Operational | |

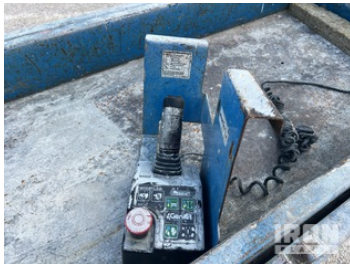
| Item | Assessment | Photo |
|---|---|---|
| Upper Function Controls | ☆☆☆☆ | |

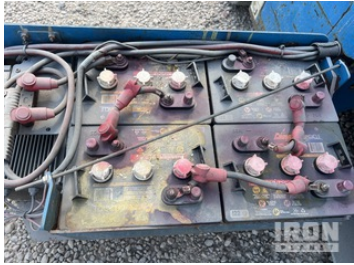
| Electrical Operating System | | |
|---|---|---|
| Cables and Connections | No visible damage or missing components | |

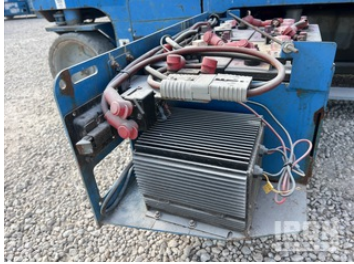
| Electrical Operating System | | |
|---|---|---|
| Battery Charger | Included Appears normal - Not operationally checked, 24 Volt, Single Phase | |

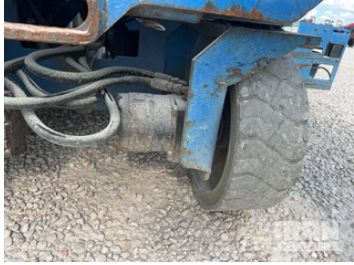
| Item | Assessment | Photo |
|---|---|---|
| Drive Motors | ★★★★☆ | |

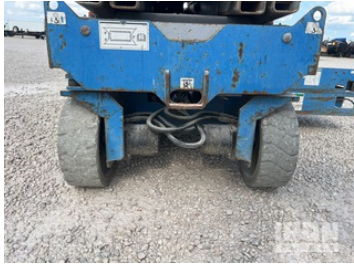
| Item | Assessment | Photo |
|---|---|---|
| Front Drive Axle | ★★★★☆ | |

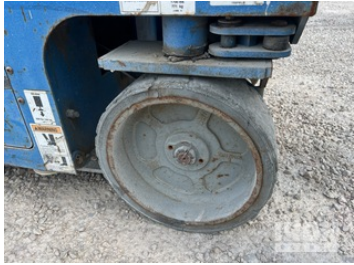
| Item | Assessment | Photo |
|---|---|---|
| Final Drives | ★★★★☆ | |

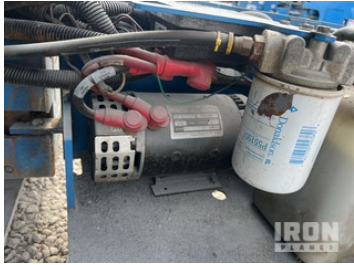
| Hydraulics | | |
|---|---|---|
| Pumps (Hydraulics) | ★★★★☆ | A close-up photograph of the hydraulic pump and filter assembly. The pump is a grey electric motor with a white filter canister attached. Various hoses and electrical wires are connected to the unit. The IronPlanet logo is visible in the bottom right corner. |

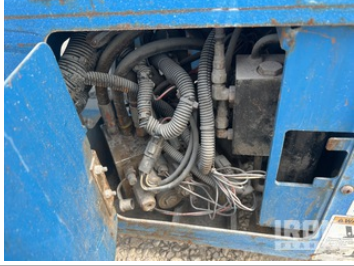
| Hydraulics | | |
|---|---|---|
| Valves | ★★★★☆ | A photograph showing the hydraulic valve manifold, which is a complex assembly of metal blocks with numerous hydraulic lines and hoses connected to it. The unit is painted blue and is located within the scissor lift's chassis. |

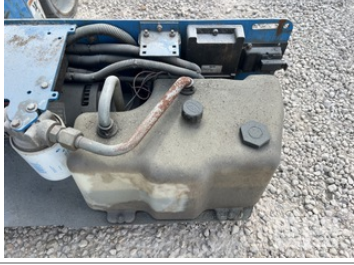
| Hydraulics | | |
|---|---|---|
| Hydraulic Tank | ★★★★☆ | A photograph of the hydraulic tank, a large, rectangular metal container with various ports and hoses. It is situated on a gravel surface. The IronPlanet logo is visible in the bottom right corner. |

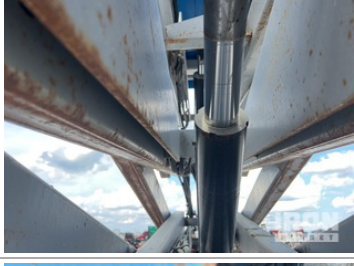
| Hydraulics | | |
|---|---|---|
| Lift Cylinders | ★★★★☆ | A photograph of a lift cylinder, showing the hydraulic ram extending upwards. The cylinder is part of the scissor mechanism that raises the lift platform. The IronPlanet logo is visible in the bottom right corner. |

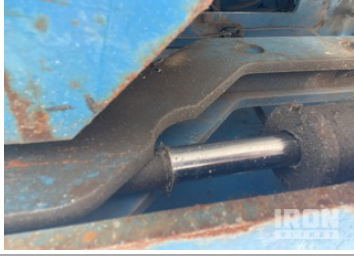
| Hydraulics | | |
|---|---|---|
| Steering Cylinder | ★★★★☆ | A photograph of a steering cylinder, which is a hydraulic cylinder used to control the steering of the lift. It is mounted on a metal frame. The IronPlanet logo is visible in the bottom right corner. |

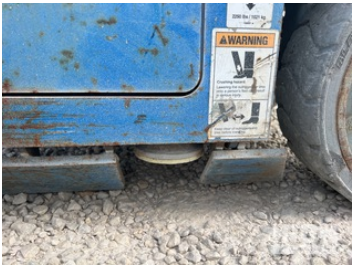
| Outrigger Cylinders | ☆☆☆☆ | |

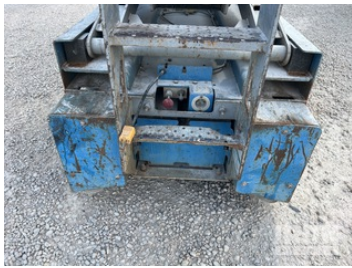
| Item | Assessment | Photo |
|---|---|---|
| Brake System | ★★☆☆<br>The brake system functioned, stopping and holding the machine. | |

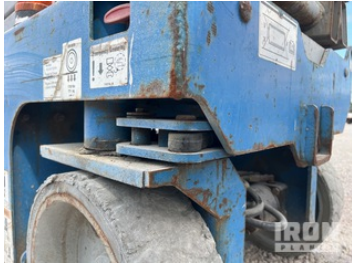
| Item | Assessment | Photo |
|---|---|---|
| Steering Linkage | ★★☆☆ | |

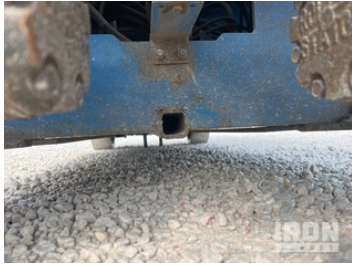
| Item | Assessment | Photo |
|---|---|---|
| Frame Condition | ★★☆☆ | |

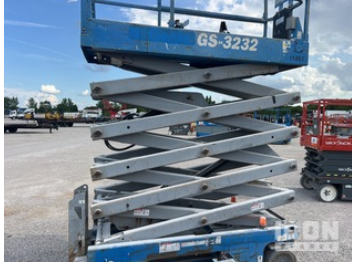
| Item | Assessment | Photo |
|---|---|---|
| Scissor Linkage | ★★☆☆ | |

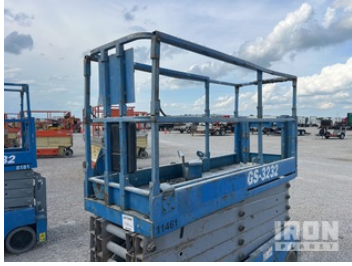
| Item | Assessment | Photo |
|---|---|---|
| Platform Condition | ★★☆☆ | |

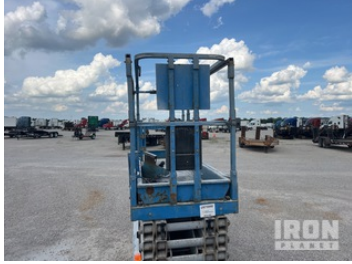
| Item | Assessment | Photo |
|---|---|---|
| Platform Extension | ★★☆☆ | |

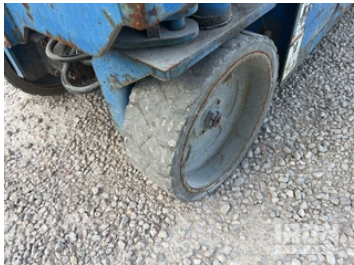
| Left Front Tire | No visible defects | |

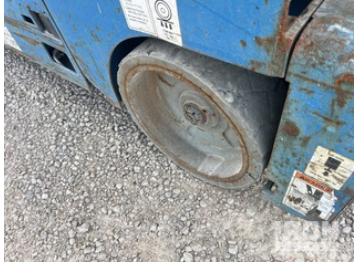
| Left Rear Tire | No visible defects | |

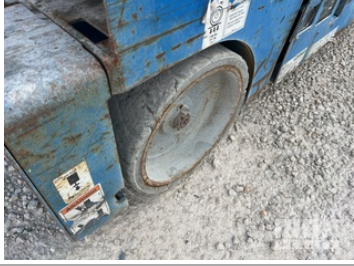
| Right Rear Tire | No visible defects | |

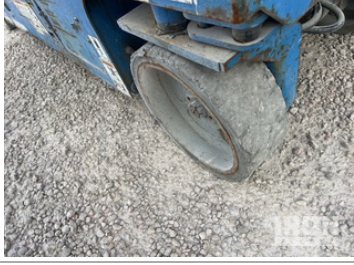
| Right Front Tire | No visible defects | |

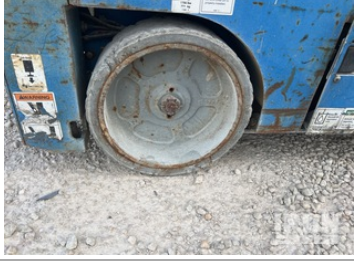
| Wheel Condition | No visible damage or missing components | |

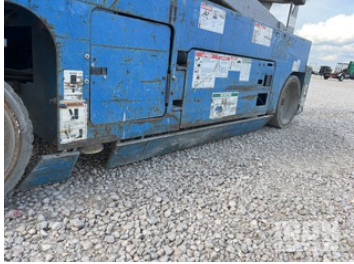
| Pothole Protection Bars | ★★★★☆<br>Functional | |

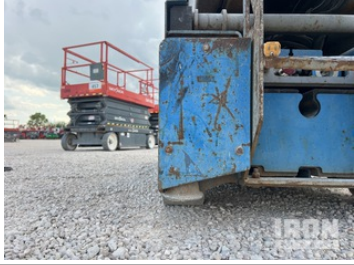
| Outriggers / Stabilizers | ★★★★☆ | |
