## Item #14251156 - 2005 JLG E450AJ 2WD Electric Articulating Boom Lift

# Inspection Report

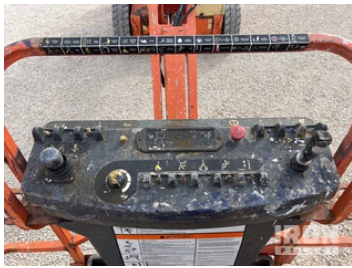
| Control Station | | |
|---|---|---|
| Control Console | Material buildup Lower housing damaged | |

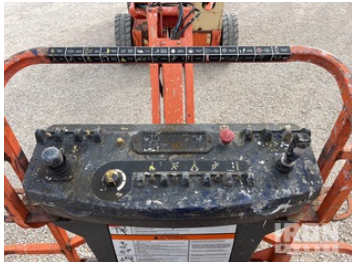
| Control Station | | |
|---|---|---|
| Function Controls | ★★★☆☆<br>Damaged boots | |

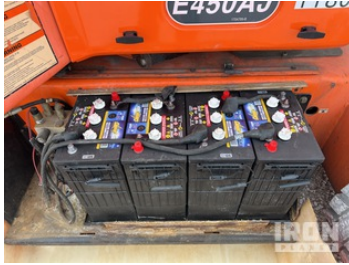
| Electrical Operating System | | |
|---|---|---|
| Cables and Connections | No visible damage or missing components | |

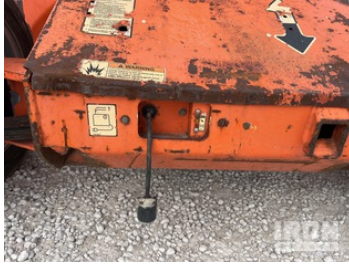
| Electrical Operating System | | |
|---|---|---|
| Battery Charger | Included Appears normal - Not operationally checked, 115 Volt, Single Phase | |

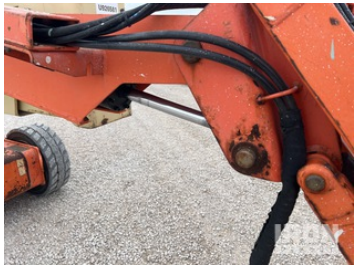
| Basket Tilt Cylinder | ★ ★ ★ ☆ | |

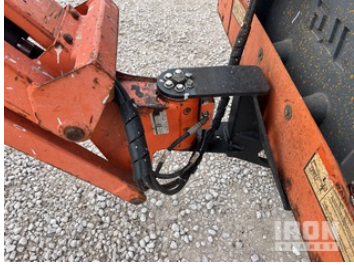
| Basket Rotator Motor | ★ ★ ★ ☆ | |

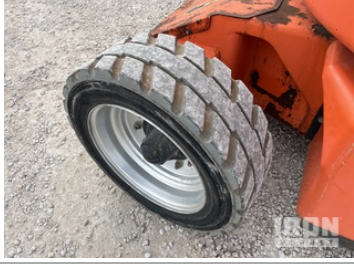
| Chassis | | |
|---|---|---|
| Left Front Tire | Cracks, Chunks missing, Tears | |

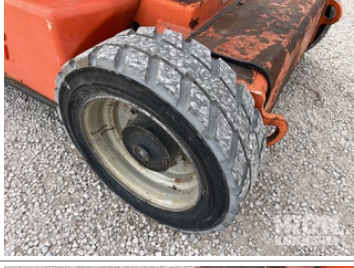
| Chassis | | |
|---|---|---|
| Left Rear Tire | Cracks, Chunks missing, Tears | |

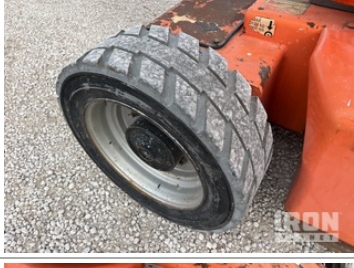
| Chassis | | |
|---|---|---|
| Right Rear Tire | Cracks, Chunks missing, Tears | |

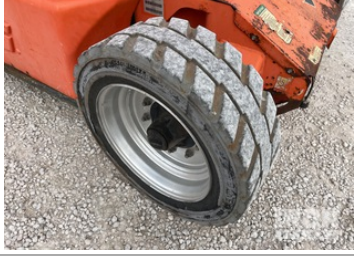
| Chassis | | |
|---|---|---|
| Right Front Tire | Cracks, Chunks missing, Tears | |
