## Item #13811319 - 2017 Skyjack SJ66T 4WD Diesel Telescopic Boom Lift

## Inspection Report

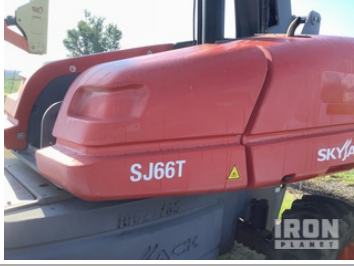
| Paint | No visible damage | |

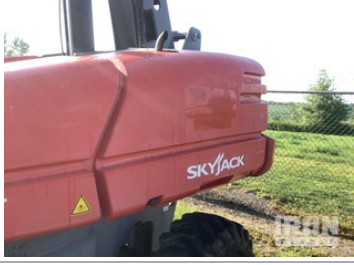
| Body Panels | Engine compartment door damaged | |

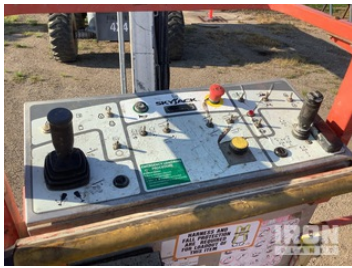
| Item | Assessment | Photo |
|---|---|---|
| Control Console | No visible damage or missing components | |

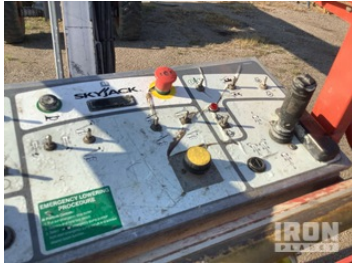
| Item | Assessment | Photo |
|---|---|---|
| Emergency Shut Off Switch | Operational | |

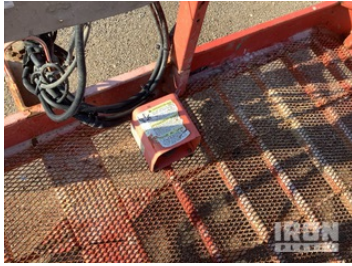
| Item | Assessment | Photo |
|---|---|---|
| Safety Control Foot Switch | ★★★★☆<br>Operational | |

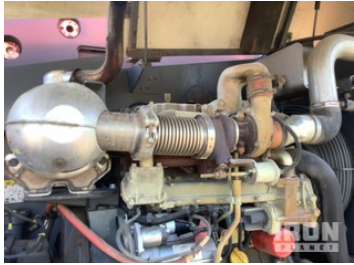
| Engine | | |
|---|---|---|
| Exhaust System | No visible damage or missing components | |

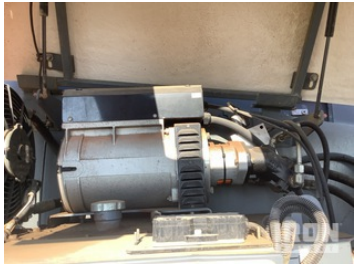
| Engine | | |
|---|---|---|
| Onboard Generator | Not operationally checked | |

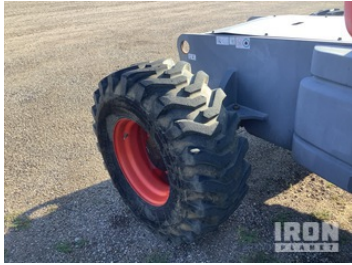
| Chassis | | |
|---|---|---|
| Left Front Tire | No visible defects | |

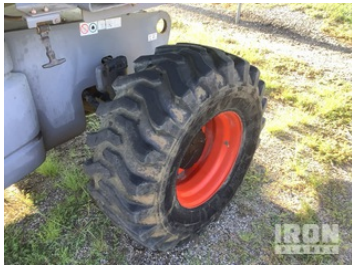
| Chassis | | |
|---|---|---|
| Left Rear Tire | No visible defects | |

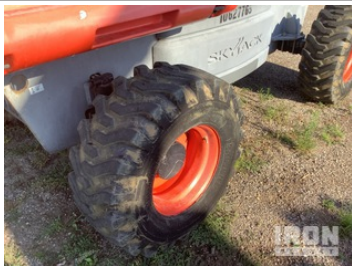
| Chassis | | |
|---|---|---|
| Right Rear Tire | No visible defects | |

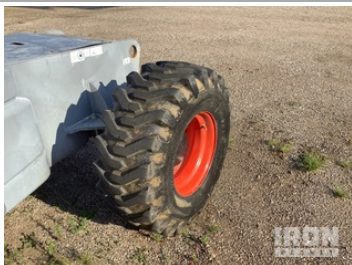
| Chassis | | |
|---|---|---|
| Right Front Tire | No visible defects | |
