## Item #13890693 - 2016 Skyjack SJ40T 4WD Diesel Telescopic Boom Lift

# Inspection Report

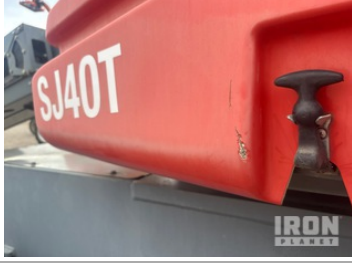
| Body Panels | Engine compartment door damaged, Hydraulic compartment door damaged | |

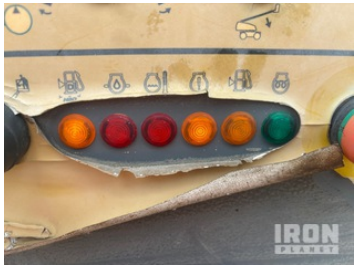
| Control Station Ground | | |
|---|---|---|
| Oil Pressure | Warning light inoperable Did not illuminate with switch on or startup | |

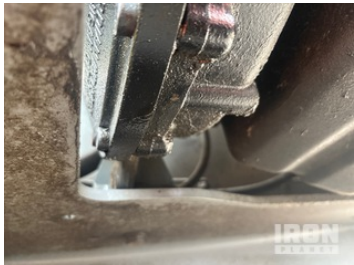
| Oil Leaks | Rear of engine, Accumulation at rear of engine | |

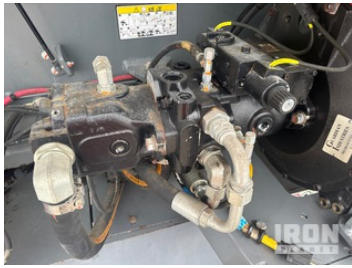
| Hydraulics | | |
|---|---|---|
| Pumps (Hydraulics) | ★★☆☆<br>Dripping leak | |

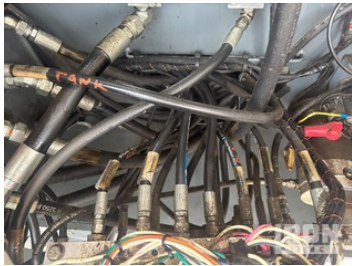
| Hydraulics | | |
|---|---|---|
| Hoses (Hydraulic) | ★★☆☆<br>Leaking hoses on bottom of hydraulic tank | |

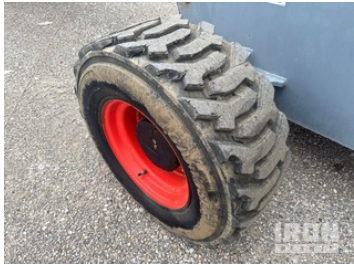
| Left Front Tire | Chunks missing, Tears | |

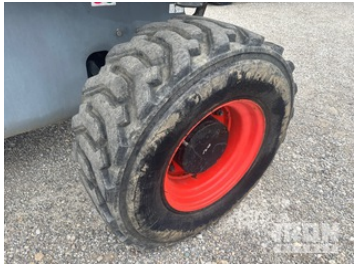
| Left Rear Tire | Cracks, Tears | |

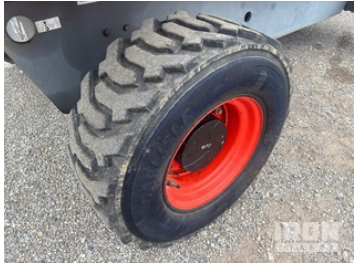
| Right Rear Tire | Cracks, Tears | |

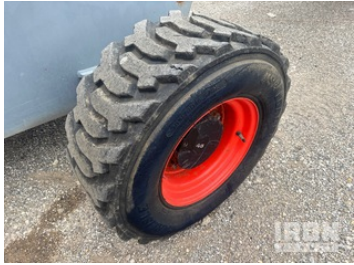
| Right Front Tire | Chunks missing, Tears | |
