## Item #13811404 - 2018 JLG 4069LE Electric Scissor Lift

# Inspection Report

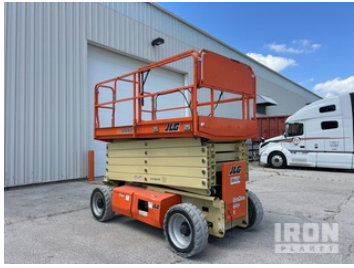
| Paint | No visible damage | |

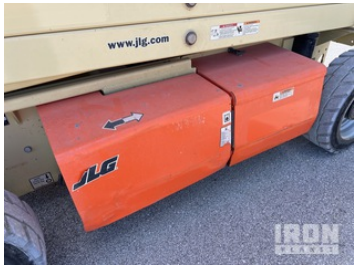
| Body Panels | Hydraulic compartment door damaged, Front door damaged. | |

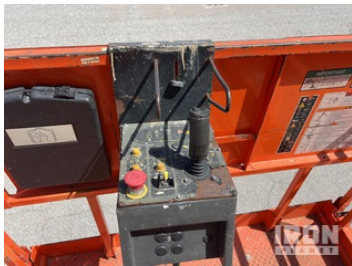
| Item | Assessment | Photo |
|---|---|---|
| Control Console | No visible damage or missing components | |

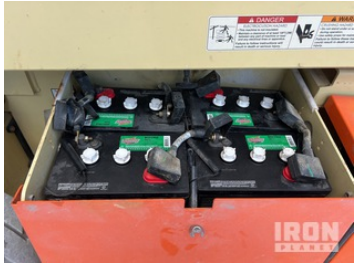
| Electrical Operating System | | |
|---|---|---|
| Cables and Connections | No visible damage or missing components | |

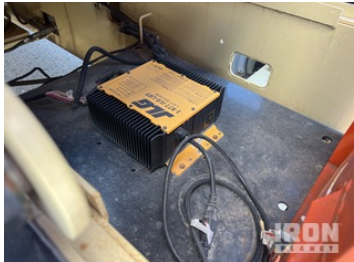
| Electrical Operating System | | |
|---|---|---|
| Battery Charger | Included Appears normal - Not operationally checked, 120 Volt, Single Phase | |

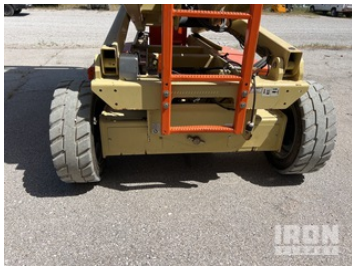
| Item | Assessment | Photo |
|---|---|---|
| Brake System | ★★☆☆<br>The brake system functioned, stopping and holding the machine. | |

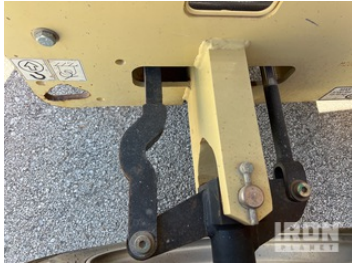
| Item | Assessment | Photo |
|---|---|---|
| Steering Linkage | ★★☆☆ | |

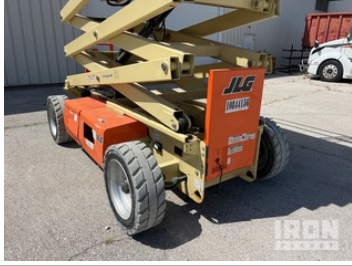
| Item | Assessment | Photo |
|---|---|---|
| Frame Condition | ★★☆☆ | |

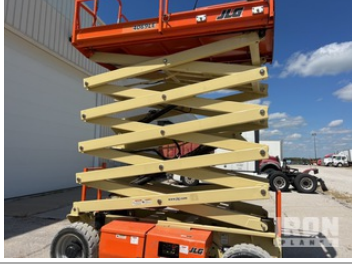
| Item | Assessment | Photo |
|---|---|---|
| Scissor Linkage | ★★☆☆ | |

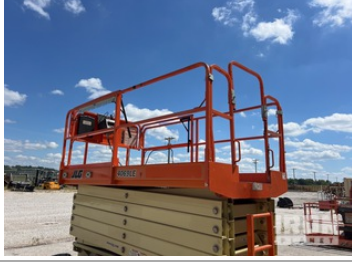
| Item | Assessment | Photo |
|---|---|---|
| Platform Condition | ★★☆☆ | |

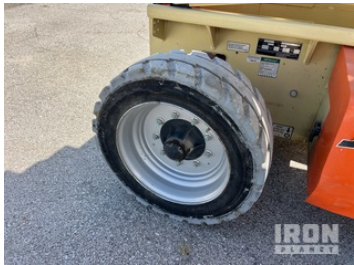
| Left Front Tire | Cracks, Chunks missing | |

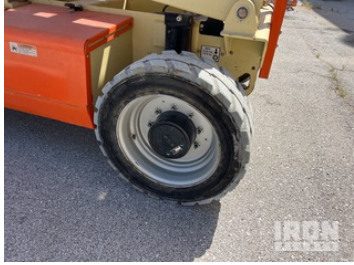
| Left Rear Tire | Cracks, Chunks missing | |

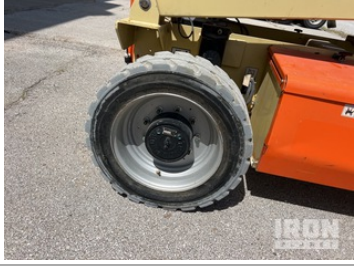
| Right Rear Tire | Cracks, Chunks missing | |

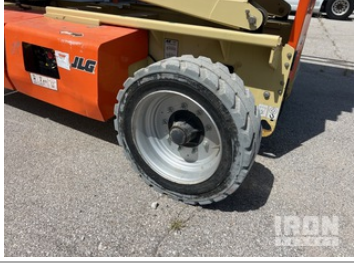
| Right Front Tire | Cracks, Chunks missing | |
