Item #14094985 - 2017 JLG 450AJ 4WD Diesel Articulating Boom Lift

Inspection Report

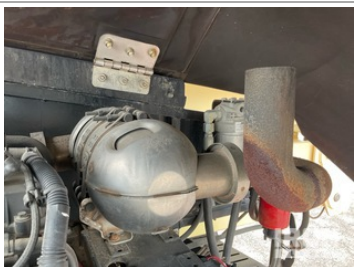
Exhaust System	No visible damage or missing components

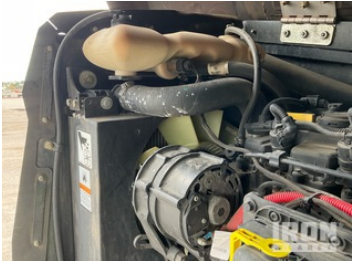
Radiator	★★★★☆

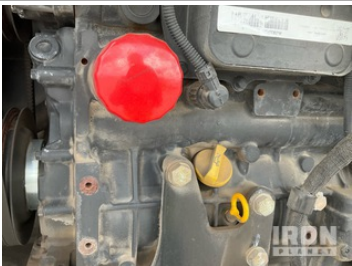
Oil Leaks	No dripping leaks

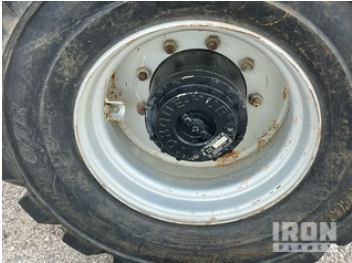
Right Front Final Drive	☆☆☆☆

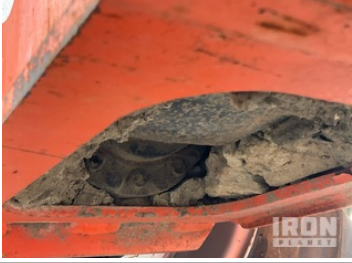
Right Front Drive Motor	☆☆☆☆

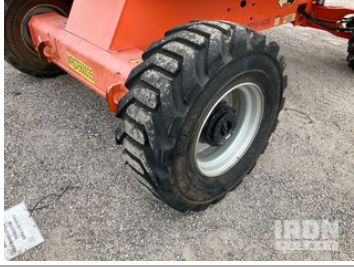
Brake System	★★★★☆	
Left Front Tire	Cracks, Chunks missing

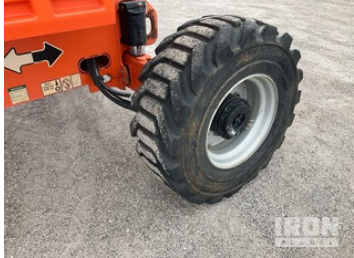
Left Rear Tire	Cracks, Chunks missing

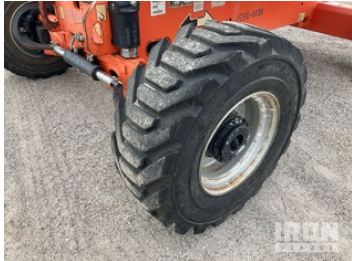
Right Rear Tire	Cracks, Chunks missing

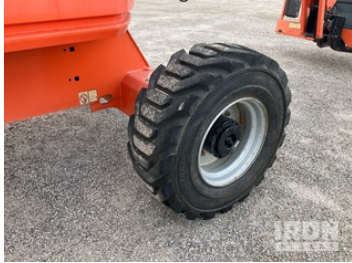
Right Front Tire	Cracks, Chunks missing

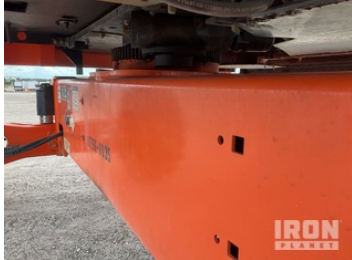
Turntable Bearing	★★★★☆

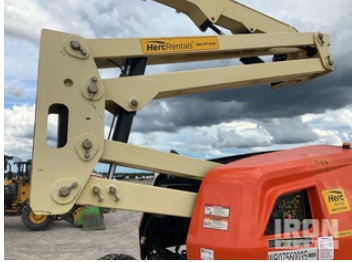
Boom Condition	★★★★☆

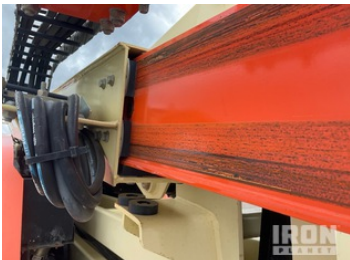
A photograph showing the right side of the articulating boom of a scissor lift. The boom is orange and yellow, extending upwards against a cloudy sky. An "IRON PLANET" watermark is visible in the bottom right corner.
Boom Wear Guides	★★★★☆
