## Item #14251171 - 2005 JLG 600S 4WD Diesel Telescopic Boom Lift

# Inspection Report

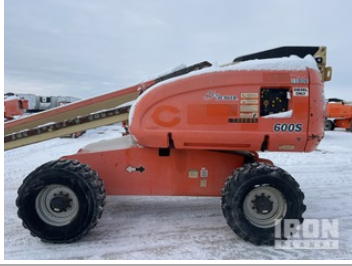
| Paint | Concrete residue Other unknown material | |

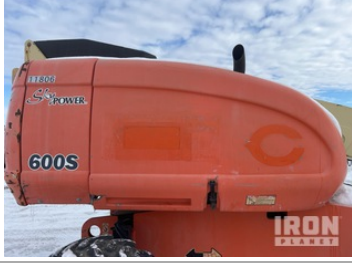
| Body Panels | Engine compartment door damaged, Hydraulic compartment door damaged | |

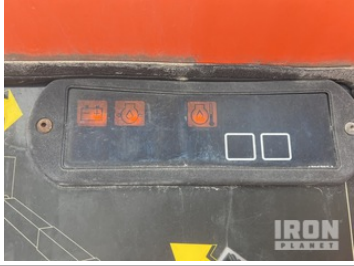
| Control Station Ground | | |
|---|---|---|
| Oil Pressure | The fault indicator shuts off after the engine oil pressure rises. | |

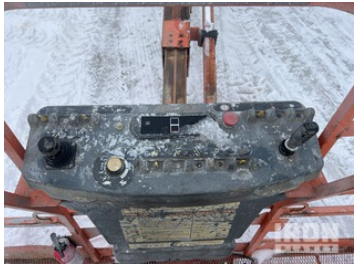
| Item | Assessment | Photo |
|---|---|---|
| Control Console | Control area (top) damaged Material buildup | |

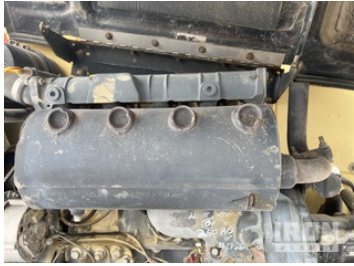
| Engine | | |
|---|---|---|
| Exhaust System | Muffler damaged | |

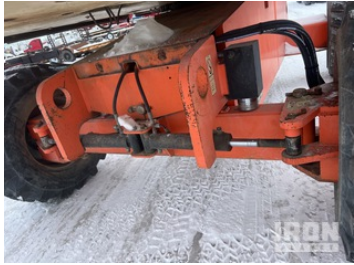
| Chassis | | |
|---|---|---|
| Steering Linkage | ★★★☆☆ | |

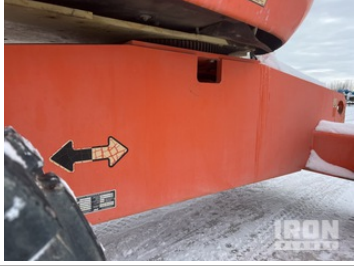
| Chassis | | |
|---|---|---|
| Frame Condition | ★★★☆☆ | |

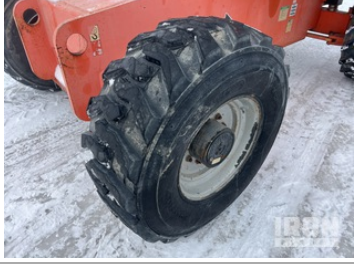
| Chassis | | |
|---|---|---|
| Left Front Tire | Cracks, Chunks missing, Tears | |

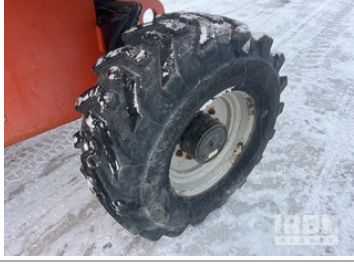
| Chassis | | |
|---|---|---|
| Left Rear Tire | Cracks, Chunks missing, Tears | |

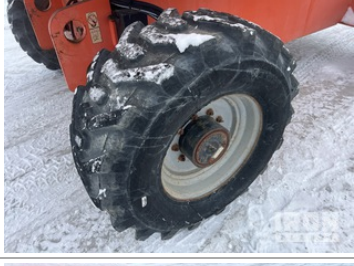
| Chassis | | |
|---|---|---|
| Right Rear Tire | Cracks, Chunks missing, Tears | |

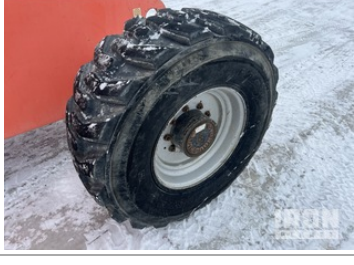
| Chassis | | |
|---|---|---|
| Right Front Tire | Cracks, Chunks missing, Tears | |
