## Item #14097075 - 2017 JLG 660SJ 4WD Diesel Telescopic Boom Lift

- Features: 65 ft Max Platform Height, 520 lb Max Weight Capacity, Jib, Power to Platform, 2017 US EPA Label, Deutz TD2.9L4 4 Cylinder 50 hp Diesel Engine, 355/55D625 Foam-Filled Tires
- Meter Reading: 2,858 Hours
- Serial # : 0300236821
- Inspection Completed: 12/2/25

## Inspection Report

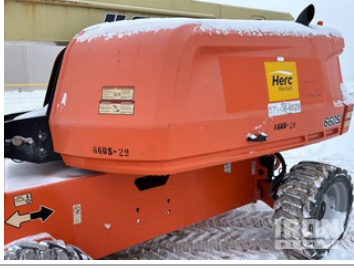
| Paint | No visible damage | |

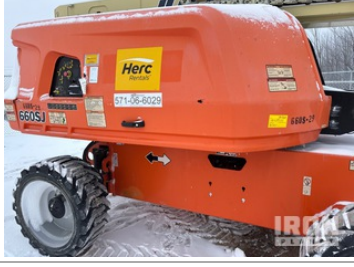
| Body Panels | No visible damage or missing components | |

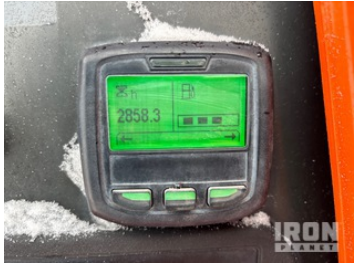
| Control Station Ground | | |
|---|---|---|
| Gauges | Operational | |

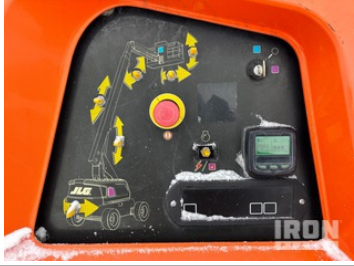
| Control Station Ground | | |
|---|---|---|
| Function Controls | ★★★★☆ | |

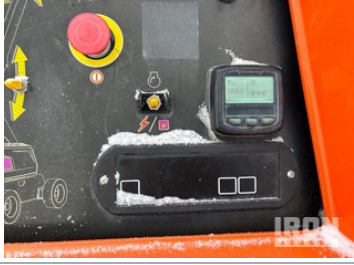
| Control Station Ground | | |
|---|---|---|
| Oil Pressure | No oil pressure indicator | |

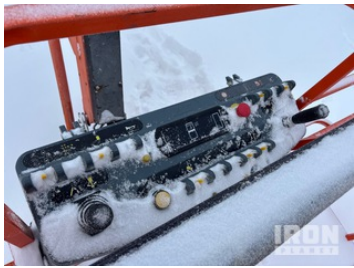
| Item | Assessment | Photo |
|---|---|---|
| Control Console | No visible damage or missing components | |

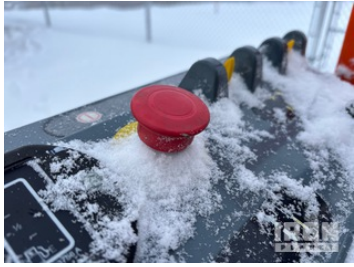
| Item | Assessment | Photo |
|---|---|---|
| Emergency Shut Off Switch | Operational | |

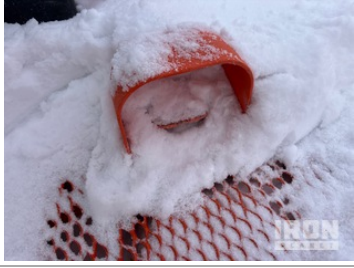
| Item | Assessment | Photo |
|---|---|---|
| Safety Control Hand/Foot Switch | ★★★★☆ | |

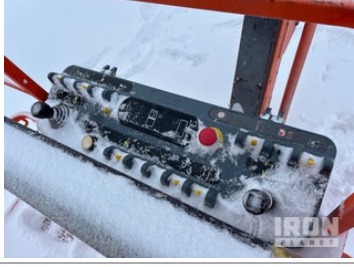
| Item | Assessment | Photo |
|---|---|---|
| Function Controls | ★★★★☆ | |

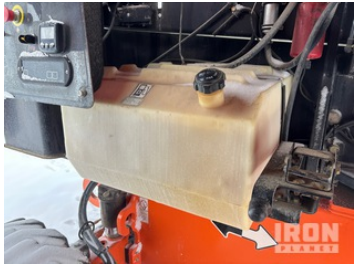
| Engine | | |
|---|---|---|
| Fuel System | Operational | |

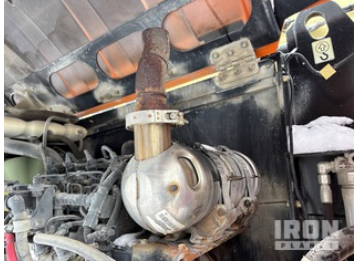
| Engine | | |
|---|---|---|
| Exhaust System | No visible damage or missing components | |

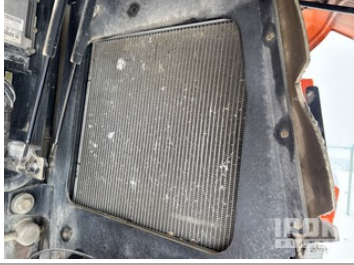
| Engine | | |
|---|---|---|
| Radiator | ★★★★☆ | |

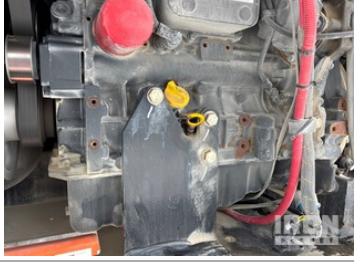
| Engine | | |
|---|---|---|
| Oil Leaks | No dripping leaks | |

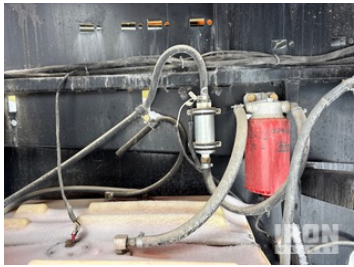
| Fuel Leaks | No dripping leaks | |

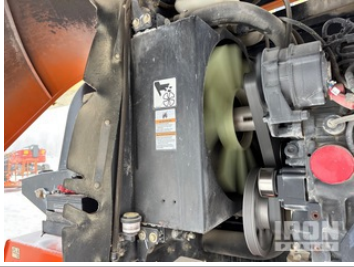
| Cooling System Leaks | No dripping leaks | |

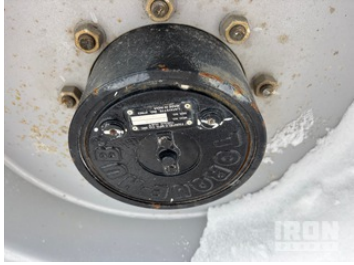
| Item | Assessment | Photo |
|---|---|---|
| Left Front Final Drive | ★★★★☆ | A close-up photograph of the left front final drive assembly, showing a black circular cover with a central bolt and surrounding mounting hardware. |

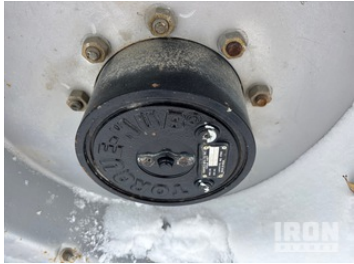
| Item | Assessment | Photo |
|---|---|---|
| Left Rear Final Drive | ★★★★☆ | A close-up photograph of the left rear final drive assembly, showing a black circular cover with a central bolt and surrounding mounting hardware. |

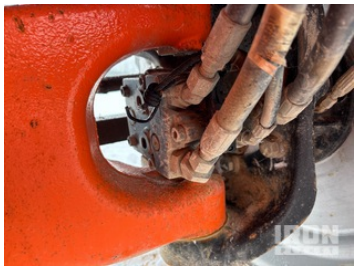
| Item | Assessment | Photo |
|---|---|---|
| Left Rear Drive Motor | ★★★★☆ | A photograph showing the left rear drive motor, which is a red, cylindrical component with a central shaft and surrounding mechanical parts. |

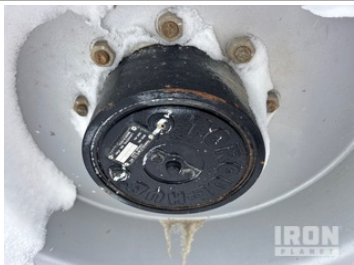
| Item | Assessment | Photo |
|---|---|---|
| Right Rear Final Drive | ★★★★☆ | A close-up photograph of the right rear final drive assembly, showing a black circular cover with a central bolt and surrounding mounting hardware. |

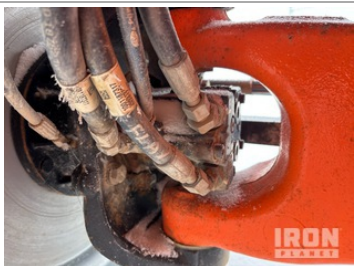
| Item | Assessment | Photo |
|---|---|---|
| Right Rear Drive Motor | ★★★★☆ | A photograph showing the right rear drive motor, which is a red, cylindrical component with a central shaft and surrounding mechanical parts. |

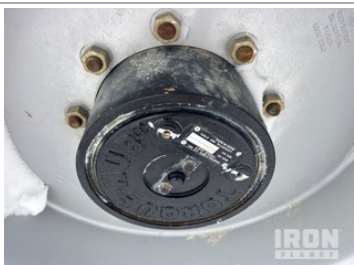
| Item | Assessment | Photo |
|---|---|---|
| Right Front Final Drive | ★★★★☆ | A close-up photograph of the right front final drive assembly, showing a black circular cover with a central bolt and surrounding mounting hardware. |

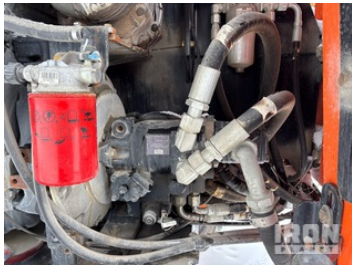
| Hydraulics | | |
|---|---|---|
| Pumps (Hydraulics) | ★★★☆☆ | |

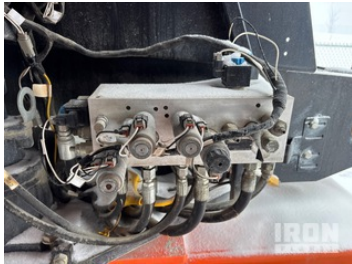
| Hydraulics | | |
|---|---|---|
| Valves | ★★★☆☆ | |

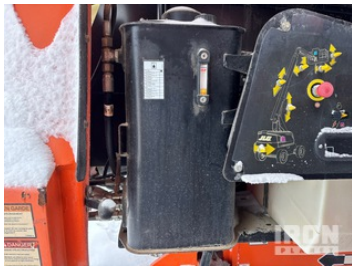
| Hydraulics | | |
|---|---|---|
| Hydraulic Tank | ★★★☆☆ | |

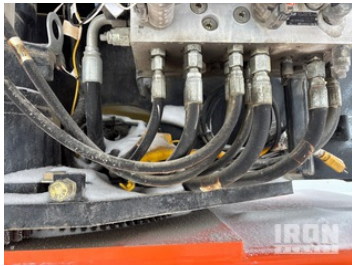
| Hydraulics | | |
|---|---|---|
| Hoses (Hydraulic) | ★★★☆☆ | |

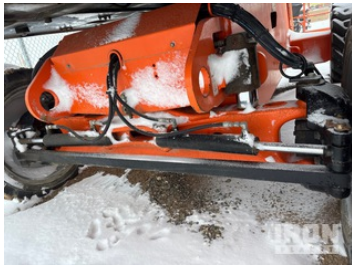
| Hydraulics | | |
|---|---|---|
| Steering Cylinders | ★★★☆☆ | |

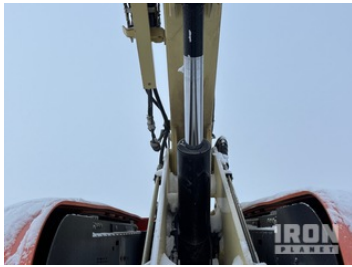
| Hydraulics | | |
|---|---|---|
| Boom Lift Cylinder | ★★★☆☆ | |

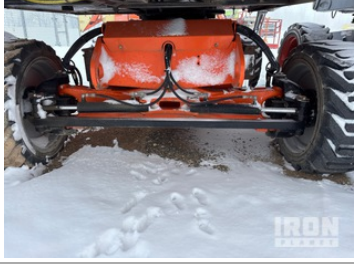
| Chassis | | |
|---|---|---|
| Steering Linkage | ★★★★☆ | |

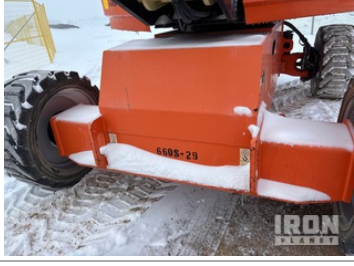
| Chassis | | |
|---|---|---|
| Frame Condition | ★★★★☆ | |

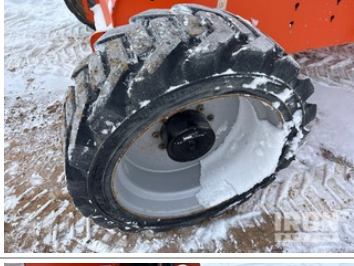
| Chassis | | |
|---|---|---|
| Left Front Tire | No visible defects | |

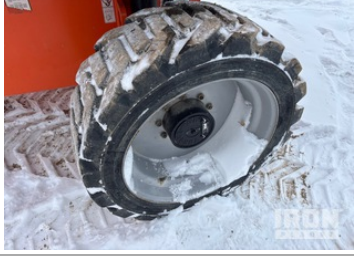
| Chassis | | |
|---|---|---|
| Left Rear Tire | No visible defects | |

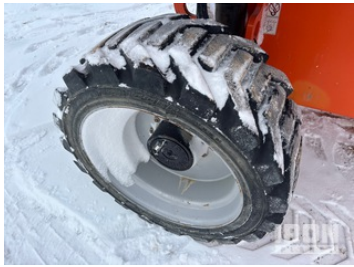
| Right Rear Tire | Tears | |

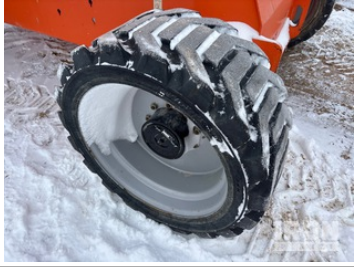
| Right Front Tire | No visible defects | |

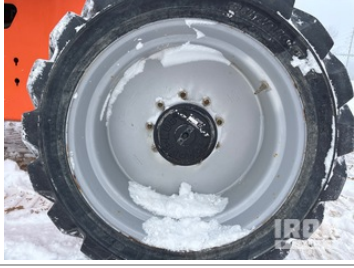
| Wheel Condition | No visible damage or missing components | |

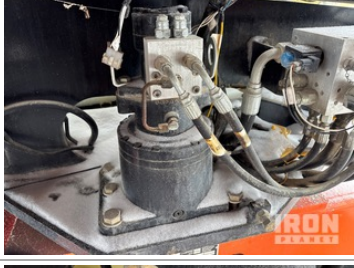
| Swing Motor | ★★★★☆ | |

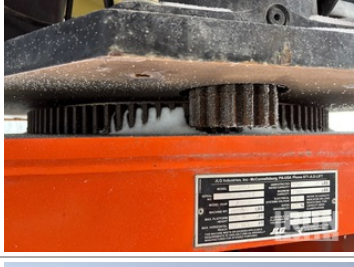
| Hydraulic Center Swivel | ★★★★☆ | |

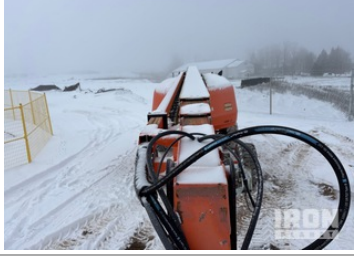
| Boom Condition | ★★★★☆ | |
