## Item #14349303 - 2016 JLG 1055 Telehandler

# Inspection Report

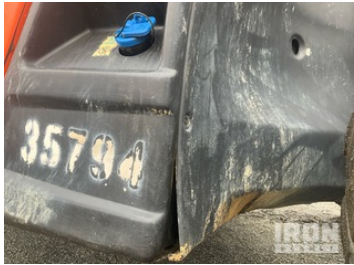
| Body Panels | No visible damage or missing components Fuel tank cover not bolted properly screw missing | |

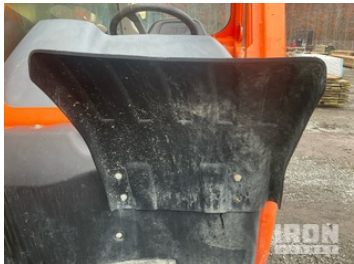
| Fenders | Left rear missing, Right front missing, Right rear missing | |

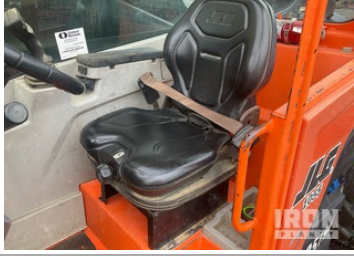
| Control Station | | |
|---|---|---|
| Seat/Armrests | Operator arm rest torn | |

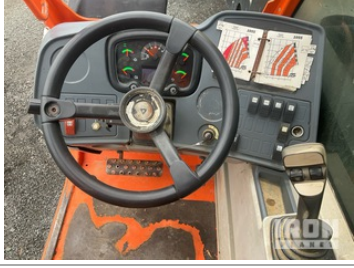
| Steering Control | ★★☆☆<br>Steering wheel switches missing | |

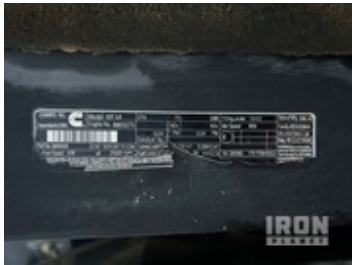
| Emission Label | Data tag damaged | |

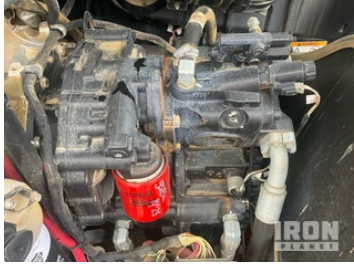
| Item | Assessment | Photo |
|---|---|---|
| Transmission | ★★☆☆<br>Operational | |

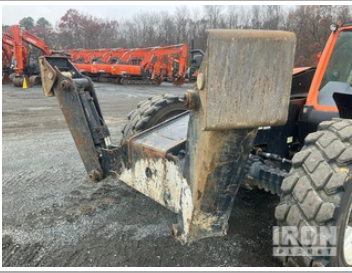
| <p>Outriggers</p> | <p>☆☆☆☆<br/>Street pads</p> | |
