## Item #13810958 - 2016 JLG 600AJ 4WD Diesel Articulating Boom Lift

# Inspection Report

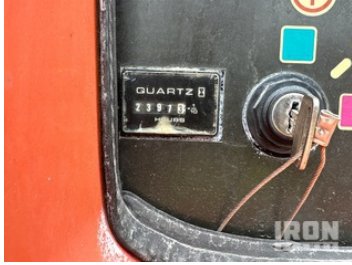
| Hour Meter / Odometer | 2397 hrs, Meter inoperable, Meter didn't change during inspection | |

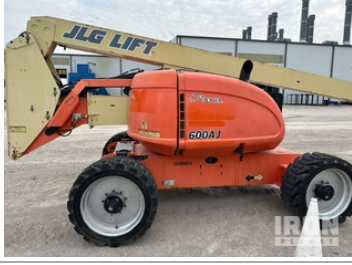
| Body Panels | No visible damage or missing components | |

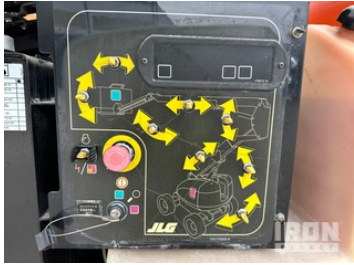
| Control Station Ground | | |
|---|---|---|
| Function Controls | ★★★★☆ | |

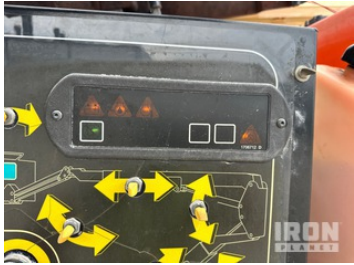
| Control Station Ground | | |
|---|---|---|
| Warning Lights | Operational | |

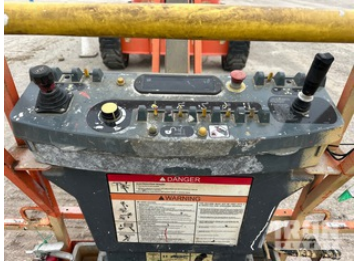
| Item | Assessment | Photo |
|---|---|---|
| Control Console | No visible damage or missing components | |

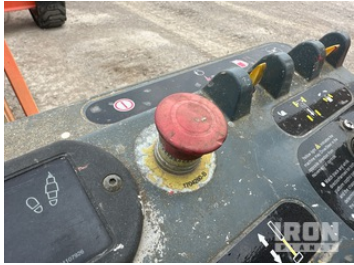
| Item | Assessment | Photo |
|---|---|---|
| Emergency Shut Off Switch | Operational | |

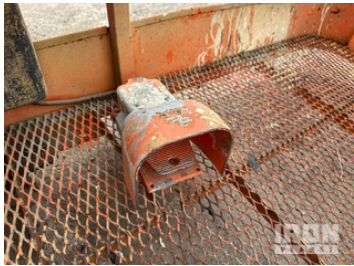
| Item | Assessment | Photo |
|---|---|---|
| Safety Control Foot Switch | Operational | |

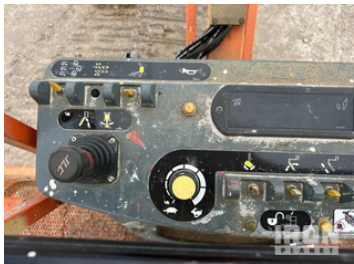
| Item | Assessment | Photo |
|---|---|---|
| Function Controls | ★★★★☆ | |

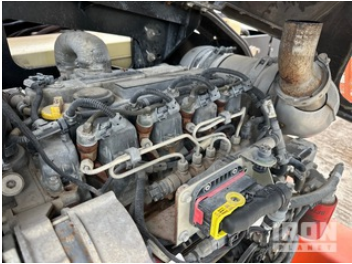
| Engine | | |
|---|---|---|
| Fuel System | Operational | |

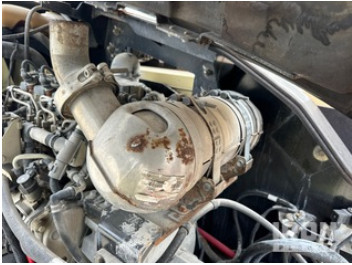
| Engine | | |
|---|---|---|
| Exhaust System | No visible damage or missing components | |

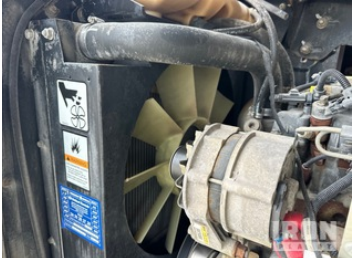
| Engine | | |
|---|---|---|
| Radiator | ★★★★☆ | |

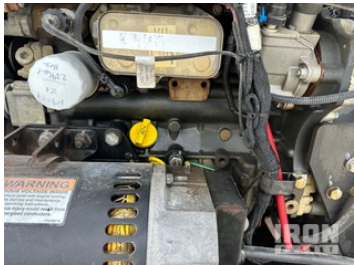
| Oil Leaks | No dripping leaks | |

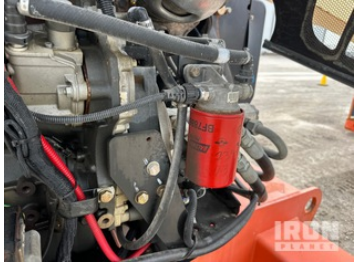
| Fuel Leaks | No dripping leaks | |

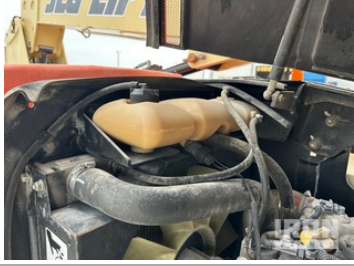
| Cooling System Leaks | No dripping leaks | |

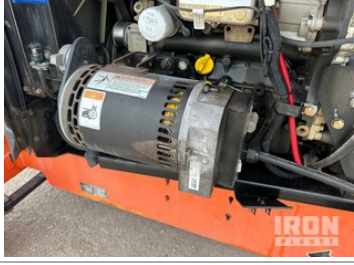
| Onboard Generator | Not operationally checked | |

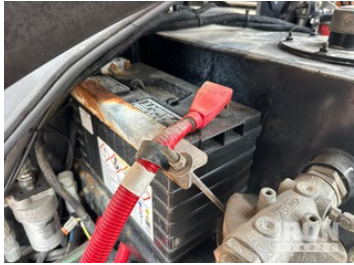
| Electrical Operating System | | |
|---|---|---|
| Cables and Connections | No visible damage or missing components | |

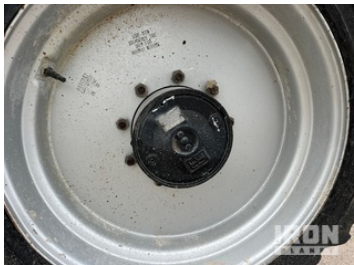
| Item | Assessment | Photo |
|---|---|---|
| Left Front Final Drive | ★★★★☆ | |

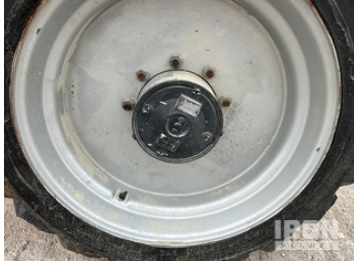
| Item | Assessment | Photo |
|---|---|---|
| Left Rear Final Drive | ★★★★☆ | |

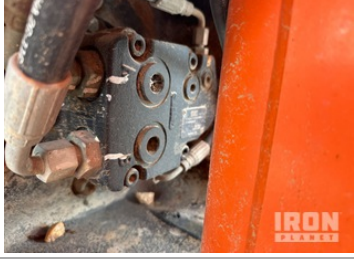
| Item | Assessment | Photo |
|---|---|---|
| Right Rear Drive Motor | ★★★★☆ | |

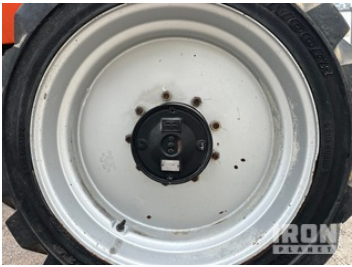
| Right Front Final Drive | ☆☆☆☆ | |

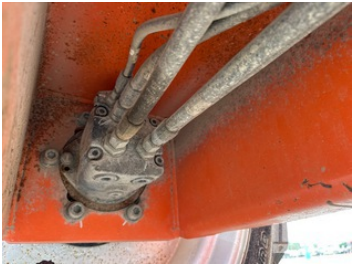
| Right Front Drive Motor | ☆☆☆☆ | |

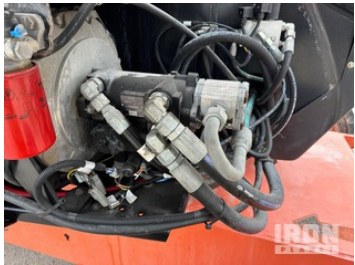
| Hydraulics | | |
|---|---|---|
| Pumps (Hydraulics) | ★★★★☆ | |

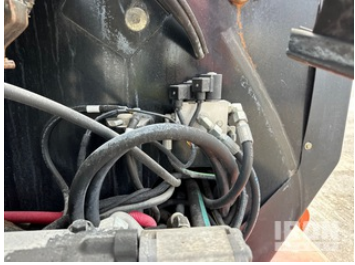
| Hydraulics | | |
|---|---|---|
| Valves | ★★★★☆ | |

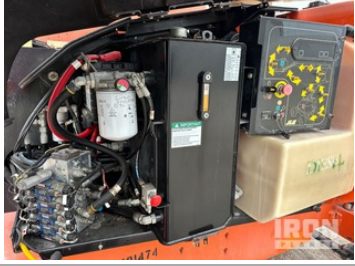
| Hydraulics | | |
|---|---|---|
| Hydraulic Tank | ★★★★☆ | |

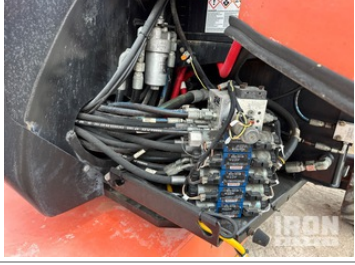
| Hydraulics | | |
|---|---|---|
| Hoses (Hydraulic) | ★★★★☆ | |

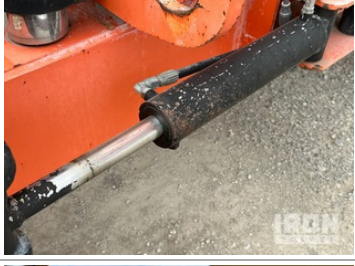
| Hydraulics | | |
|---|---|---|
| Steering Cylinders | ★★★★☆ | |

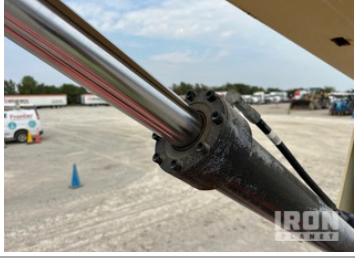
| Hydraulics | | |
|---|---|---|
| Boom Lift Cylinder | ★★★★☆ | |

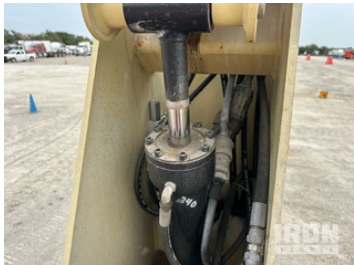
| Secondary Boom Cylinder | ★★★★☆ | |

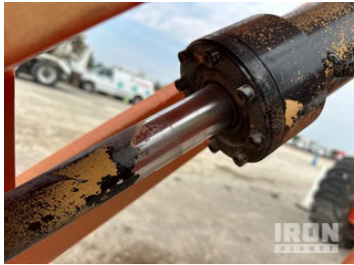
| Jib Cylinder | ★★★★☆ | |

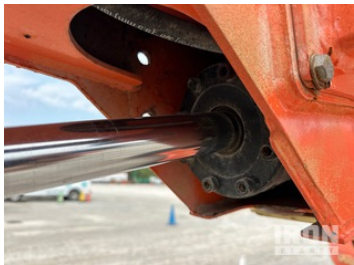
| Basket Tilt Cylinder | ★★★★☆ | |

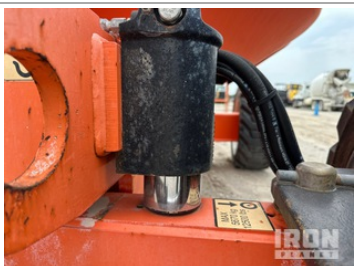
| Frame Leveling Cylinders | ★★★★☆ | |

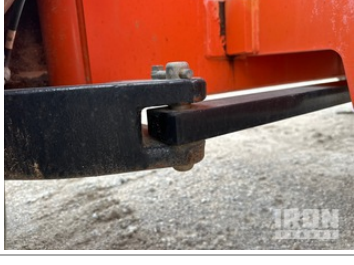
| Chassis | | |
|---|---|---|
| Steering Linkage | ★★★★☆ | |

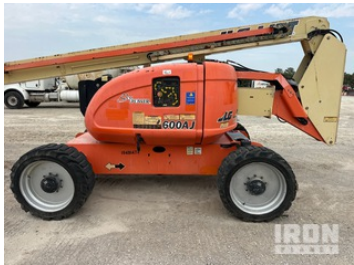
| Frame Condition | ★★★★☆ | |

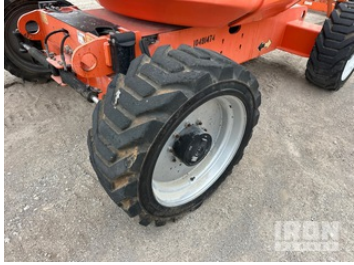
| Left Front Tire | No visible defects | |

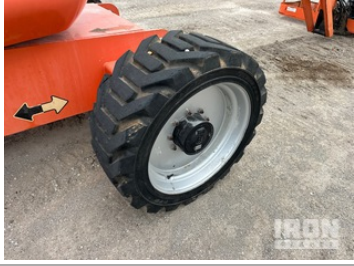
| Left Rear Tire | No visible defects | |

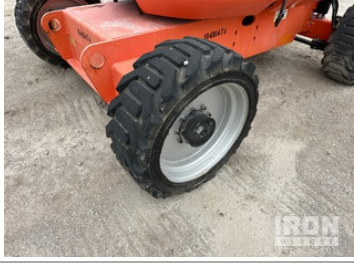
| Right Rear Tire | No visible defects | |

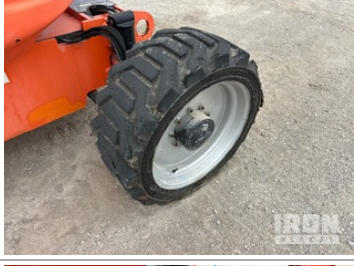
| Right Front Tire | No visible defects | |

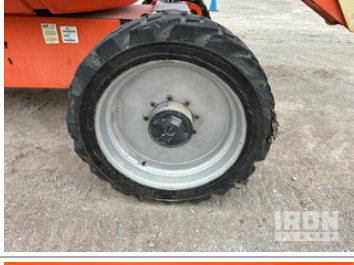
| Wheel Condition | No visible damage or missing components | |

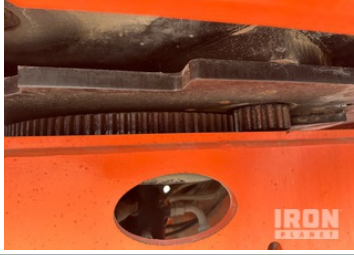
| Turntable Bearing | ★★★★☆ | |

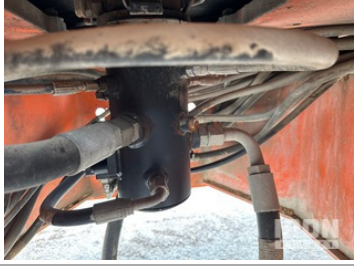
| Hydraulic Center Swivel | ★★★★☆ | |

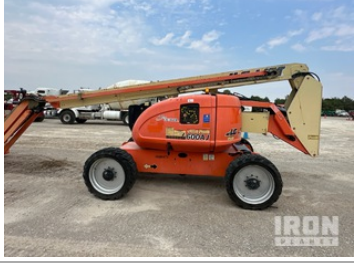
| Boom Condition | ★★★★☆ | |

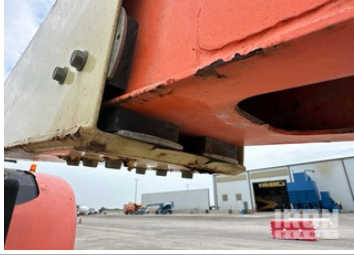
| Boom Wear Guides | ★★★★☆ | |

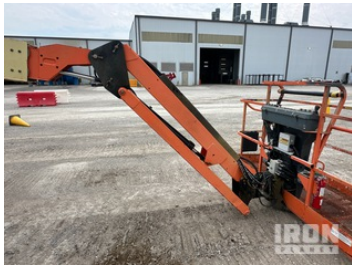
| Jib Condition | ★ ★ ★ ☆ | |
