Item #13810768 - 2017 JLG 4069LE Electric Scissor Lift

Inspection Report

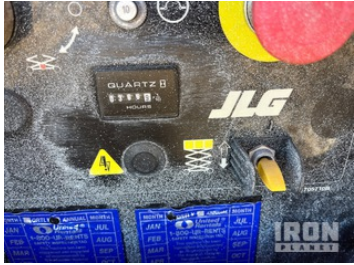
Control Station Ground		
Item	Assessment	Photo
Function Controls	★ ★ ★ ☆

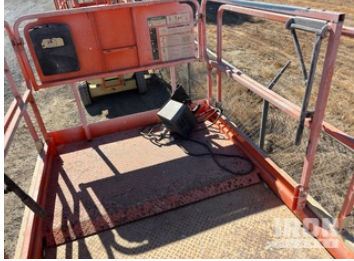
Item	Assessment	Photo
Control Console	No visible damage or missing components

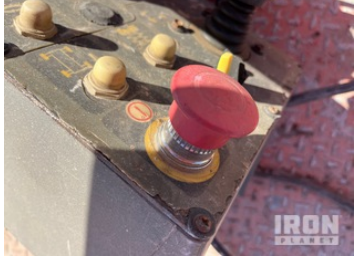
Emergency Shut Off Switch	Operational

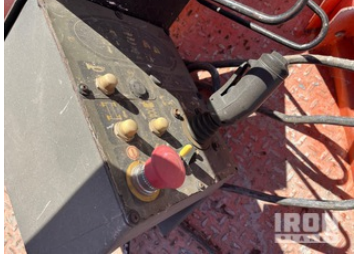
Upper Function Controls	★★★★☆

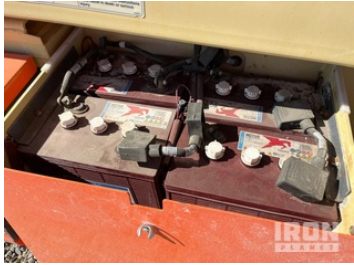
Electrical Operating System		
Item	Assessment	Photo
Operating Voltage	48 Volts	
Battery Condition	Functioned during the inspection	
Cables and Connections	No visible damage or missing components

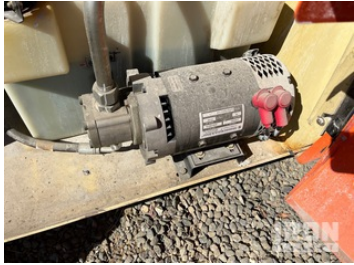
Hydraulics		
Item	Assessment	Photo
Pumps (Hydraulics)	★★★★☆

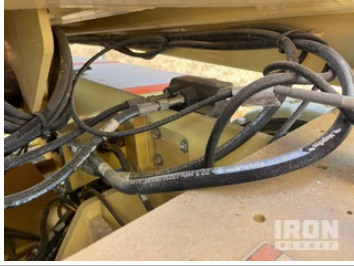
Valves	★★★★☆

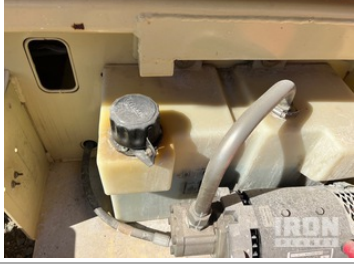
Hydraulic Tank	★★★★☆

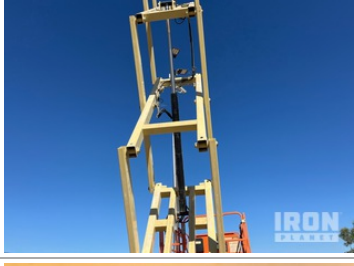
Lift Cylinders	★★★★☆

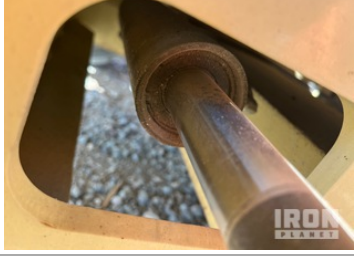
Steering Cylinder	★★★★☆

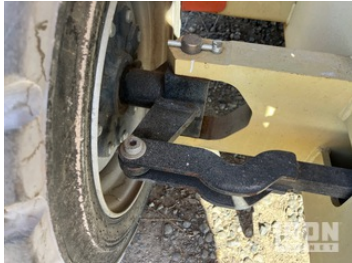
Steering Linkage	<p>★★★★☆</p>

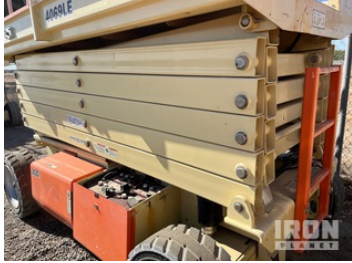
Frame Condition	<p>★★★★☆</p>

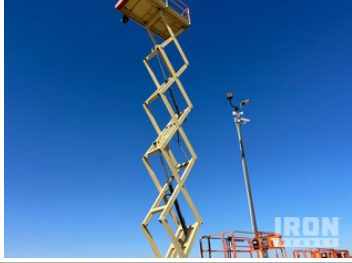
Scissor Linkage	<p>★★★★☆</p>

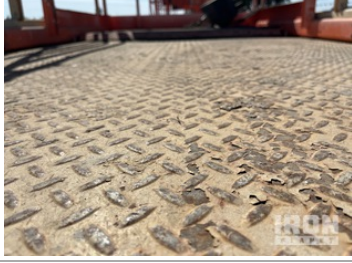
Platform Condition	<p>★★★★☆</p>

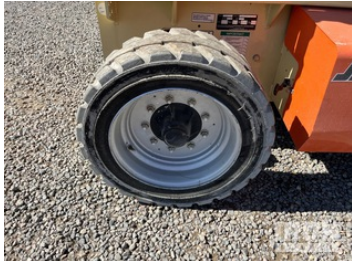
Left Front Tire	No visible defects

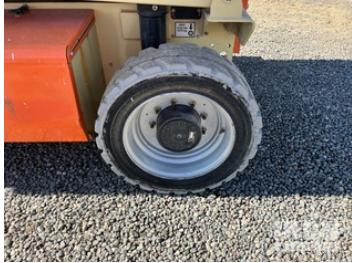
Left Rear Tire	No visible defects

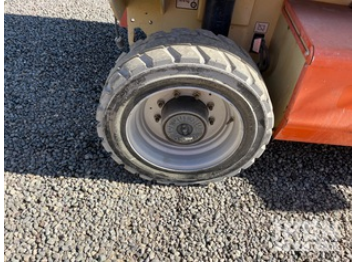
Right Rear Tire	No visible defects

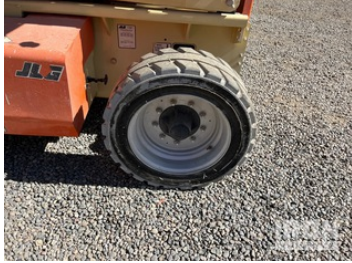
Right Front Tire	No visible defects

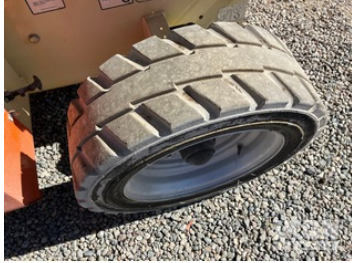
Wheel Condition	No visible damage or missing components
