## Item #13810790 - 2016 Genie Z45/25JDC 2WD Electric Articulating Boom Lift

- Features: 45 ft Max Platform Height, 500 lb Max Weight Capacity, Jib, Power to Platform, 9-14.5 Tires
- Meter Reading: 912 Hours
- Serial # : Z452515D-489
- Inspection Completed: 8/22/25

# Inspection Report

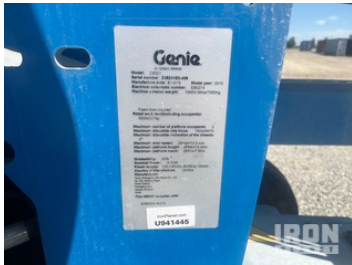
| Serial Number / VIN | Z452515D-489 | |

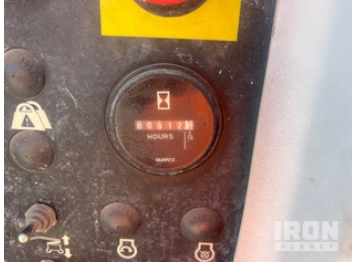
| Hour Meter / Odometer | 912 hrs | |

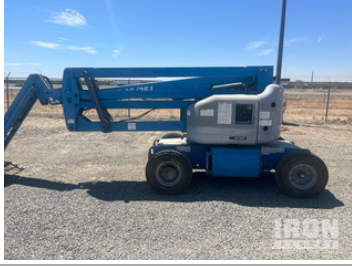
| Paint | No visible damage | |

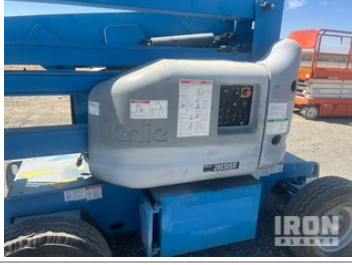
| Body Panels | No visible damage or missing components | |

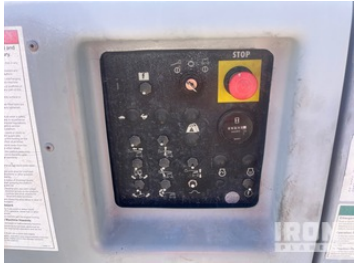
| Control Station Ground | | |
|---|---|---|
| Gauges | Operational | |

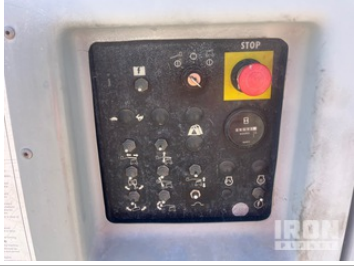
| Control Station Ground | | |
|---|---|---|
| Function Controls | ★★★★☆ | |

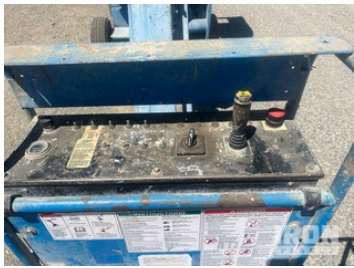
| Control Station | | |
|---|---|---|
| Control Console | No visible damage or missing components | |

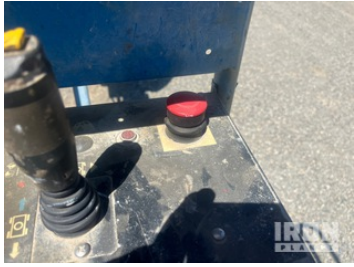
| Control Station | | |
|---|---|---|
| Emergency Shut Off Switch | Operational | |

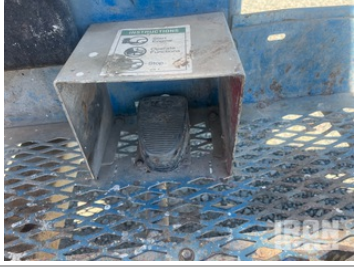
| Control Station | | |
|---|---|---|
| Safety Control Foot Switch | ★★★★☆ | |

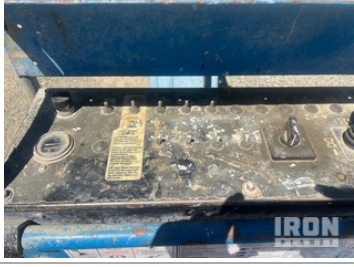
| Control Station | | |
|---|---|---|
| Function Controls | ★★★★☆ | |

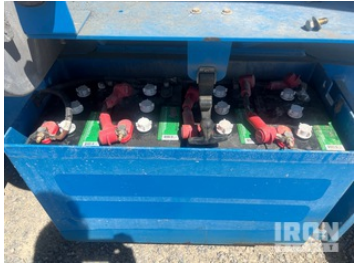
| Electrical Operating System | | |
|---|---|---|
| Cables and Connections | No visible damage or missing components | |

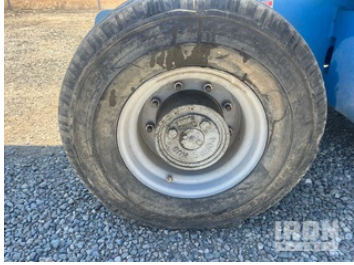
| Item | Assessment | Photo |
|---|---|---|
| Left Front Final Drive | ★★★★☆ | |

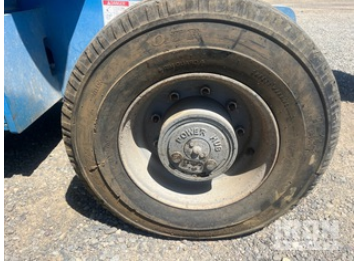
| Item | Assessment | Photo |
|---|---|---|
| Right Front Final Drive | ★★★★☆ | |

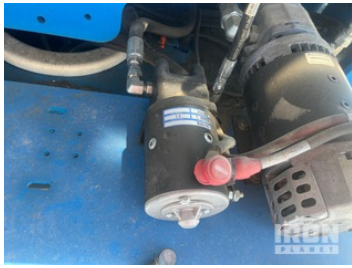
| Hydraulics | | |
|---|---|---|
| Pumps (Hydraulics) | ★★★★☆ | |

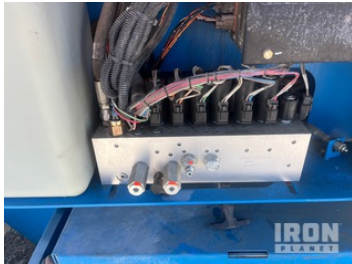
| Hydraulics | | |
|---|---|---|
| Valves | ★★★★☆ | |

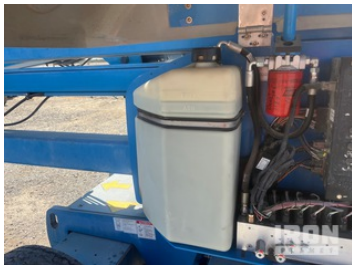
| Hydraulics | | |
|---|---|---|
| Hydraulic Tank | ★★★★☆ | |

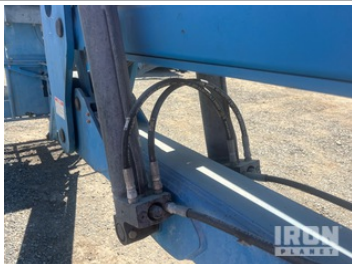
| Hydraulics | | |
|---|---|---|
| Hoses (Hydraulic) | ★★★★☆ | |

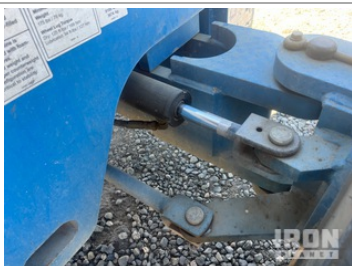
| Hydraulics | | |
|---|---|---|
| Steering Cylinders | ★★★★☆ | |

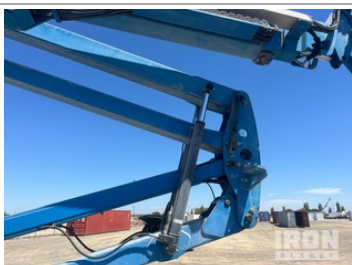
| Hydraulics | | |
|---|---|---|
| Boom Lift Cylinder | ★★★★☆ | |

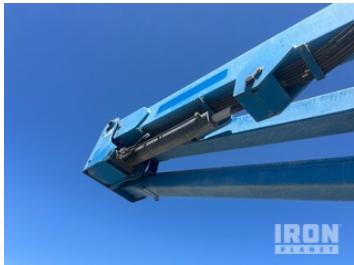
| Secondary Boom Cylinder | ★★★★☆ | |

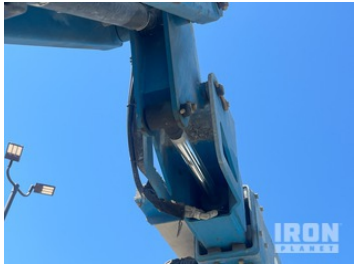
| Jib Cylinder | ★★★★☆ | |

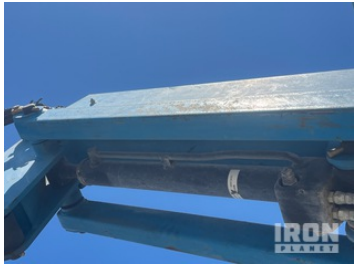
| Basket Tilt Cylinder | ★★★★☆ | |

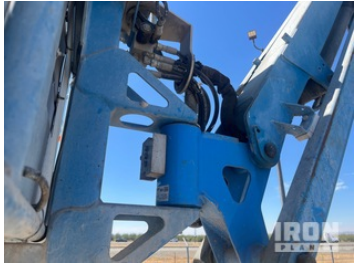
| Basket Rotator Motor | ★★★★☆ | |

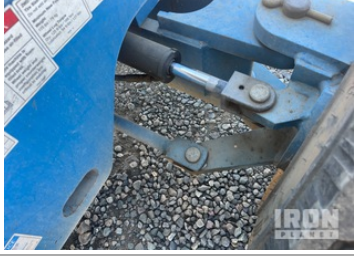
| Chassis | | |
|---|---|---|
| Steering Linkage | ★★★★☆ | |

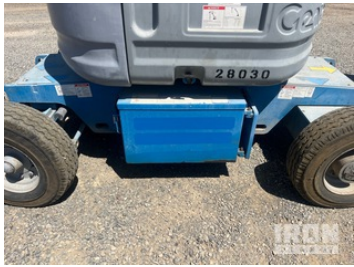
| Frame Condition | ★★★★☆ | |

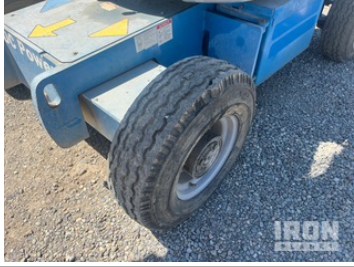
| Left Front Tire | No visible defects | |

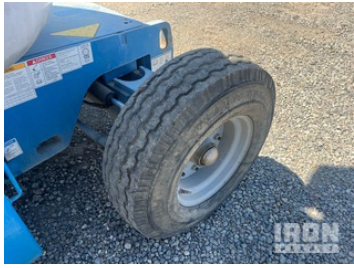
| Left Rear Tire | No visible defects | |

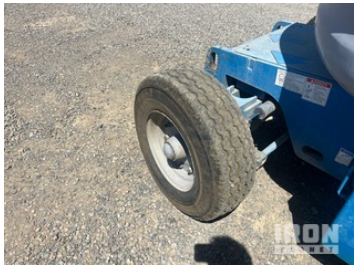
| Right Rear Tire | No visible defects | |

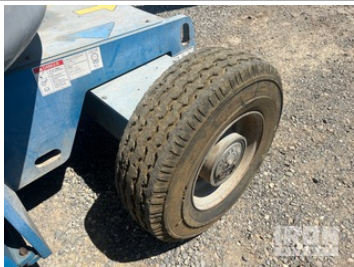
| Right Front Tire | No visible defects | |

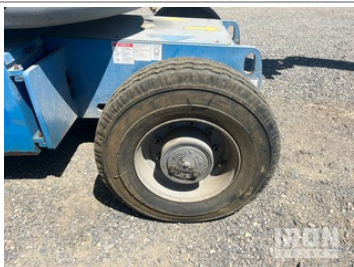
| Wheel Condition | No visible damage or missing components | |

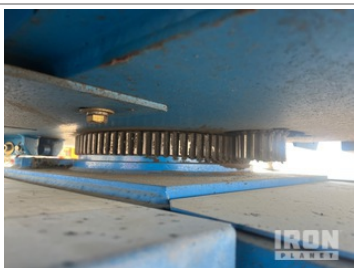
| Turntable Bearing | ★★★★☆ | |

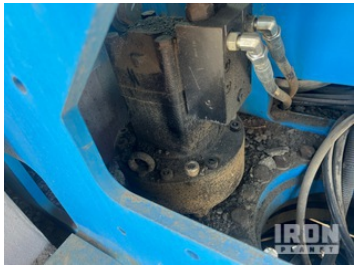
| Swing Motor | ★★★★☆ | |

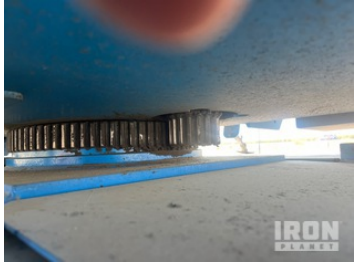
| Hydraulic Center Swivel | ★★★★☆ | |

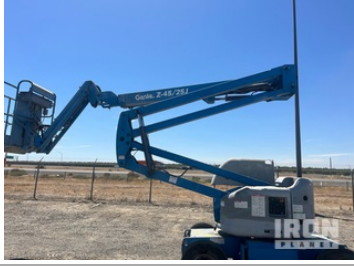
| Boom Condition | ★★★★☆ | |

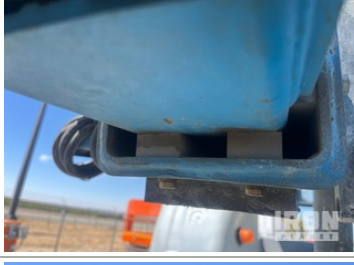
| Boom Wear Guides | ★★★★☆ | |

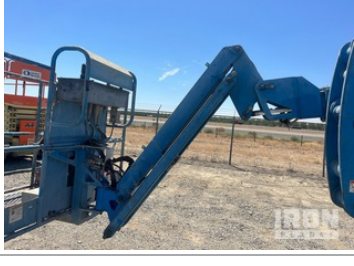
| Jib Condition | ★★★★☆ | |
