## Item #14177554 - 2022 Skyjack SJ45 AJ 4WD Diesel Articulating Boom Lift

# Inspection Report

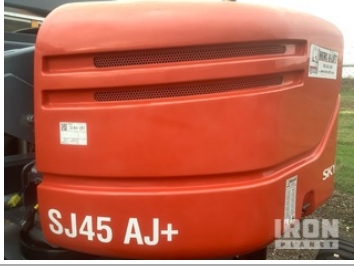
| Paint | No visible damage | |

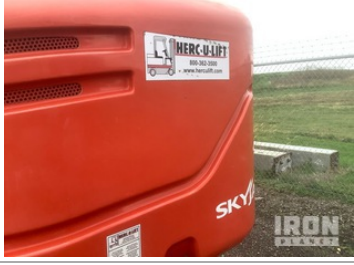
| Body Panels | No visible damage or missing components | |

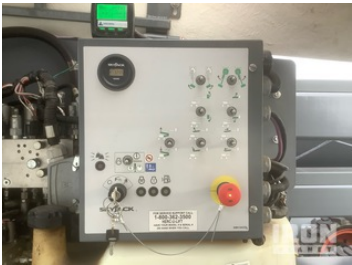
| Control Station Ground | | |
|---|---|---|
| Function Controls | ☆☆☆☆ | |

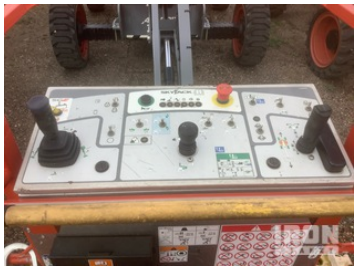
| Item | Assessment | Photo |
|---|---|---|
| Control Console | No visible damage or missing components | |

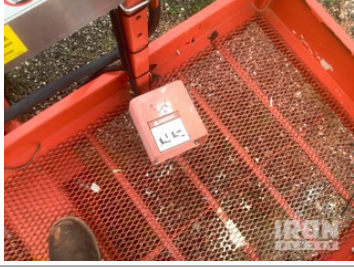
| Item | Assessment | Photo |
|---|---|---|
| Safety Control Hand/Foot Switch | ★★★★☆<br>Operational | |

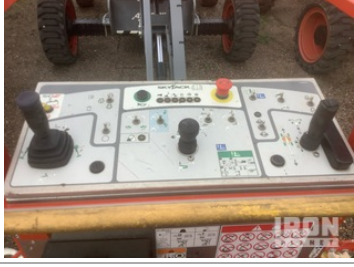
| Item | Assessment | Photo |
|---|---|---|
| Function Controls | ★★★★☆ | |

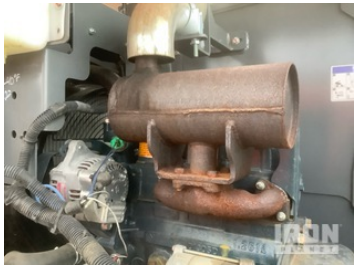
| Engine | | |
|---|---|---|
| Exhaust System | No visible damage or missing components | |

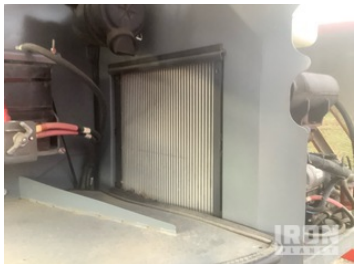
| Engine | | |
|---|---|---|
| Radiator | ★★★★☆ | |

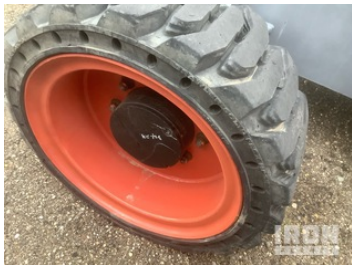
| Item | Assessment | Photo |
|---|---|---|
| Left Front Final Drive | ★★★★☆ | |

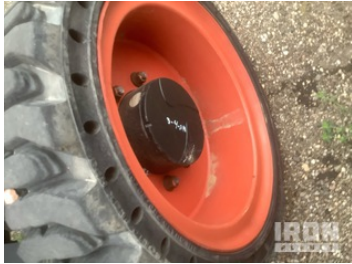
| Item | Assessment | Photo |
|---|---|---|
| Left Rear Final Drive | ★★★★☆ | |

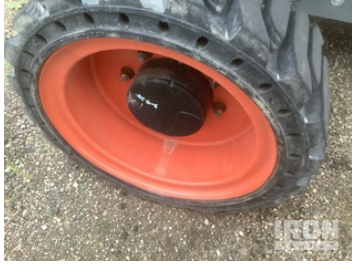
| Item | Assessment | Photo |
|---|---|---|
| Right Rear Final Drive | ★★★★☆ | |

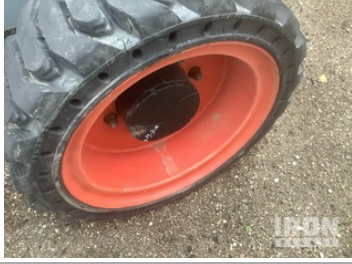
| Item | Assessment | Photo |
|---|---|---|
| Right Front Final Drive | ★★★★☆ | |

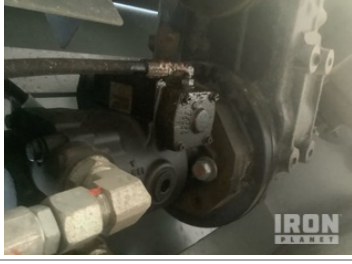
| Item | Assessment | Photo |
|---|---|---|
| Front Center Drive Motor | ★★★★☆ | |

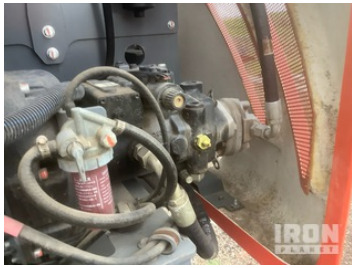
| Hydraulics | | |
|---|---|---|
| Pumps (Hydraulics) | ★★★★☆ | |

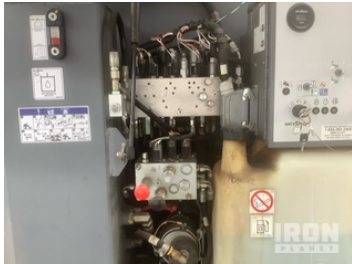
| Hydraulics | | |
|---|---|---|
| Valves | ★★★★☆ | |

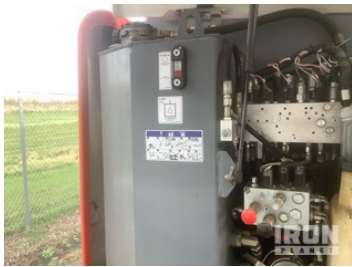
| Hydraulics | | |
|---|---|---|
| Hydraulic Tank | ★★★★☆ | |

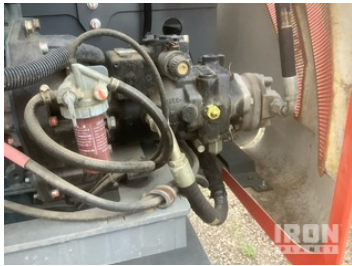
| Hydraulics | | |
|---|---|---|
| Hoses (Hydraulic) | ★★★★☆ | |

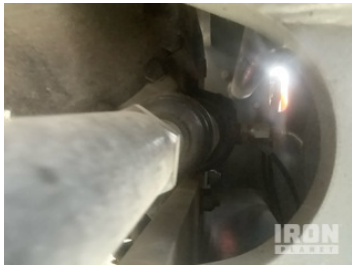
| Hydraulics | | |
|---|---|---|
| Steering Cylinders | ★★★★☆ | |

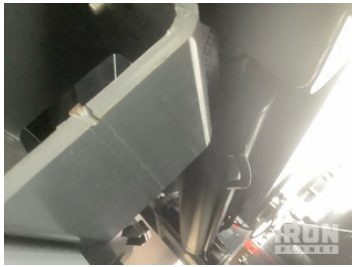
| Hydraulics | | |
|---|---|---|
| Boom Lift Cylinder | ★★★★☆ | |

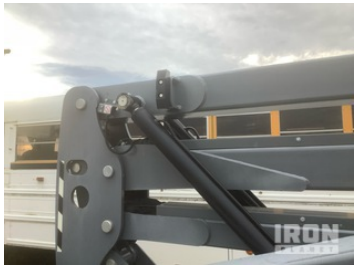
| Secondary Boom Cylinder | ★★★★☆ | |

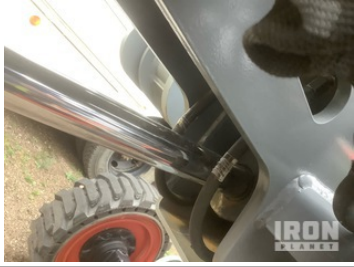
| Jib Cylinder | ★★★★☆ | |

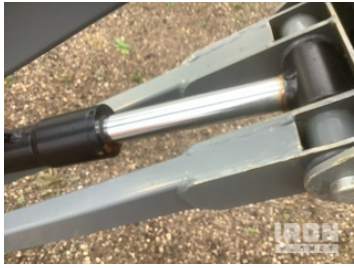
| Basket Tilt Cylinder | ★★★★☆ | |

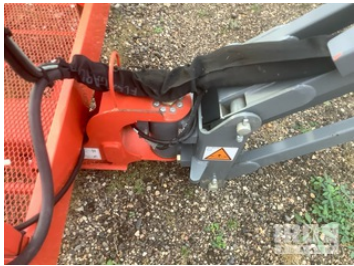
| Basket Rotator Motor | ★★★★☆ | |

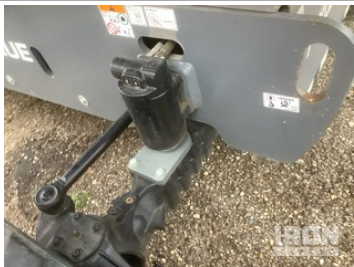
| Frame Leveling Cylinders | ★★★★☆ | |

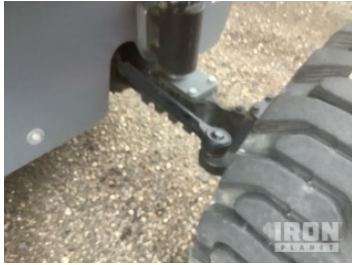
| Chassis | | |
|---|---|---|
| Steering Linkage | ★★★★☆ | |

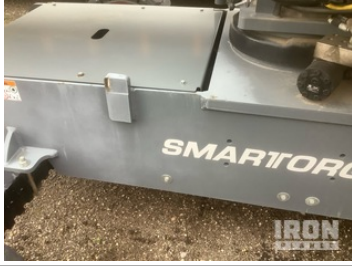
| Chassis | | |
|---|---|---|
| Frame Condition | ★★★★☆ | |

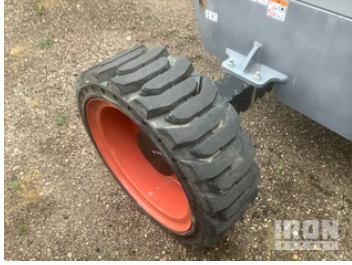
| Chassis | | |
|---|---|---|
| Left Front Tire | No visible defects | |

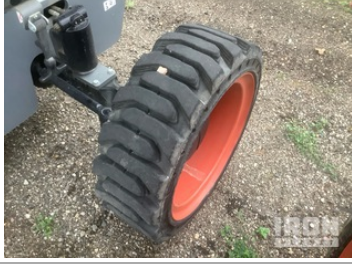
| Chassis | | |
|---|---|---|
| Left Rear Tire | No visible defects | |

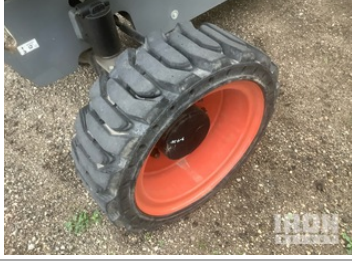
| Chassis | | |
|---|---|---|
| Right Rear Tire | No visible defects | |

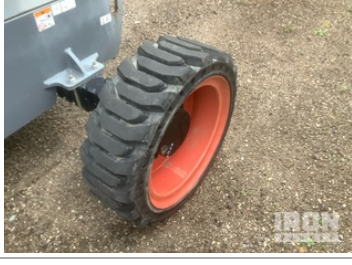
| Chassis | | |
|---|---|---|
| Right Front Tire | No visible defects | |

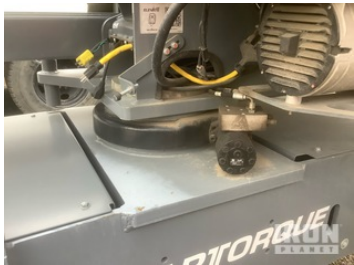
| Turntable Bearing | ★★★★☆ | |

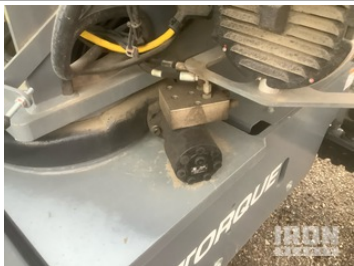
| Swing Motor | ★★★★☆ | |

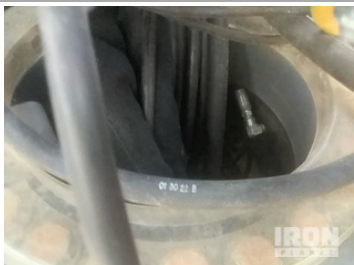
| Hydraulic Center Swivel | ★★★★☆ | |

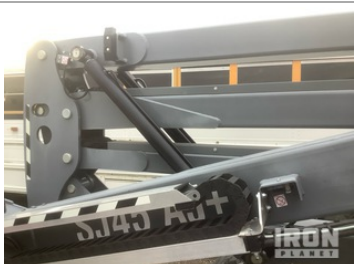
| Boom Condition | ★★★★☆ | |

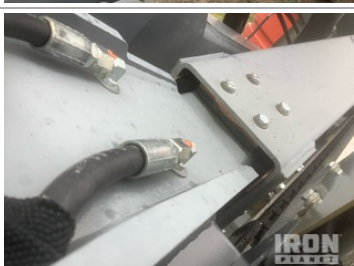
| Boom Wear Guides | ★★★★☆ | |

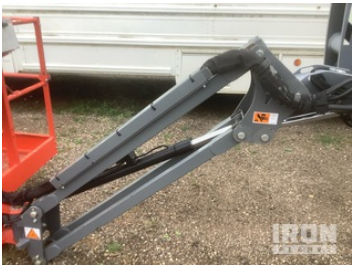
| Jib Condition | ☆☆☆☆ | |
