## Item #14097041 - 2016 JLG 800 AJ 4WD Diesel Articulating Boom Lift

# Inspection Report

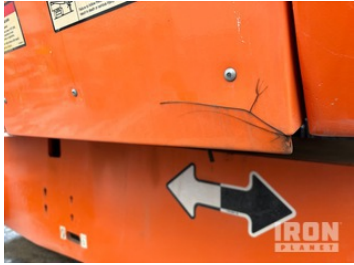
| Body Panels | Hydraulic compartment door damaged | |

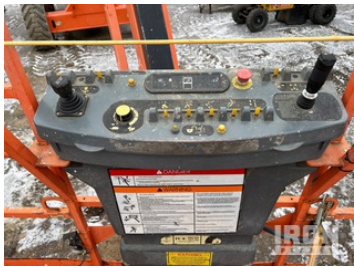
| Item | Assessment | Photo |
|---|---|---|
| Control Console | Material buildup | |

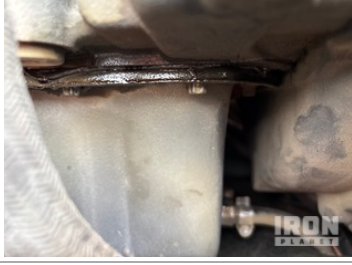
| Engine | | |
|---|---|---|
| Oil Leaks | Oil Pan | |

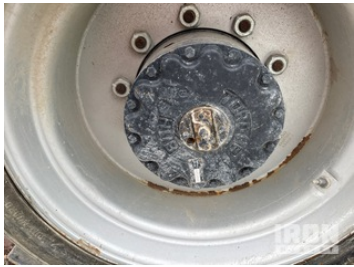
| Right Front Final Drive | ★ ★ ★ ☆ | |

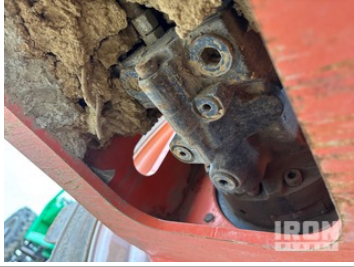
| Right Front Drive Motor | ★ ★ ★ ☆ | |

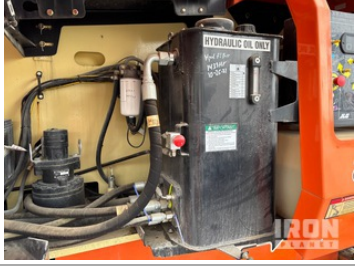
| Hydraulics | | |
|---|---|---|
| Hydraulic Tank | ★★★★☆<br>Low fluid level | |

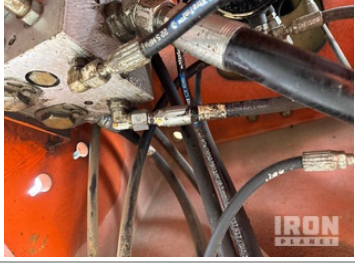
| Hydraulics | | |
|---|---|---|
| Hoses (Hydraulic) | ★★★☆☆<br>Leaks underneath | |

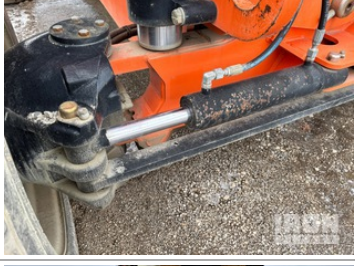
| Hydraulics | | |
|---|---|---|
| Steering Cylinders | ★★★★☆<br>Damage to rods | |

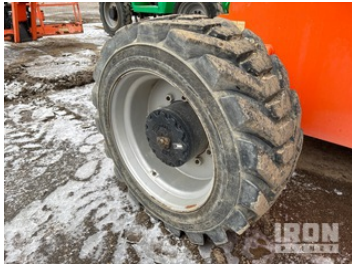
| Left Front Tire | Chunks missing, Tears | |

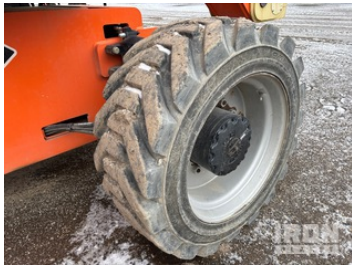
| Left Rear Tire | Chunks missing, Tears | |

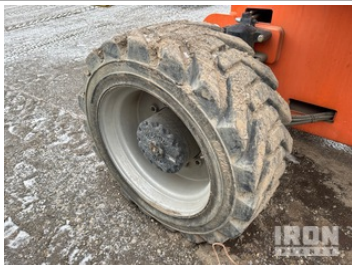
| Right Rear Tire | Chunks missing, Tears | |

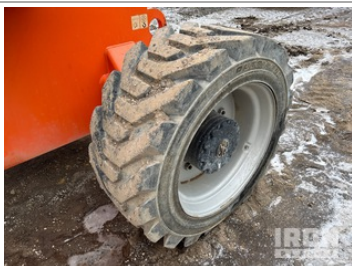
| Right Front Tire | Chunks missing, Tears | |

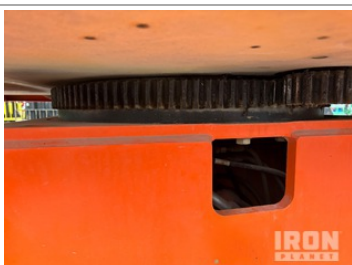
| Turntable Bearing | ★★☆☆ | |

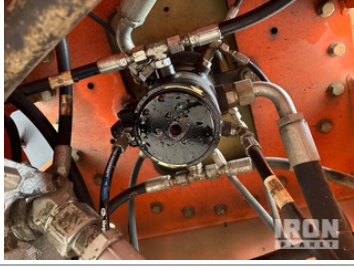
| Hydraulic Center Swivel | ★★★☆☆<br>Dripping leak | |

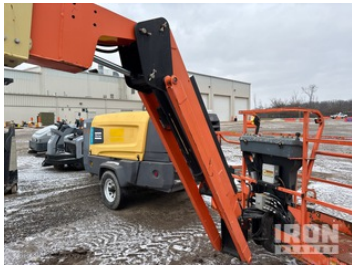
| Jib Condition | ☆☆☆☆ | |

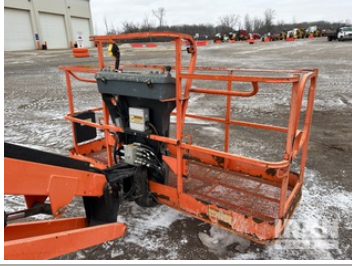
| Work Basket | Damage | |
