## Item #14340468 - 2015 Skyjack SJ7135RT Diesel 4x4 Scissor Lift

# Inspection Report

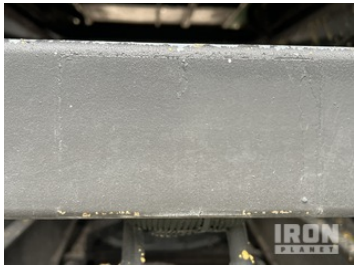
| Serial Number / VIN | 34003267, The serial number is not legible. This unit may be difficult to export. Identified by Id number | |

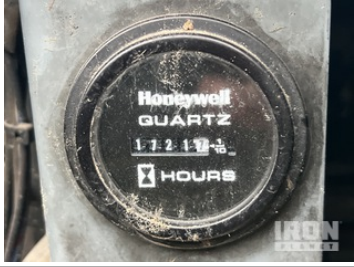
| Hour Meter / Odometer | 1721 hrs | |

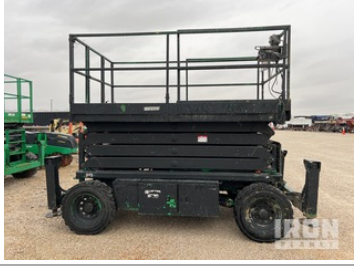
| Paint | Other unknown material | |

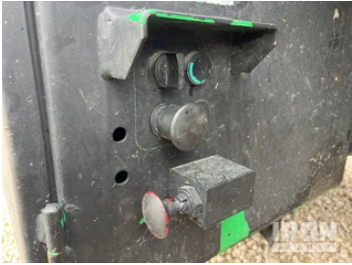
| Control Station Ground | | |
|---|---|---|
| Function Controls | ☆☆☆☆ | |

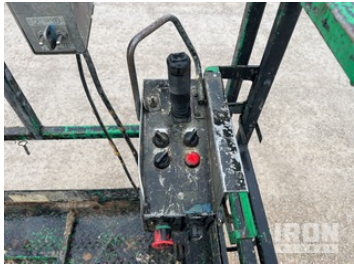
| Item | Assessment | Photo |
|---|---|---|
| Control Console | Material buildup | |

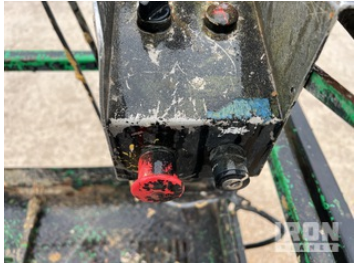
| Item | Assessment | Photo |
|---|---|---|
| Emergency Shut Off Switch | Operational | |

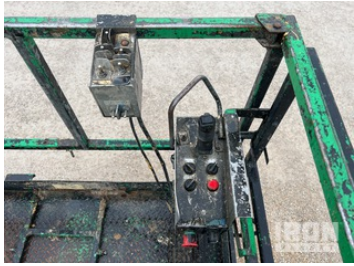
| Item | Assessment | Photo |
|---|---|---|
| Upper Function Controls | ★★☆☆☆<br>Outrigger controls do not respond; Lift speed does not run on high | |

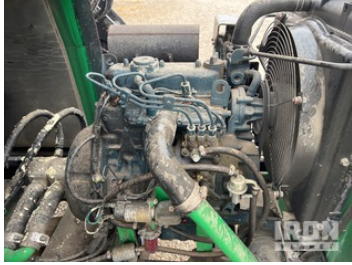
| Engine | | |
|---|---|---|
| Fuel System | Operational | |

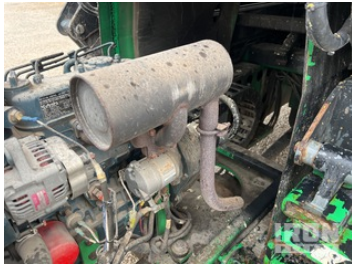
| Engine | | |
|---|---|---|
| Exhaust System | No visible damage or missing components | |

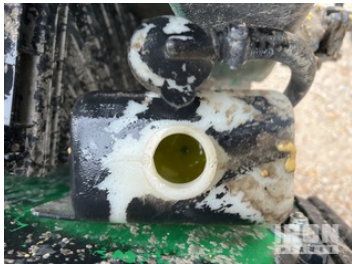
| Engine | | |
|---|---|---|
| Radiator | ★★★★☆ | |

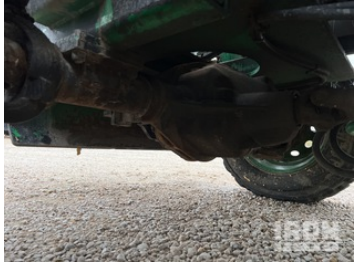
| Item | Assessment | Photo |
|---|---|---|
| Front Drive Axle | ★★★★☆ | |

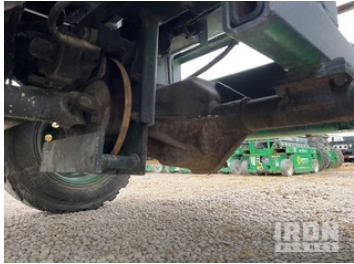
| Item | Assessment | Photo |
|---|---|---|
| Rear Drive Axle | ★★★★☆ | |

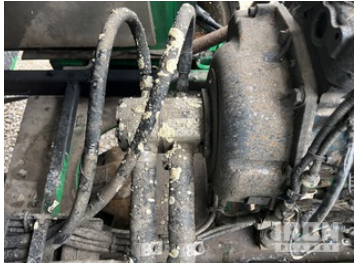
| Hydraulics | | |
|---|---|---|
| Pumps (Hydraulics) | ★★★★☆ | |

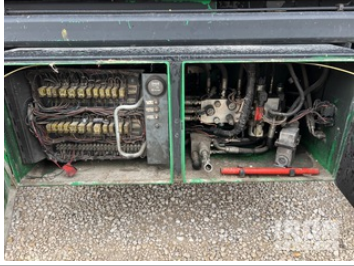
| Hydraulics | | |
|---|---|---|
| Valves | ★★★★☆ | |

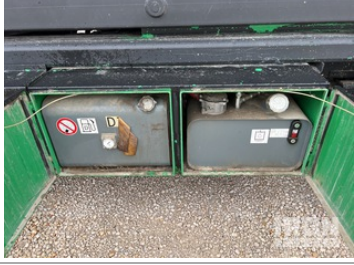
| Hydraulics | | |
|---|---|---|
| Hydraulic Tank | ★★★★☆ | |

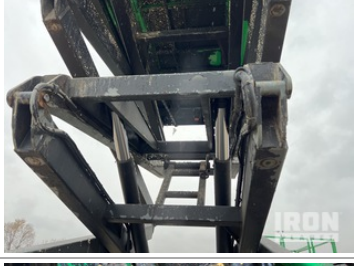
| Hydraulics | | |
|---|---|---|
| Lift Cylinders | ★★★★☆ | |

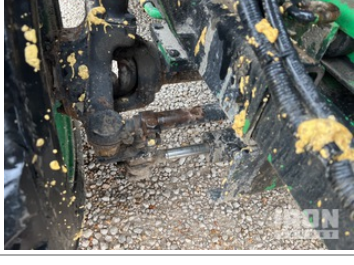
| Hydraulics | | |
|---|---|---|
| Steering Cylinder | ★★★★☆ | |

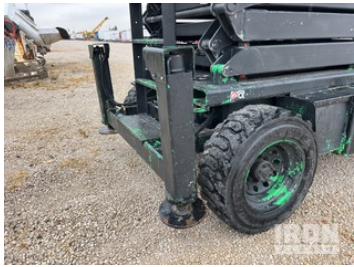
| Outrigger Cylinders | controls in op | |

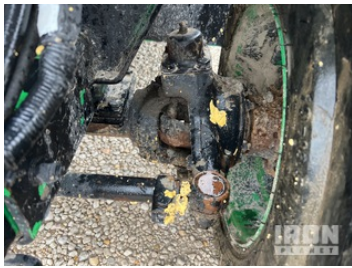
| Item | Assessment | Photo |
|---|---|---|
| Steering Linkage | ★★★★☆ | |

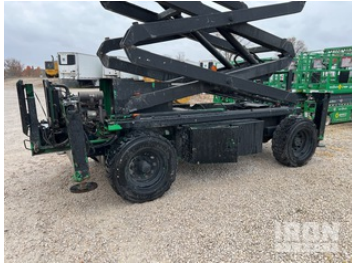
| Item | Assessment | Photo |
|---|---|---|
| Frame Condition | ★★★★☆ | |

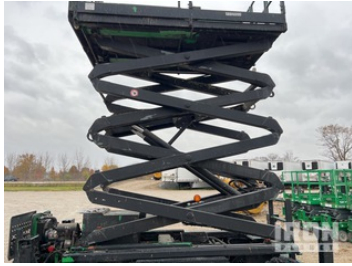
| Item | Assessment | Photo |
|---|---|---|
| Scissor Linkage | ★★★★☆ | |

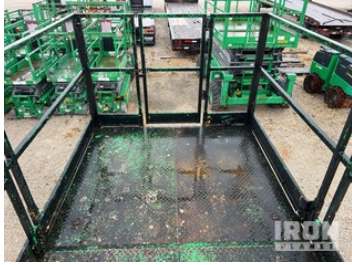
| Item | Assessment | Photo |
|---|---|---|
| Platform Condition | ★★★★☆ | |

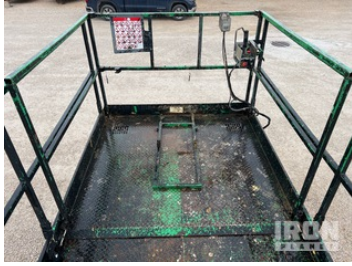
| Item | Assessment | Photo |
|---|---|---|
| Platform Extension | ★★★★☆ | |

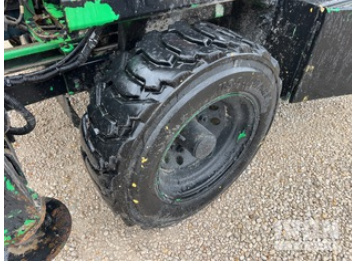
| Item | Assessment | Photo |
|---|---|---|
| Left Front Tire | Cracks, Chunks missing, Tears | |

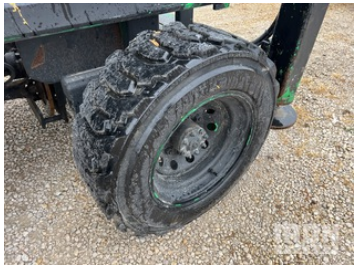
| Left Rear Tire | Cracks, Chunks missing, Tears | |

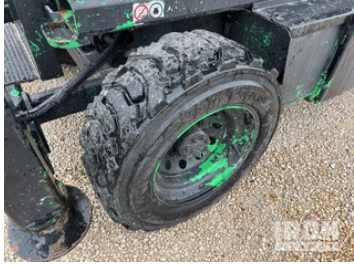
| Right Rear Tire | Cracks, Chunks missing, Tears | |

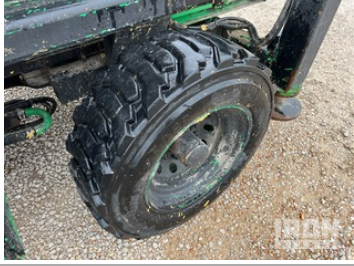
| Right Front Tire | Cracks, Chunks missing, Tears | |

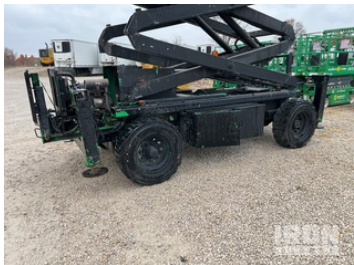
| Outriggers / Stabilizers | ★☆☆☆☆<br>Do not respond to controls | |
