## Item #13869113 - 2018 Genie S40 4WD Diesel Telescopic Boom Lift

# Inspection Report

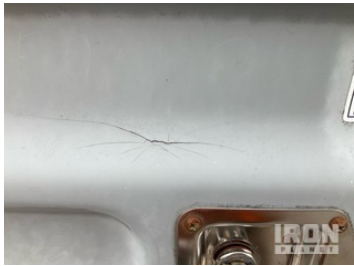
| Body Panels | No visible damage or missing components Both side doors has cracked | |

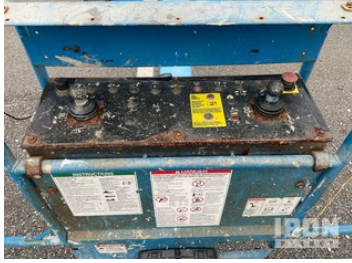
| Item | Assessment | Photo |
|---|---|---|
| Control Console | Control area (top) damaged | |

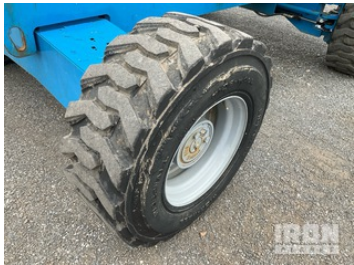
| Left Front Tire | Cracks, Chunks missing | |

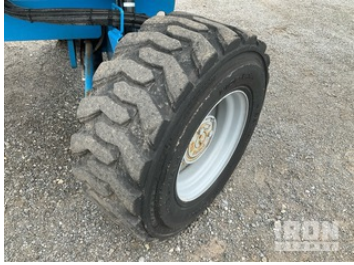
| Left Rear Tire | Cracks, Chunks missing | |

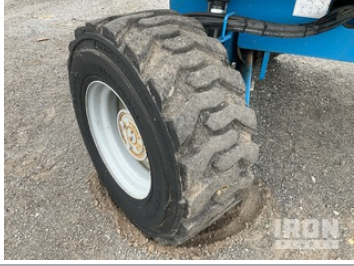
| Right Rear Tire | Cracks, Chunks missing | |

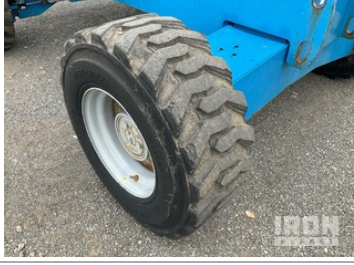
| Right Front Tire | Cracks, Chunks missing | |

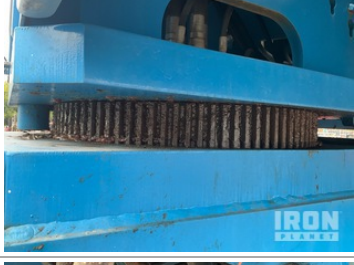
| Turntable Bearing | ★★★☆☆ | |
