## Item #14095011 - 2017 Skyjack SJ 45T 4WD Diesel Telescopic Boom Lift

# Inspection Report

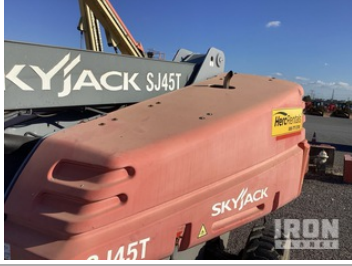
| Paint | No visible damage | |

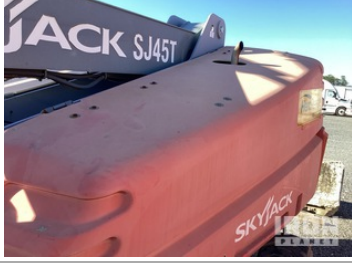
| Body Panels | Hydraulic compartment door damaged, Hood has a strong vibration | |

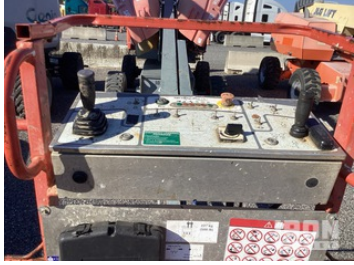
| Item | Assessment | Photo |
|---|---|---|
| Control Console | No visible damage or missing components | |

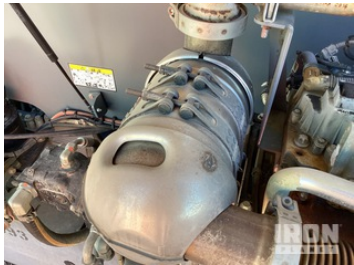
| Engine | | |
|---|---|---|
| Exhaust System | No visible damage or missing components | |

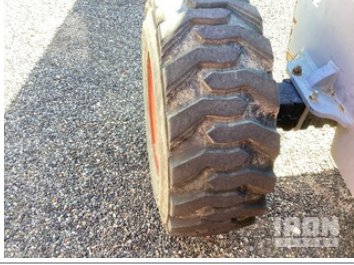
| Chassis | | |
|---|---|---|
| Left Front Tire | No visible defects | |

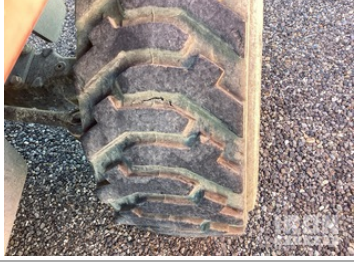
| Chassis | | |
|---|---|---|
| Left Rear Tire | Tears | |

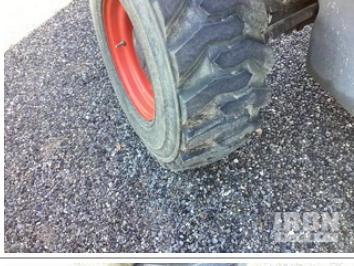
| Chassis | | |
|---|---|---|
| Right Rear Tire | No visible defects | |

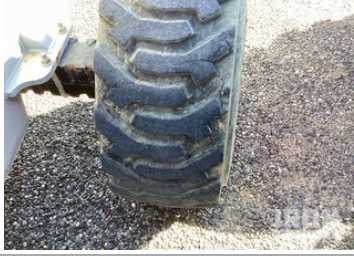
| Chassis | | |
|---|---|---|
| Right Front Tire | Tears | |

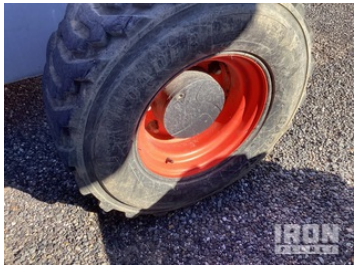
| Wheel Condition | No visible damage or missing components | |
