## Item #13869120 - 2017 Genie GTH-1056 Telehandler

# Inspection Report

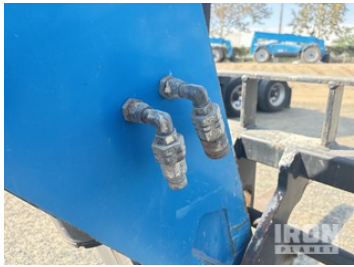
| Auxiliary Hydraulic Plumbing | Capped off | |

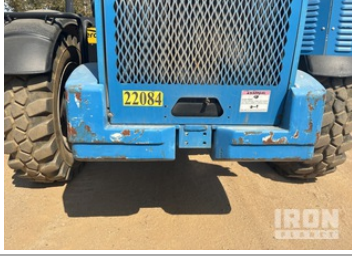
| General Appearance | | |
|---|---|---|
| Paint | Damage | |

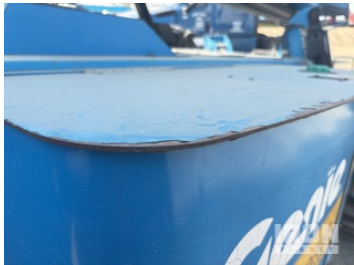
| Body Panels | Rust damage | |

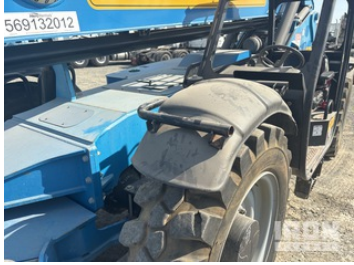
| Fenders | Left front damaged, Left rear damaged, Right front damaged, Right rear damaged | |

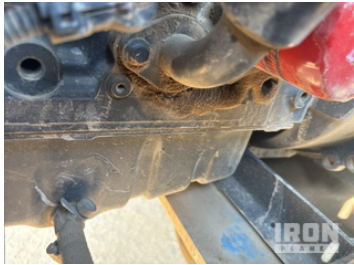
| Engine | | |
|---|---|---|
| Oil Leaks | Filter seep | |

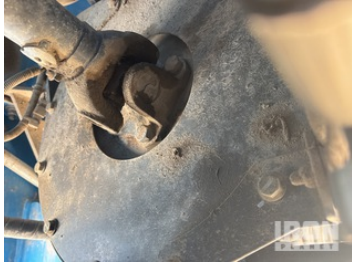
| Item | Assessment | Photo |
|---|---|---|
| Transmission | ★★☆☆<br>Operational | |

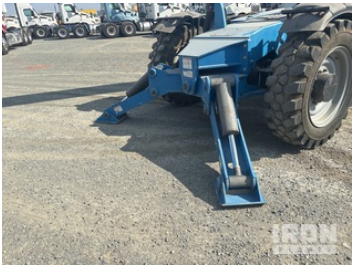
| Outriggers | ☆☆☆☆ | |
