Item #14095008 - 2018 Genie GTH-844 Telehandler

Inspection Report

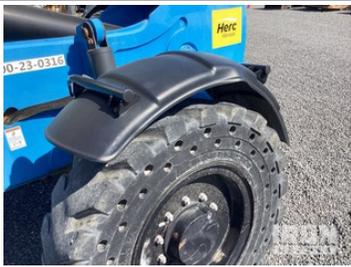
<p>The image shows the rear of the blue telehandler. It has 'HercRentals' and 'Genie' branding. There is an 'IRON PLANET' logo in the bottom right corner.</p>
<p>Fenders</p>	<p>Left rear damaged, Right rear damaged</p>

<p>The image is a close-up of the rear wheel and fender area. The fender is cracked and damaged. There is a yellow 'Herc' sticker and a white label with the number '10-23-0316'. There is an 'IRON PLANET' logo in the bottom right corner.</p>
<p>Steps</p>	<p>No visible damage or missing components</p>

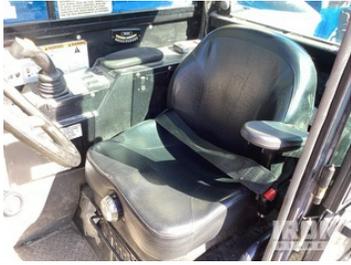
Control Station		
Item	Assessment	Photo
Seat/Armrests	Operator seat armrest damaged

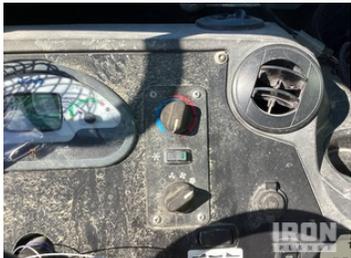
Air Conditioner	Inoperable	
Heater	Not operationally checked	
Limited Function Check	The main components are in place and operational as noted.	
Control Station #1

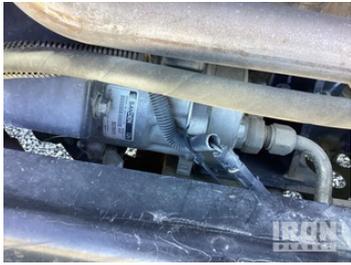
A/C Compressor	Compressor will not engage

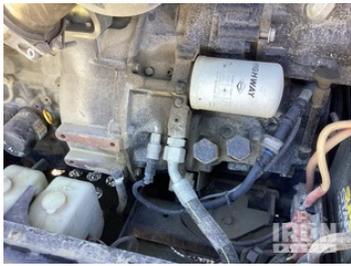
Drivetrain		
Operational test is limited to low speed in a confined flat area without load. Differential interlocks, full transmission shifting and functionality of all drive axles cannot be fully verified. Inspector listens for abnormal noises, observes leaks and notes physical damage.		
Item	Assessment	Photo
Transmission	★★☆☆ Operational

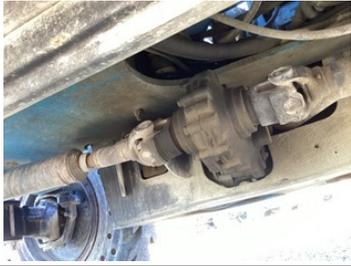
Transfer Case / Drop Box	★★☆☆ Operational

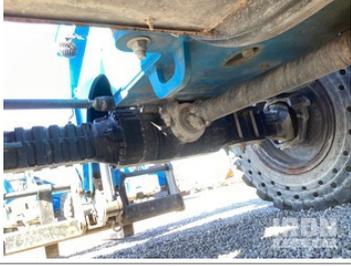
Front Drive Axle	★★☆☆

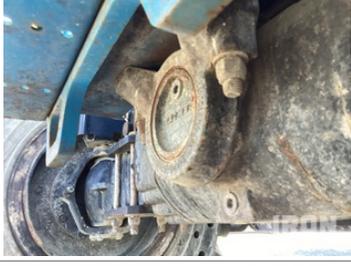
Front Axle Oscillating Pin	★★☆☆

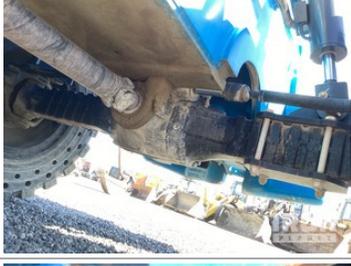
Rear Drive Axle	★★☆☆

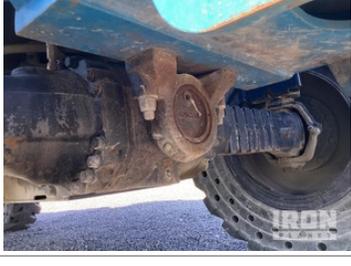
Rear Axle Oscillating Pin	★★☆☆

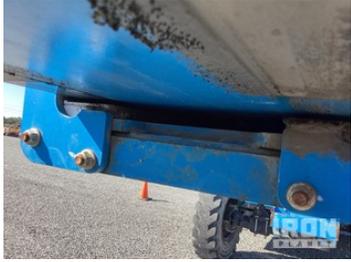
Boom Wear Guides	★★☆☆☆ Heavy wear
