## Item #14094971 - 2018 JCB 509.42 Telehandler

# Inspection Report

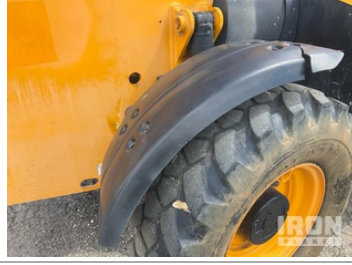
| Fenders | Left front cracked, Right front damaged, Right rear damaged | |

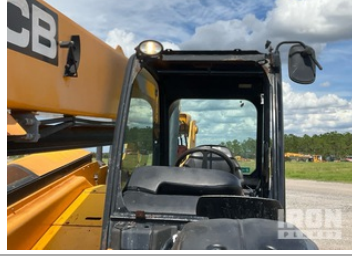
| Exterior Lights | LR work light inoperable Inoperable / damaged / missing | |

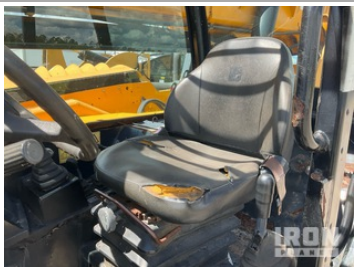
| Control Station | | |
|---|---|---|
| Seat/Armrests | Operator seat cushion damaged | |

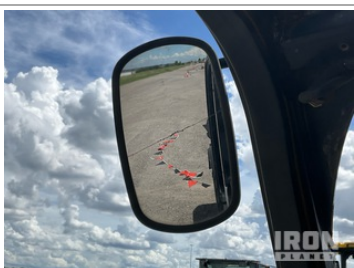
| Control Station | | |
|---|---|---|
| Mirrors | left mirror cracked | |

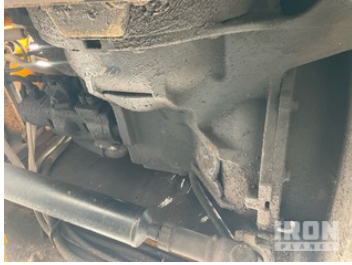
| Item | Assessment | Photo |
|---|---|---|
| Transmission | ★★☆☆<br>Operational | |

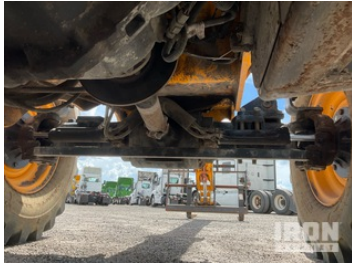
| Item | Assessment | Photo |
|---|---|---|
| Front Drive Axle | ★★☆☆ | |

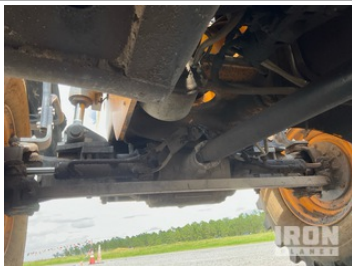
| Item | Assessment | Photo |
|---|---|---|
| Rear Drive Axle | ★★☆☆ | |

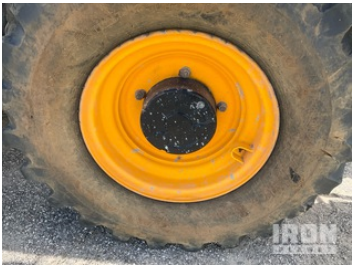
| Final Drives | ☆☆☆☆ | |

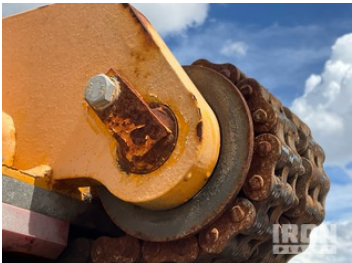
| Rollers and Guides | ☆☆☆☆ | |

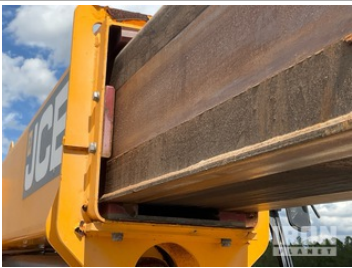
| Boom Wear Guides | ☆☆☆☆ | |

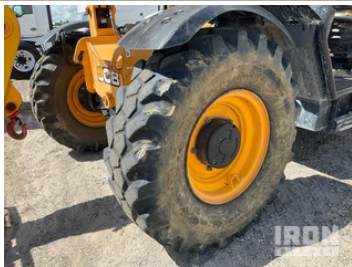
| Item | Assessment | Photo |
|---|---|---|
| Left Front Tire | Size: 1400-24 Brand: Galaxy Tread<br>Depth: 10/32 | |

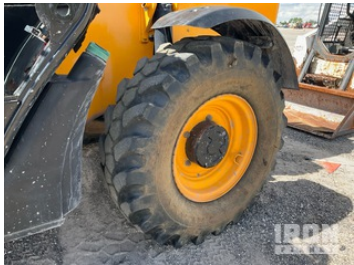
| Left Rear Tire | Size: 1400-24 Brand: Galaxy Tread<br>Depth: 12/32 | |

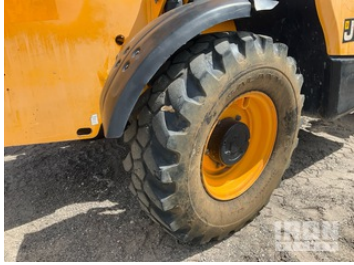
| Right Rear Tire | Size: 1400-24 Brand: Galaxy Tread<br>Depth: 13/32 | |

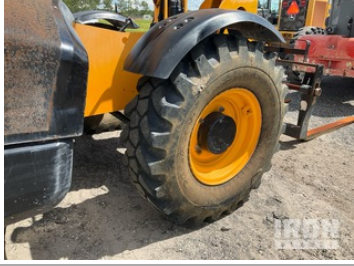
| Right Front Tire | Size: 1400-24 Brand: Galaxy Tread<br>Depth: 14/32 | |
