## Item #14340565 - 2016 Skyjack SJ 4740 Electric Scissor Lift

# Inspection Report

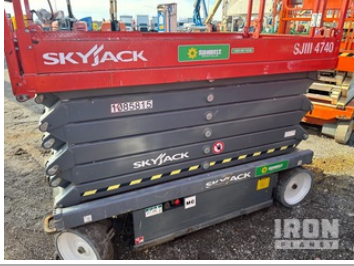
| Paint | No visible damage | |

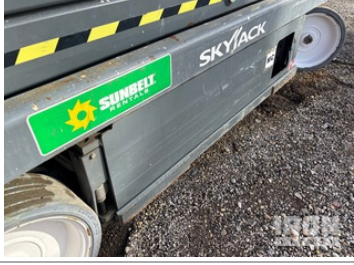
| Body Panels | No visible damage or missing components | |

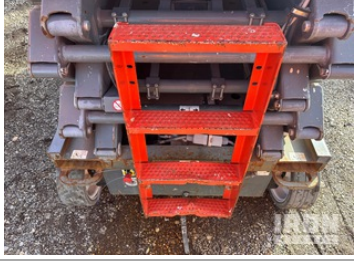
| Steps/Ladders | Bent | |

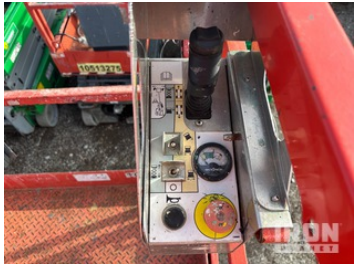
| Item | Assessment | Photo |
|---|---|---|
| Control Console | No visible damage or missing components | |

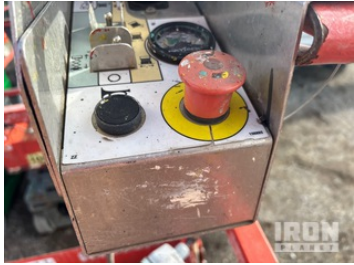
| Item | Assessment | Photo |
|---|---|---|
| Emergency Shut Off Switch | Operational | |

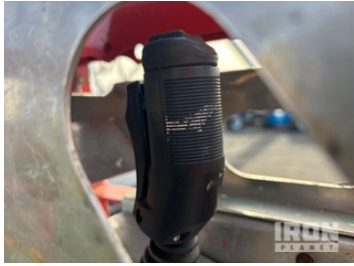
| Item | Assessment | Photo |
|---|---|---|
| Safety Control Hand/Foot Switch | ★★★★☆<br>Operational | |

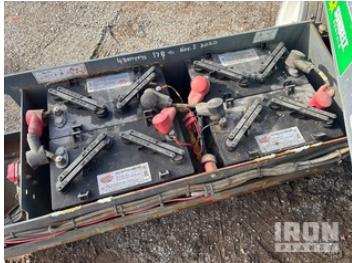
| Electrical Operating System | | |
|---|---|---|
| Cables and Connections | No visible damage or missing components | |

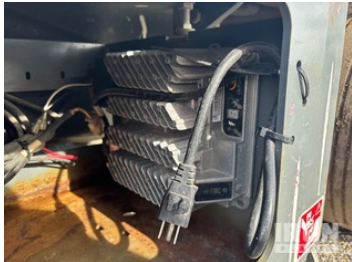
| Electrical Operating System | | |
|---|---|---|
| Battery Charger | Appears normal - Not operationally checked, 100-240 Volt | |

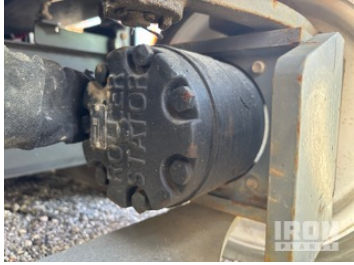
| Item | Assessment | Photo |
|---|---|---|
| Drive Motors | ★★★☆☆ | |

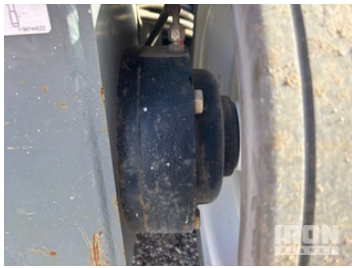
| Item | Assessment | Photo |
|---|---|---|
| Brake System | ★★☆☆<br>The brake system functioned, stopping and holding the machine. | |

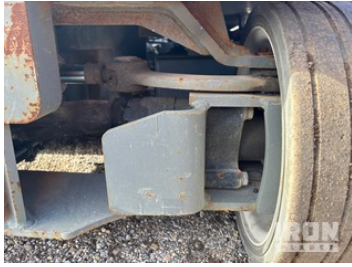
| Item | Assessment | Photo |
|---|---|---|
| Steering Linkage | ★★☆☆ | |

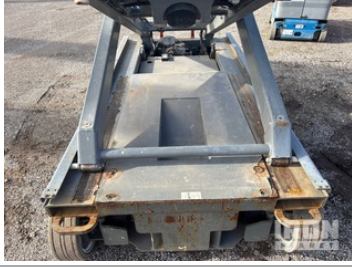
| Item | Assessment | Photo |
|---|---|---|
| Frame Condition | ★★☆☆ | |

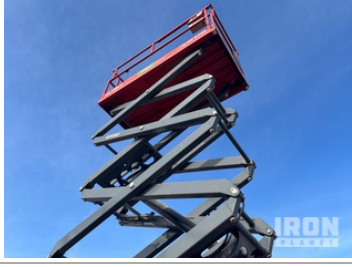
| Item | Assessment | Photo |
|---|---|---|
| Scissor Linkage | ★★☆☆ | |

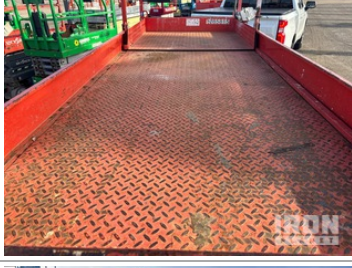
| Item | Assessment | Photo |
|---|---|---|
| Platform Condition | ★★☆☆ | |

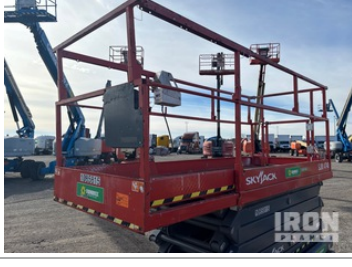
| Item | Assessment | Photo |
|---|---|---|
| Platform Extension | ★★☆☆ | |

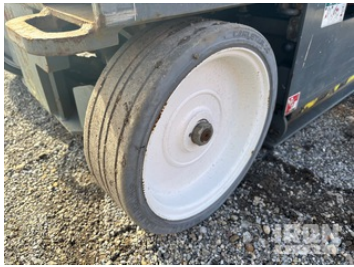
| Left Front Tire | Tears | |

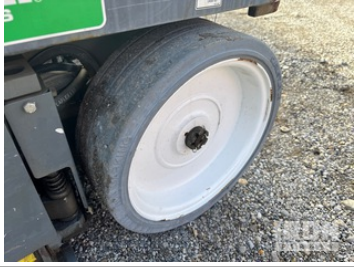
| Left Rear Tire | No visible defects | |

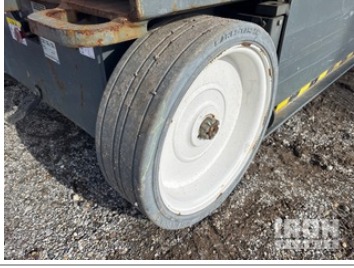
| Right Rear Tire | No visible defects | |

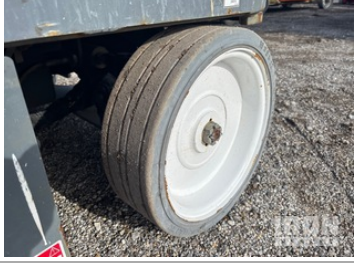
| Right Front Tire | No visible defects | |

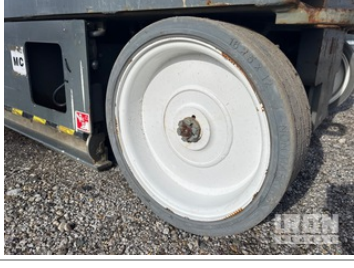
| Wheel Condition | No visible damage or missing components | |

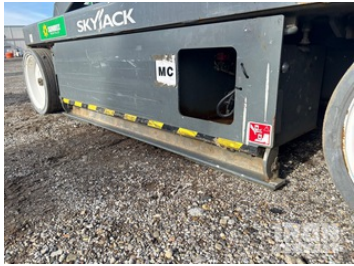
| Pothole Protection Bars | ★★★★☆<br>Functional | |
