## Item #14340466 - 2015 Skyjack SJ6826 RT Dual Fuel 4x4 Scissor Lift

# Inspection Report

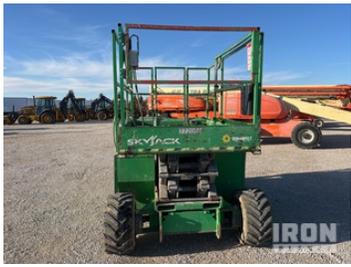
<p>Paint</p>	<p>Other unknown material</p>

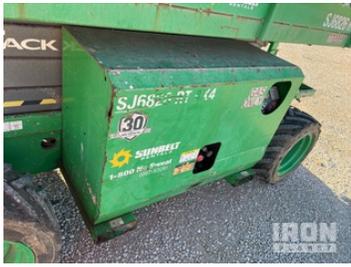
<p>Body Panels</p>	<p>Hydraulic compartment door damaged</p>

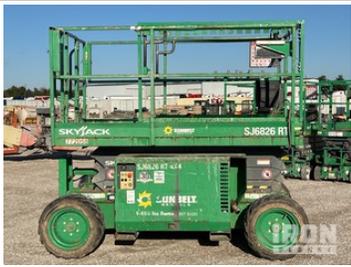
<p>Basket / Safety Railing</p>	<p>Left railing bent</p>	
<p>General Appearance #1</p>

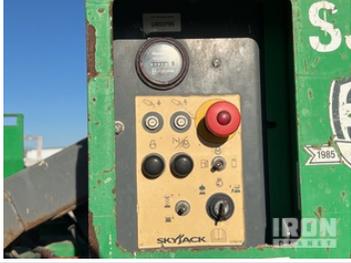
Function Controls	★★★★☆

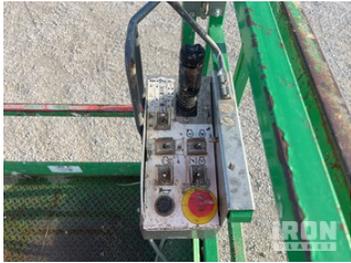
<b>Control Station Upper</b>		
Pin connection pivot point wear inspections are limited to sound, sight and feel observations. Dial indicator testing is not performed.		
<b>Item</b>	<b>Assessment</b>	<b>Photo</b>
Control Console	Material buildup

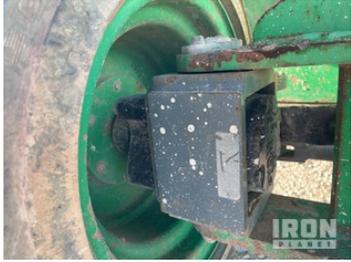
<b>Drivetrain</b>		
Operational test is limited to low speed in a confined flat area without load. Differential interlocks, full transmission shifting and functionality of all drive axles cannot be fully verified. Inspector listens for abnormal noises, observes leaks and notes physical damage.		
<b>Item</b>	<b>Assessment</b>	<b>Photo</b>
Drive Motors	★★★☆☆

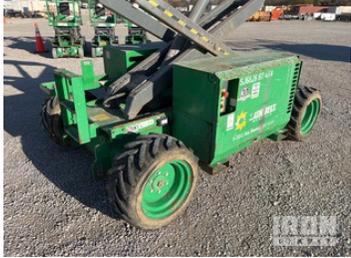
<b>Chassis</b>		
IronPlanet pin connection pivot point wear inspections are limited to sound, sight and feel observations. Dial indicator testing is not performed.		
<b>Item</b>	<b>Assessment</b>	<b>Photo</b>
Frame Condition	★★★☆☆

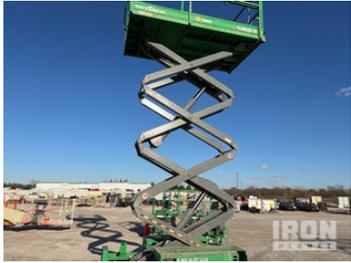
Scissor Linkage	★★★☆☆

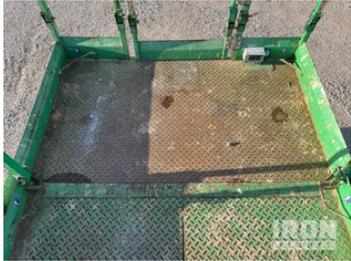
Platform Condition	★★★☆☆

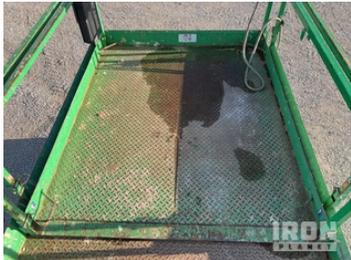
Platform Extension	★★★☆☆

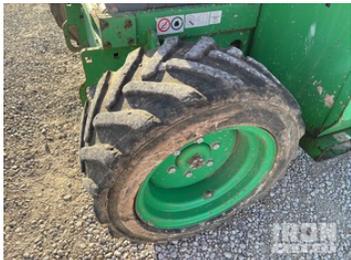
Left Front Tire	Cracks, Chunks missing, Tears

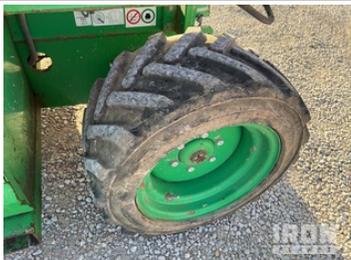
Left Rear Tire	Cracks, Chunks missing, Tears

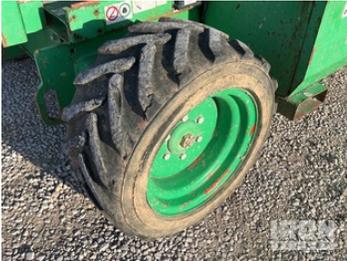
Right Rear Tire	Cracks, Chunks missing, Tears

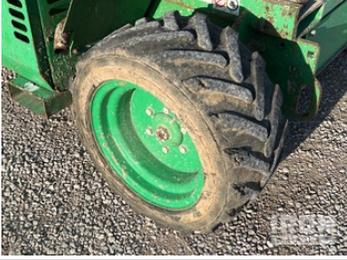
Right Front Tire	Cracks, Chunks missing, Tears
