## Item #13811481 - 2016 JLG 4069LE Electric Vertical Mast Lift

- Features: 40 ft Max Platform Height, 800 lb Max Weight Capacity, Platform Extension, Power to Platform, Solid Non-Marking Tires, Upper Control Box
- Meter Reading: 503 Hours
- Serial # : 0200252451
- Inspection Completed: 9/3/25

# Inspection Report

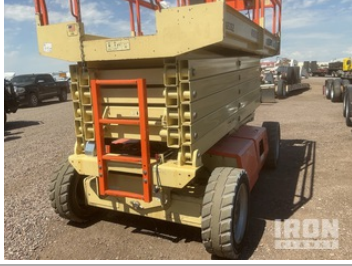
| Paint | No visible damage | |

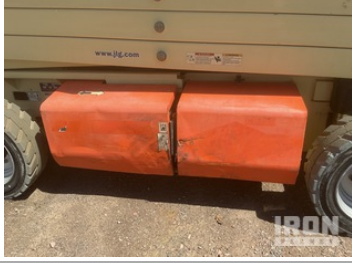
| Body Panels | Battery compartment door damaged,<br>Hydraulic compartment door damaged | |

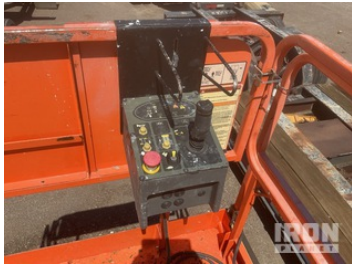
| Item | Assessment | Photo |
|---|---|---|
| Control Console | No visible damage or missing components | |

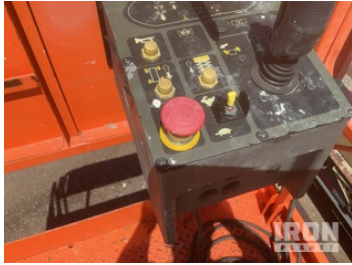
| Item | Assessment | Photo |
|---|---|---|
| Emergency Shut Off Switch | Operational | |

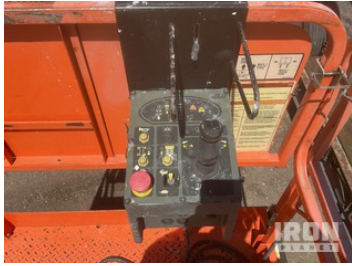
| Item | Assessment | Photo |
|---|---|---|
| Upper Function Controls | ★☆☆☆☆<br>Unit just beeps intermittently will not respond to controls | |
| Limited Function Check | The main components are in place and operational as noted. No lights or functions working on upper box. Platform will raise and lower from ground controls | |

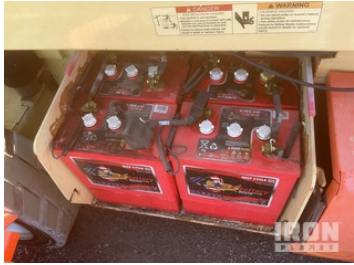
| Electrical Operating System | | |
|---|---|---|
| Cables and Connections | No visible damage or missing components | |

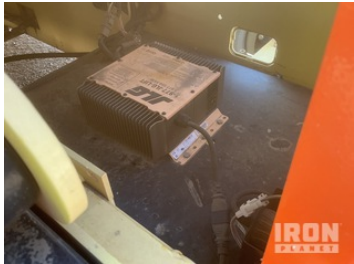
| Electrical Operating System | | |
|---|---|---|
| Battery Charger | Included Appears normal - Not operationally checked, 110 Volt, Single Phase | |

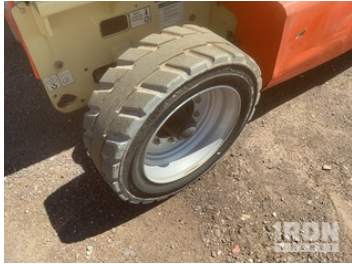
| Item | Assessment | Photo |
|---|---|---|
| Left Front Tire | Cracks | |

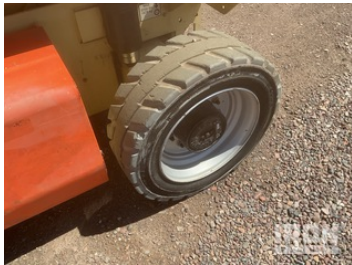
| Left Rear Tire | Cracks | |

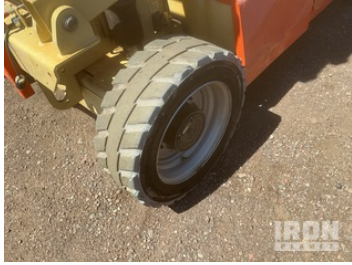
| Right Rear Tire | Cracks | |

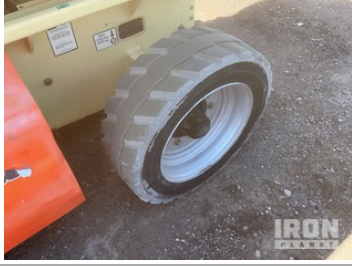
| Right Front Tire | Cracks | |

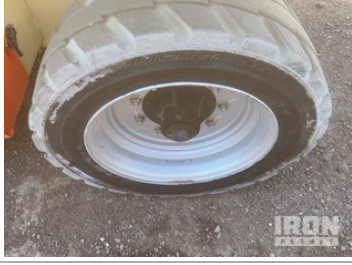
| Wheel Condition | No visible damage or missing components | |
