## Item #14340554 - 2016 Skyjack SJ4632 Electric Scissor Lift

# Inspection Report

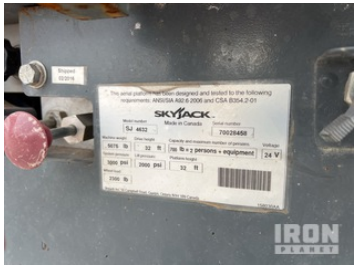
| Serial Number / VIN | 70028458 | |

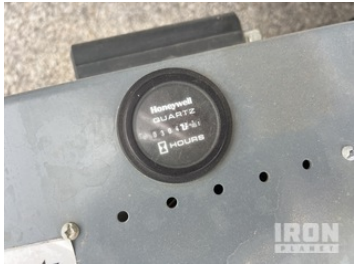
| Hour Meter / Odometer | 304 hrs | |

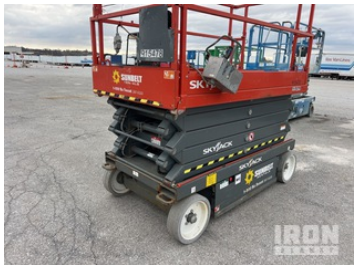
| Paint | No visible damage | |

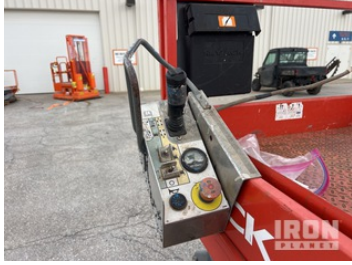
| Item | Assessment | Photo |
|---|---|---|
| Control Console | No visible damage or missing components | |

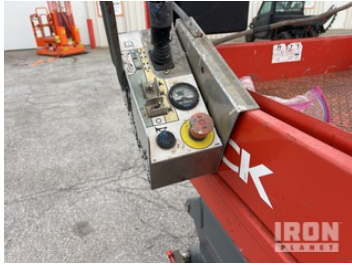
| Item | Assessment | Photo |
|---|---|---|
| Emergency Shut Off Switch | Operational | |

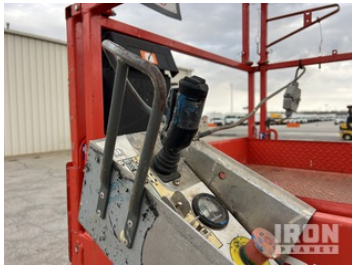
| Item | Assessment | Photo |
|---|---|---|
| Safety Control Hand/Foot Switch | ★★★★☆<br>Operational | |

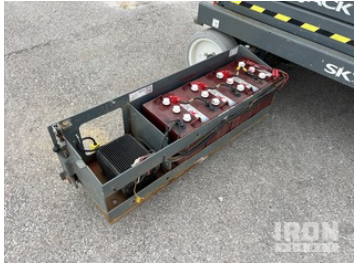
| Electrical Operating System | | |
|---|---|---|
| Cables and Connections | No visible damage or missing components | |

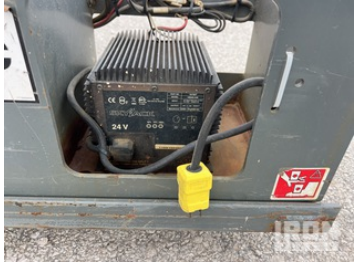
| Electrical Operating System | | |
|---|---|---|
| Battery Charger | Included Appears normal - Not operationally checked, 100-240 Volt, Single Phase | |

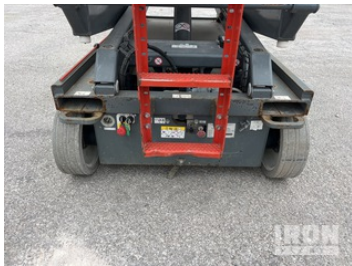
| Item | Assessment | Photo |
|---|---|---|
| Brake System | ★★☆☆<br>The brake system functioned, stopping and holding the machine. | |

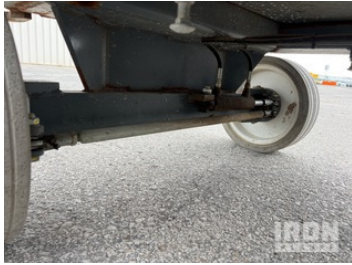
| Item | Assessment | Photo |
|---|---|---|
| Steering Linkage | ★★☆☆ | |

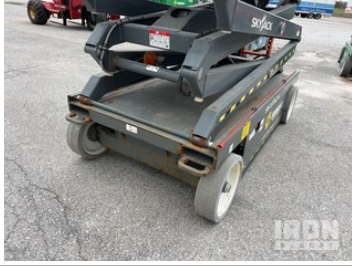
| Item | Assessment | Photo |
|---|---|---|
| Frame Condition | ★★☆☆ | |

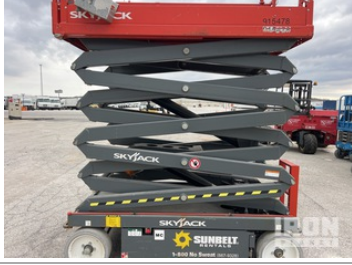
| Item | Assessment | Photo |
|---|---|---|
| Scissor Linkage | ★★☆☆ | |

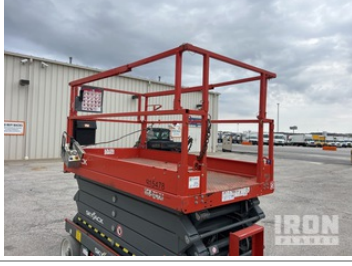
| Item | Assessment | Photo |
|---|---|---|
| Platform Condition | ★★☆☆ | |

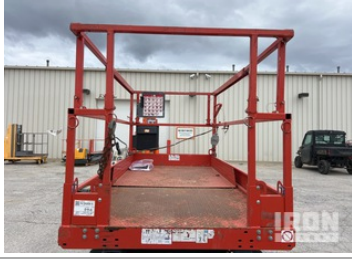
| Item | Assessment | Photo |
|---|---|---|
| Platform Extension | ★★☆☆ | |

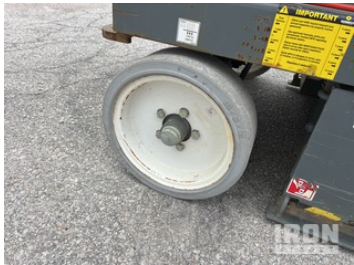
| Left Front Tire | No visible defects | |

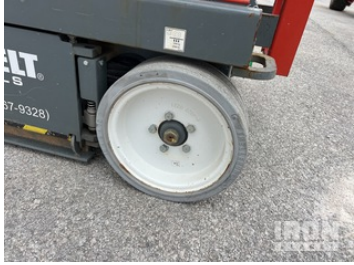
| Left Rear Tire | No visible defects | |

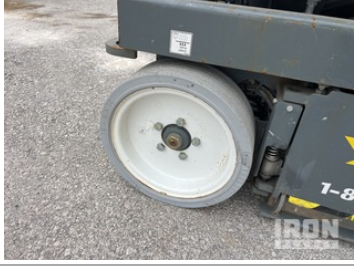
| Right Rear Tire | No visible defects | |

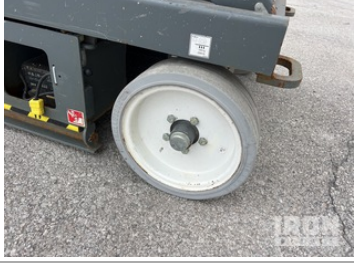
| Right Front Tire | No visible defects | |

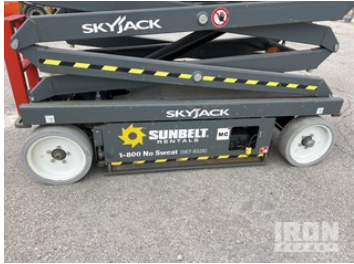
| Pothole Protection Bars | ★★★★☆<br>Functional | |
