Item #14301898 - 2017 JLG 4069LE Electric Scissor Lift

Inspection Report

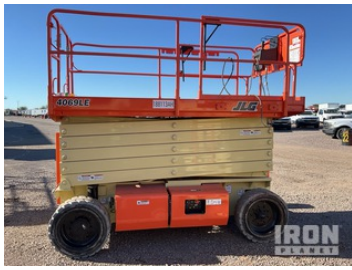
<p>Paint</p>	<p>No visible damage</p>

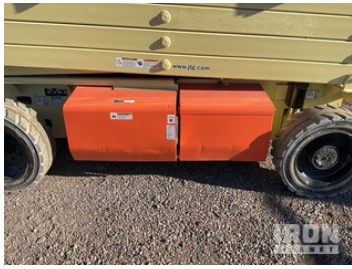
<p>Body Panels</p>	<p>No visible damage or missing components</p>

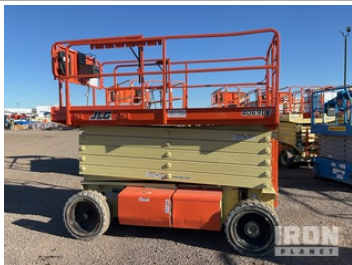
<p>Basket / Safety Railing</p>	<p>No visible damage or missing components</p>	
<p>General Appearance #1</p>

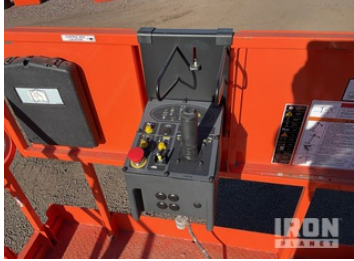
Control Station Upper		
Pin connection pivot point wear inspections are limited to sound, sight and feel observations. Dial indicator testing is not performed.		
Item	Assessment	Photo
Control Console	No visible damage or missing components

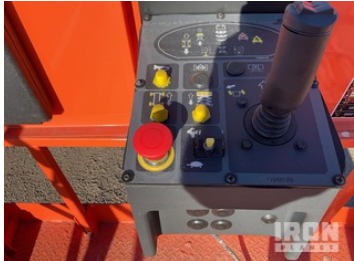
Emergency Shut Off Switch	Operational

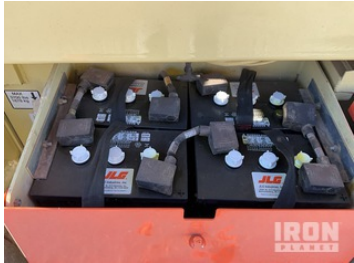
Electrical Operating System		
Item	Assessment	Photo
Operating Voltage	48 Volts	
Battery Condition	Functioned during the inspection	
Cables and Connections	No visible damage or missing components

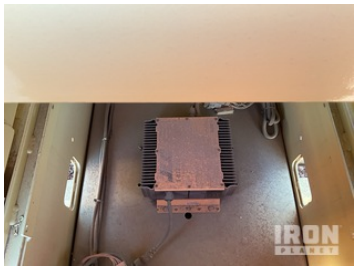
Battery Charger	Included Appears normal - Not operationally checked

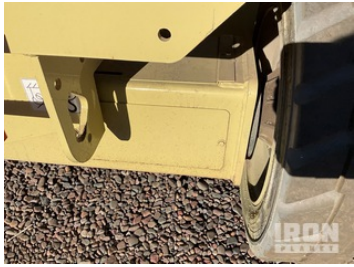
Drivetrain		
Operational test is limited to low speed in a confined flat area without load. Differential interlocks, full transmission shifting and functionality of all drive axles cannot be fully verified. Inspector listens for abnormal noises, observes leaks and notes physical damage.		
Item	Assessment	Photo
Drive Motors	★ ★ ★ ☆

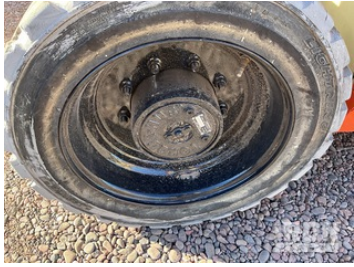
Final Drives	★ ★ ★ ☆

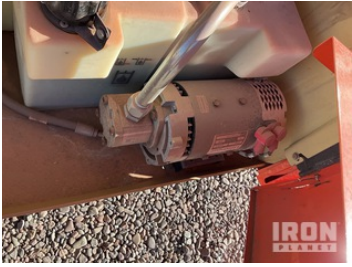
Hydraulics		
Item	Assessment	Photo
Pumps (Hydraulics)	★★★★☆

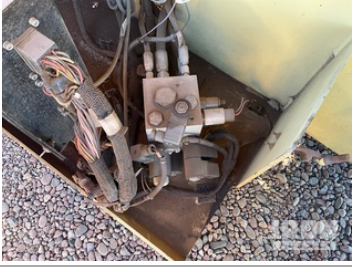
Valves	★★★★☆

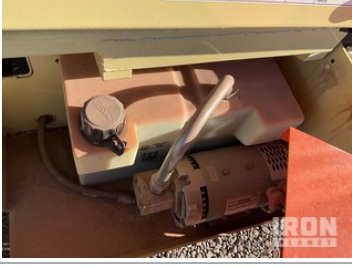
Hydraulic Tank	★★★★☆

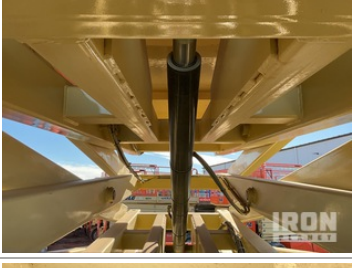
Lift Cylinders	★★★★☆

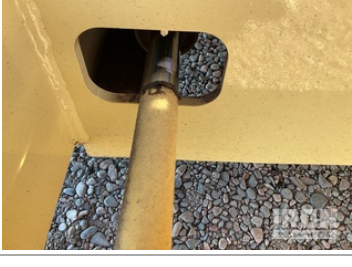
Steering Cylinder	★★★★☆

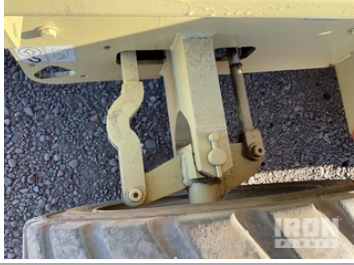
Chassis		
IronPlanet pin connection pivot point wear inspections are limited to sound, sight and feel observations. Dial indicator testing is not performed.		
Item	Assessment	Photo
Steering Linkage	★★★☆☆

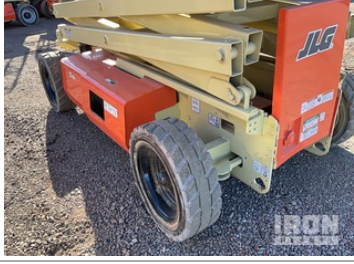
Frame Condition	★★★☆☆

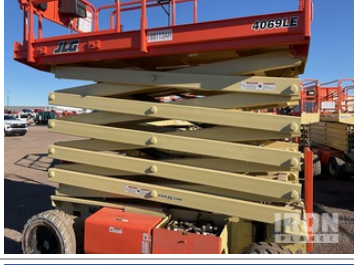
Scissor Linkage	★★★☆☆

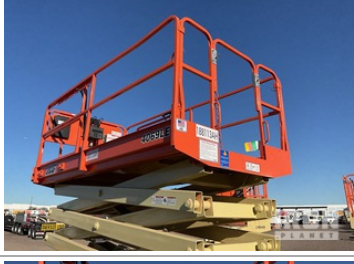
Platform Condition	★★★☆☆

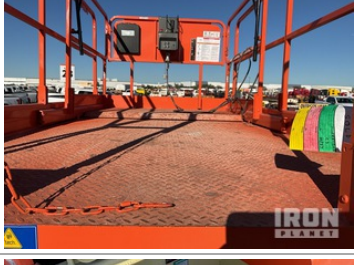
Platform Extension	★★★☆☆

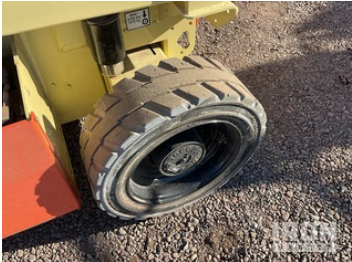
Left Rear Tire	No visible defects

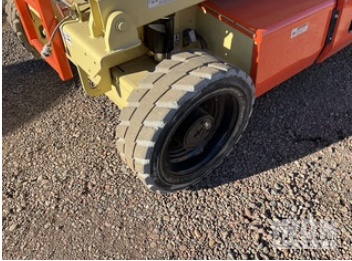
Right Rear Tire	No visible defects

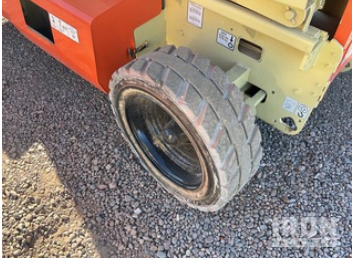
Right Front Tire	No visible defects

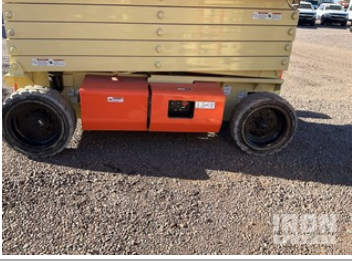
Wheel Condition	No visible damage or missing components
