## Item #13811276 - 2017 JLG 4069LE Electric Scissor Lift

## Inspection Report

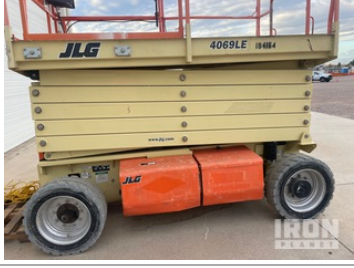
| Paint | Other unknown material | |

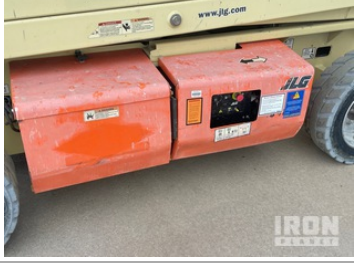
| Body Panels | Battery compartment door damaged,<br>Hydraulic compartment door damaged | |

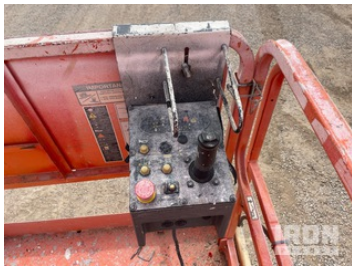
| Item | Assessment | Photo |
|---|---|---|
| Control Console | Material buildup | |

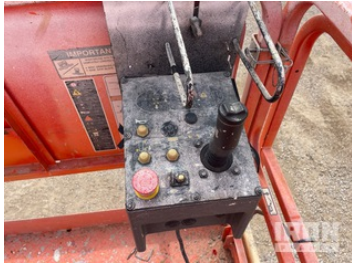
| Item | Assessment | Photo |
|---|---|---|
| Emergency Shut Off Switch | Operational | |

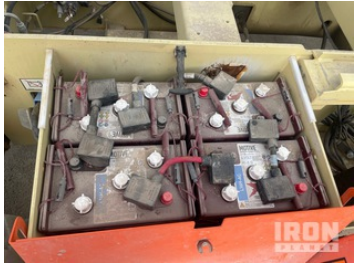
| Electrical Operating System | | |
|---|---|---|
| Cables and Connections | No visible damage or missing components | |

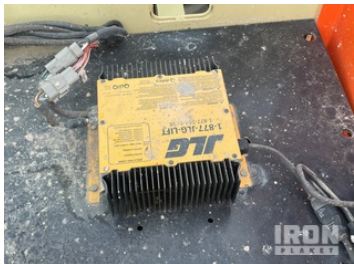
| Electrical Operating System | | |
|---|---|---|
| Battery Charger | Included 120 Volt, Single Phase | |

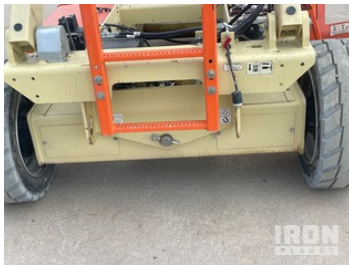
| Item | Assessment | Photo |
|---|---|---|
| Drive Motors | ★★★★☆ | |

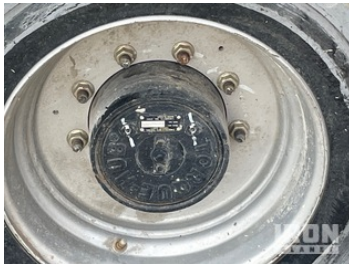
| Item | Assessment | Photo |
|---|---|---|
| Final Drives | ★★★★☆ | |

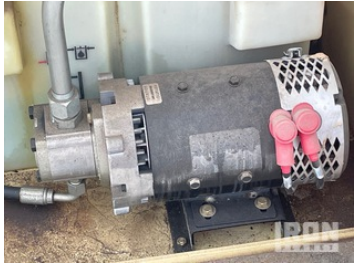
| Hydraulics | | |
|---|---|---|
| Pumps (Hydraulics) | ★★★★☆ | |

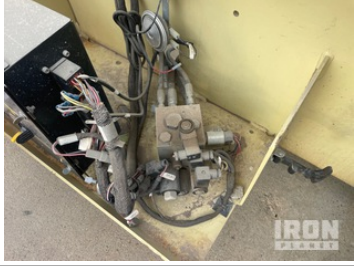
| Hydraulics | | |
|---|---|---|
| Valves | ★★★★☆ | |

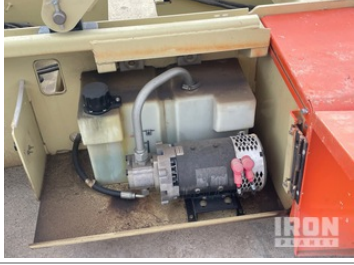
| Hydraulics | | |
|---|---|---|
| Hydraulic Tank | ★★★★☆ | |

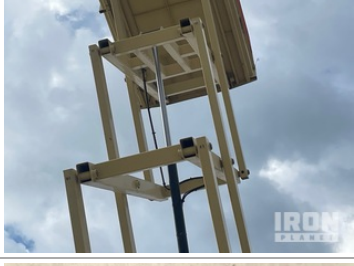
| Hydraulics | | |
|---|---|---|
| Lift Cylinders | ★★★★☆ | |

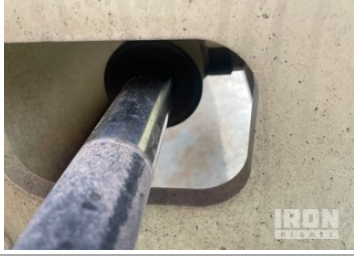
| Hydraulics | | |
|---|---|---|
| Steering Cylinder | ★★★★☆ | |

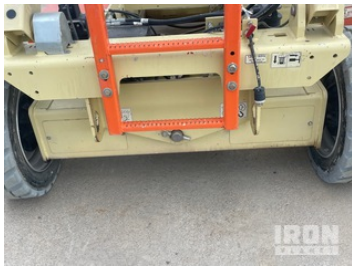
| Item | Assessment | Photo |
|---|---|---|
| Brake System | ★★☆☆<br>The brake system functioned, stopping and holding the machine. | |

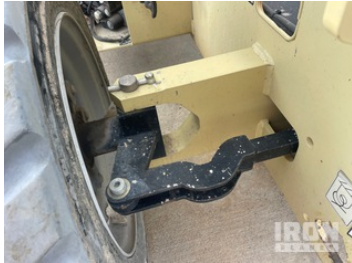
| Item | Assessment | Photo |
|---|---|---|
| Steering Linkage | ★★☆☆ | |

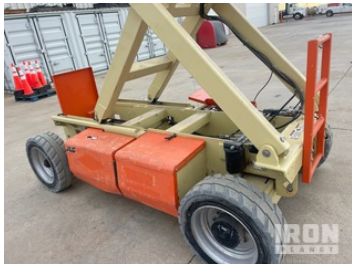
| Item | Assessment | Photo |
|---|---|---|
| Frame Condition | ★★☆☆ | |

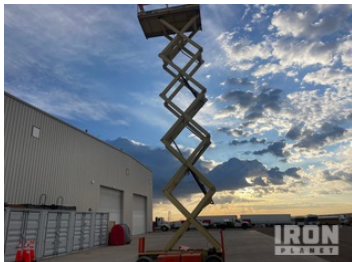
| Item | Assessment | Photo |
|---|---|---|
| Scissor Linkage | ★★☆☆ | |

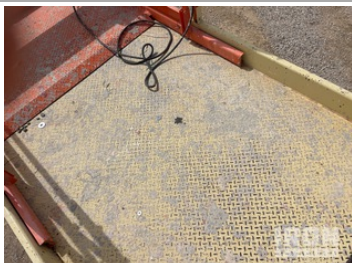
| Item | Assessment | Photo |
|---|---|---|
| Platform Condition | ★★☆☆<br>Foreign material | |

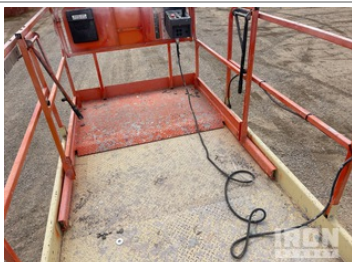
| Item | Assessment | Photo |
|---|---|---|
| Platform Extension | ★★☆☆<br>Foreign material | |

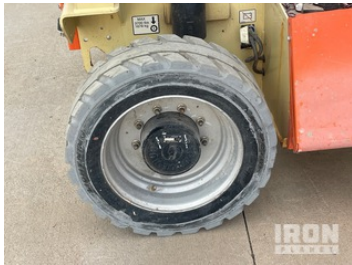
| Left Front Tire | Cracks, Chunks missing | |

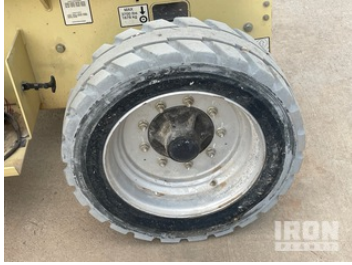
| Left Rear Tire | No visible defects | |

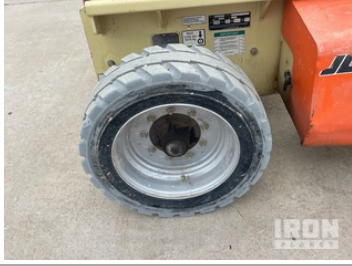
| Right Rear Tire | No visible defects | |

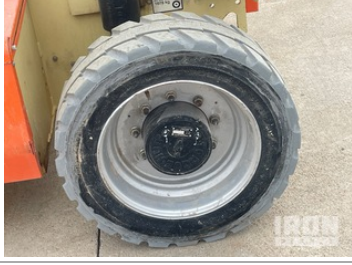
| Right Front Tire | Cracks, Chunks missing | |

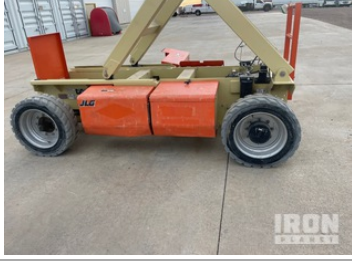
| Wheel Condition | No visible damage or missing components | |
