## Item #13811485 - 2016 JLG 4069LE Electric Vertical Mast Lift

## Inspection Report

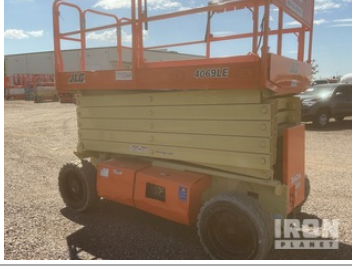
| Paint | No visible damage, Top of platform covered in gravel and sheet rock mud | |

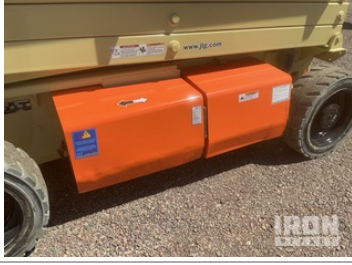
| Body Panels | Battery compartment door damaged, Hydraulic compartment door damaged | |

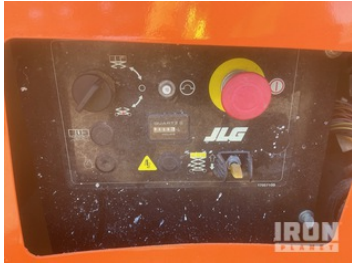
| Control Station Ground | | |
|---|---|---|
| Gauges | Operational | |

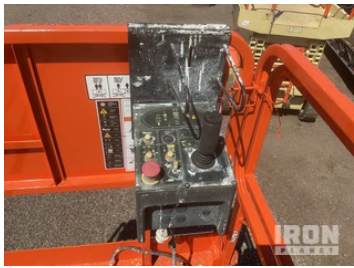
| Item | Assessment | Photo |
|---|---|---|
| Control Console | No visible damage or missing components | |

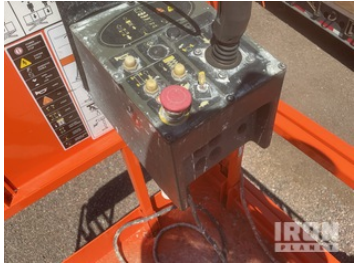
| Item | Assessment | Photo |
|---|---|---|
| Emergency Shut Off Switch | Operational | |

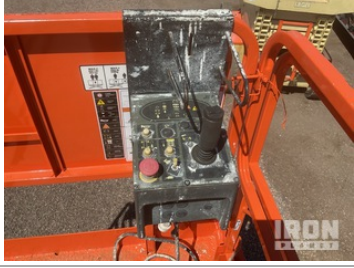
| Item | Assessment | Photo |
|---|---|---|
| Upper Function Controls | ★★★★☆ | |

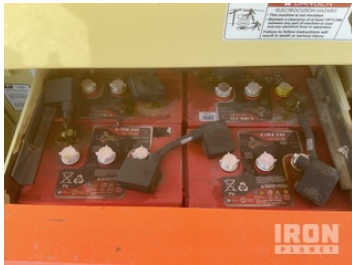
| <b>Electrical Operating System</b> | | |
|---|---|---|
| Cables and Connections | No visible damage or missing components | |

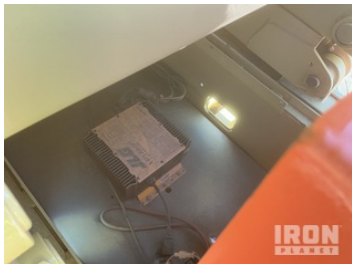
| <b>Electrical Operating System</b> | | |
|---|---|---|
| Battery Charger | Included Appears normal - Not operationally checked, 110 Volt, Single Phase | |

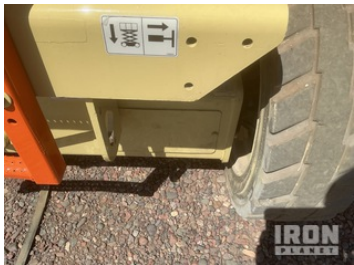
| Item | Assessment | Photo |
|---|---|---|
| Drive Motors | ★★★★☆ | |

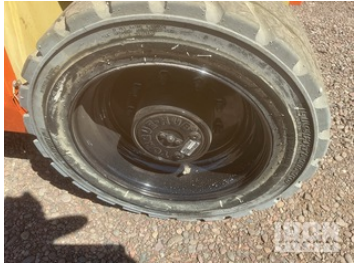
| Item | Assessment | Photo |
|---|---|---|
| Final Drives | ★★★★☆ | |

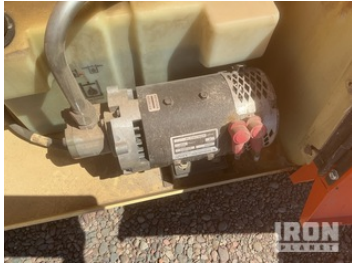
| Hydraulics | | |
|---|---|---|
| Pumps (Hydraulics) | ★★★★☆ | |

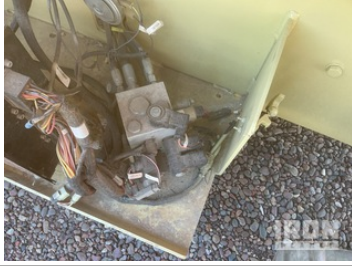
| Hydraulics | | |
|---|---|---|
| Valves | ★★★★☆ | |

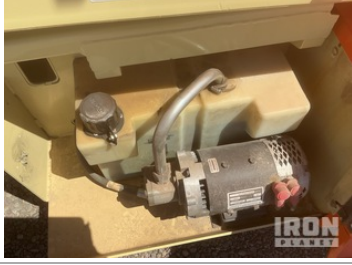
| Hydraulics | | |
|---|---|---|
| Hydraulic Tank | ★★★★☆ | |

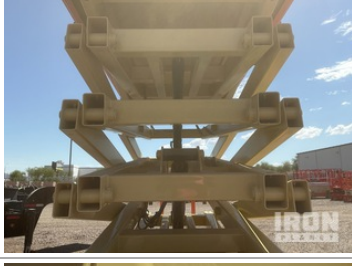
| Hydraulics | | |
|---|---|---|
| Lift Cylinders | ★★★★☆ | |

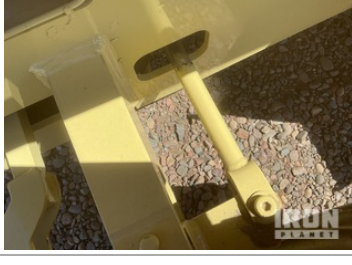
| Hydraulics | | |
|---|---|---|
| Steering Cylinder | ★★★★☆ | |

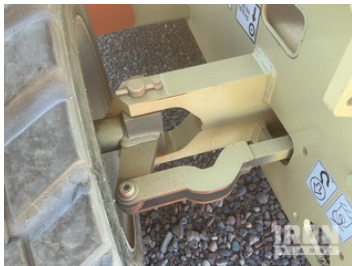
| Item | Assessment | Photo |
|---|---|---|
| Steering Linkage | ★★★★☆ | |

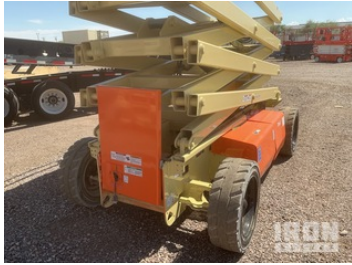
| Item | Assessment | Photo |
|---|---|---|
| Frame Condition | ★★★★☆ | |

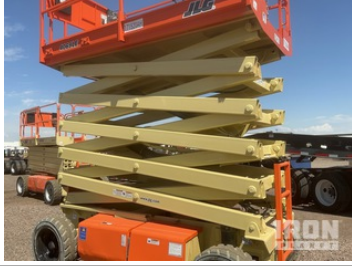
| Item | Assessment | Photo |
|---|---|---|
| Scissor Linkage | ★★★★☆ | |

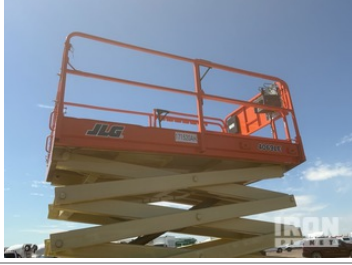
| Item | Assessment | Photo |
|---|---|---|
| Platform Condition | ★★★★☆ | |

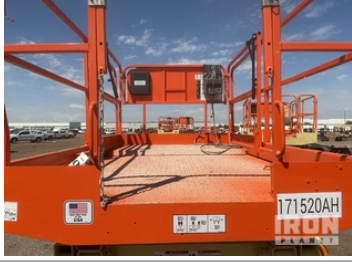
| Item | Assessment | Photo |
|---|---|---|
| Platform Extension | ★★★★☆ | |

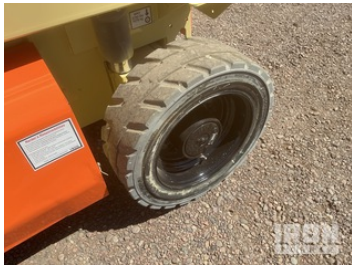
| Left Rear Tire | No visible defects | |

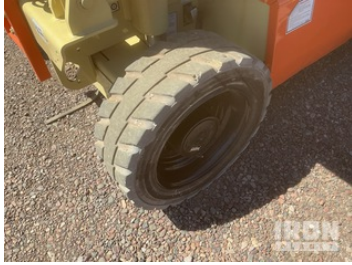
| Right Rear Tire | No visible defects | |

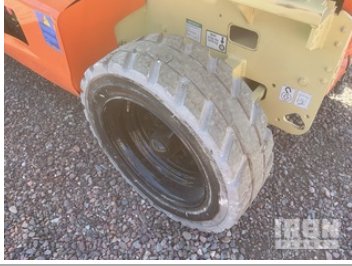
| Right Front Tire | No visible defects | |

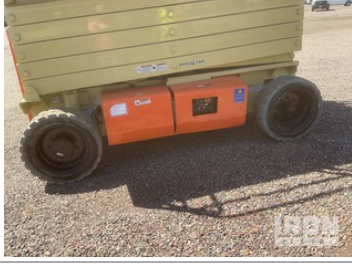
| Wheel Condition | No visible damage or missing components | |
