## Item #14339933 - 2017 Skyjack SJ4740 Electric Scissor Lift

# Inspection Report

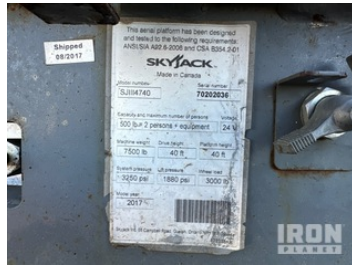
| Serial Number / VIN | 70202036 | |

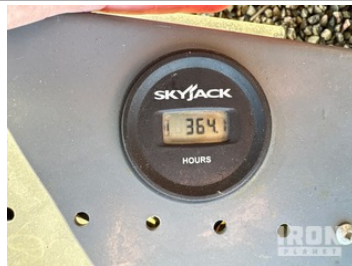
| Hour Meter / Odometer | 364 hrs | |

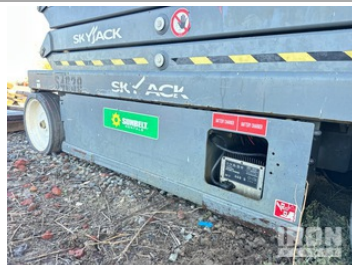
| Paint | No visible damage | |

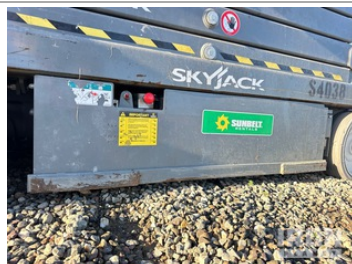
| Body Panels | No visible damage or missing components | |

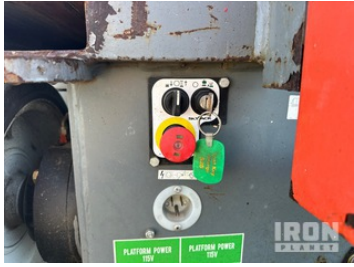
| Control Station Ground | | |
|---|---|---|
| Function Controls | ☆☆☆☆ | |

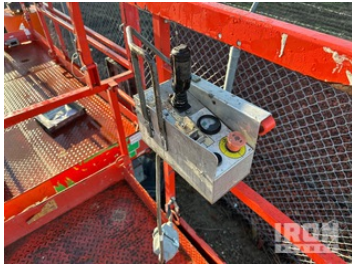
| Item | Assessment | Photo |
|---|---|---|
| Control Console | No visible damage or missing components | |

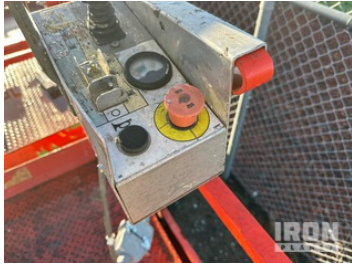
| Item | Assessment | Photo |
|---|---|---|
| Emergency Shut Off Switch | Operational | |

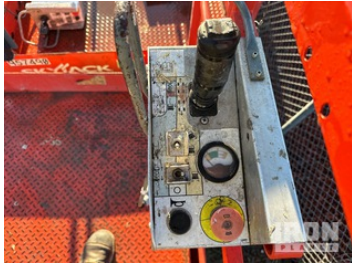
| Item | Assessment | Photo |
|---|---|---|
| Upper Function Controls | ★★★★☆ | |

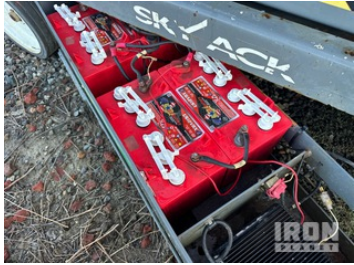
| Electrical Operating System | | |
|---|---|---|
| Cables and Connections | No visible damage or missing components | |

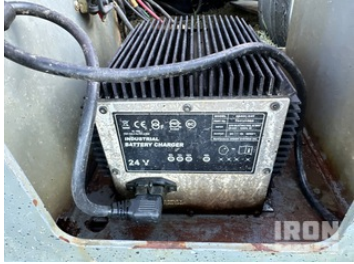
| Electrical Operating System | | |
|---|---|---|
| Battery Charger | Appears normal - Not operationally checked, Single Phase | |

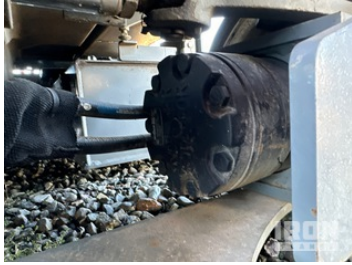
| Item | Assessment | Photo |
|---|---|---|
| Drive Motors | ★★★☆☆ | |

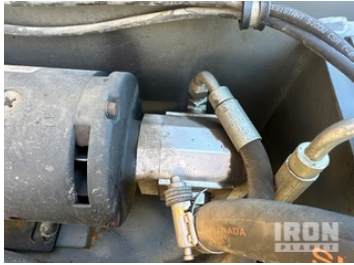
| Hydraulics | | |
|---|---|---|
| Pumps (Hydraulics) | ★★★★☆ | |

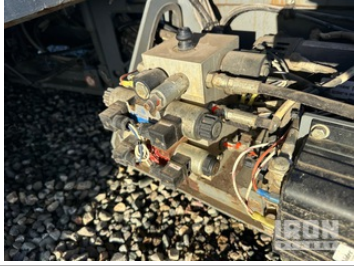
| Hydraulics | | |
|---|---|---|
| Valves | ★★★★☆ | |

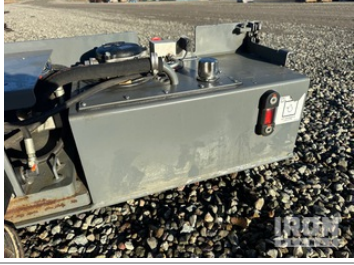
| Hydraulics | | |
|---|---|---|
| Hydraulic Tank | ★★★★☆ | |

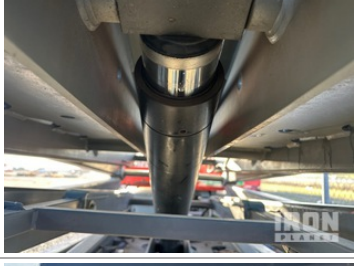
| Hydraulics | | |
|---|---|---|
| Lift Cylinders | ★★★★☆ | |

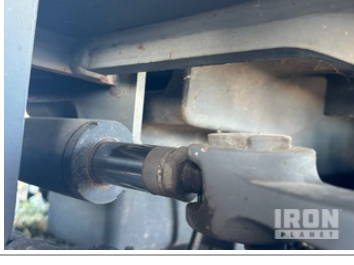
| Hydraulics | | |
|---|---|---|
| Steering Cylinder | ★★★★☆ | |

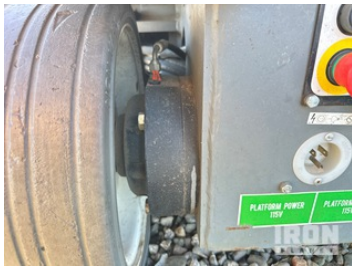
| Item | Assessment | Photo |
|---|---|---|
| Brake System | ★★☆☆<br>The brake system functioned, stopping and holding the machine. | |

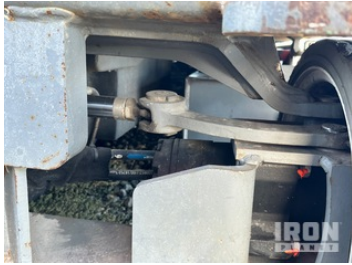
| Item | Assessment | Photo |
|---|---|---|
| Steering Linkage | ★★☆☆ | |

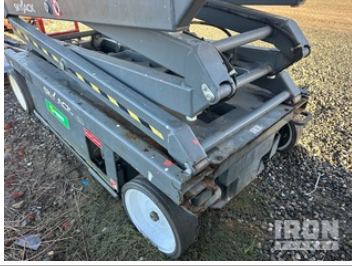
| Item | Assessment | Photo |
|---|---|---|
| Frame Condition | ★★☆☆ | |

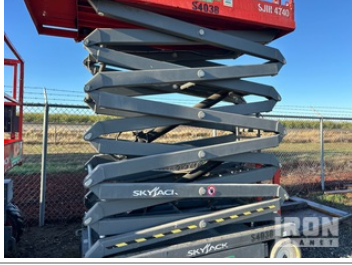
| Item | Assessment | Photo |
|---|---|---|
| Scissor Linkage | ★★☆☆ | |

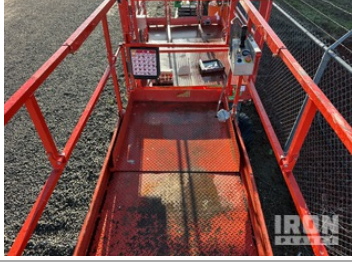
| Item | Assessment | Photo |
|---|---|---|
| Platform Condition | ★★☆☆ | |

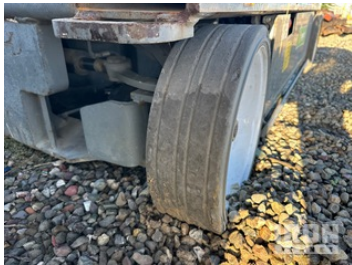
| Left Front Tire | Cracks, Tears | |

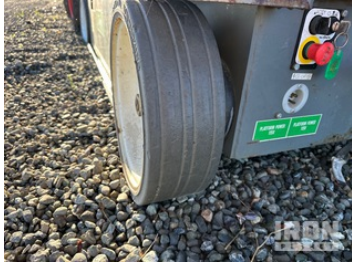
| Left Rear Tire | Cracks, Tears | |

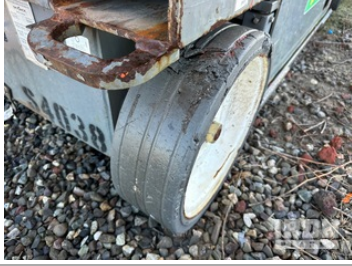
| Right Rear Tire | Cracks, Chunks missing, Tears, Deformed | |

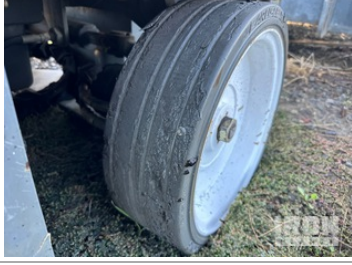
| Right Front Tire | Cracks, Chunks missing, Tears, Deformed | |

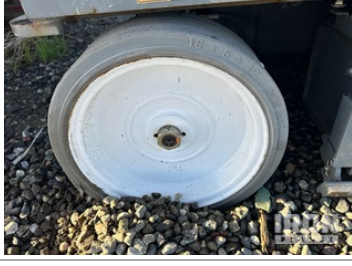
| Wheel Condition | No visible damage or missing components | |

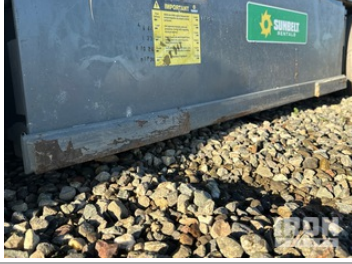
| Pothole Protection Bars | ★★★★☆<br>Functional | |
