## Item #13810957 - 2016 JLG 4069LE Electric Scissor Lift

# Inspection Report

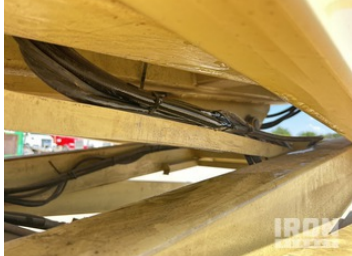
| Hydraulics | | |
|---|---|---|
| Hoses | Blown hose. | A photograph showing a close-up of a hydraulic hose that has been blown out, with the internal structure exposed. The hose is yellow and the background shows the yellow body of the machine. |

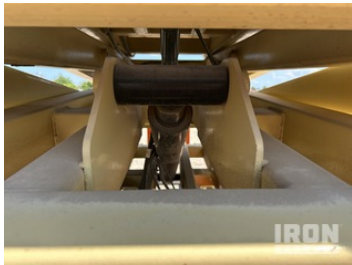
| Lift Cylinders | ★★☆☆<br>Hydraulic leak visible platform raises and then comes down. | |

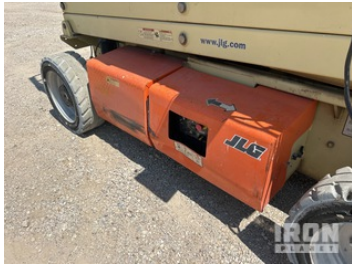
| Body Panels | Hydraulic compartment door damaged, Compartment doors on all sides damaged. | |

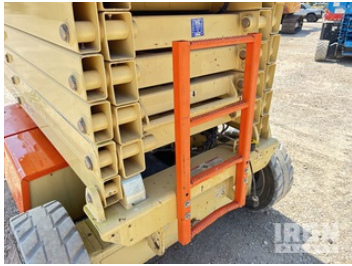
| Steps/Ladders | Bent | |

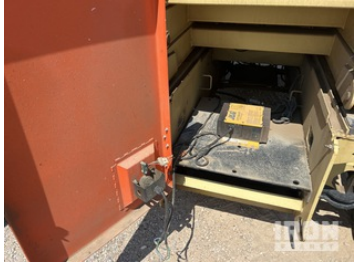
| Electrical Operating System | | |
|---|---|---|
| Battery Charger | Appears normal - Not operationally checked, 115 Volt, Single Phase Plug cover broken. | |

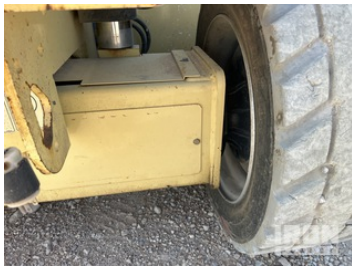
| Item | Assessment | Photo |
|---|---|---|
| Brake System | ★★☆☆<br>The brake system functioned, stopping and holding the machine. | |

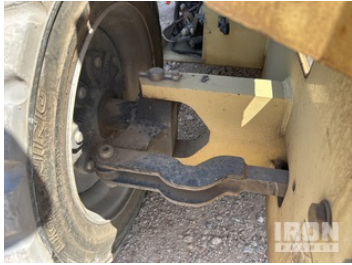
| Item | Assessment | Photo |
|---|---|---|
| Steering Linkage | ★★☆☆ | |

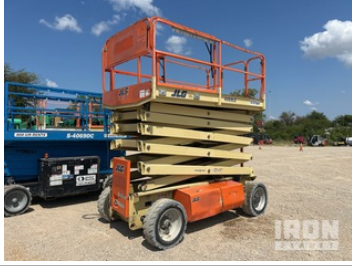
| Item | Assessment | Photo |
|---|---|---|
| Frame Condition | ★★☆☆ | |

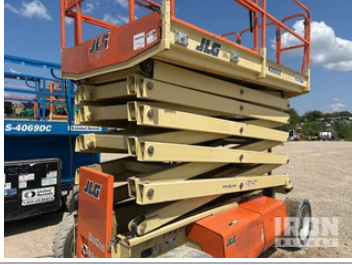
| Item | Assessment | Photo |
|---|---|---|
| Scissor Linkage | ★★☆☆ | |

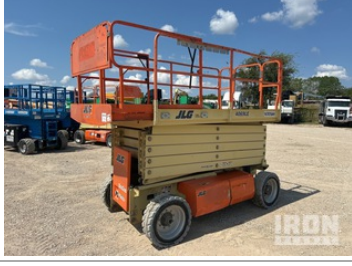
| Item | Assessment | Photo |
|---|---|---|
| Platform Condition | ★★☆☆ | |

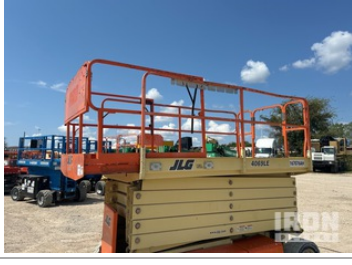
| Item | Assessment | Photo |
|---|---|---|
| Platform Extension | ★★☆☆ | |

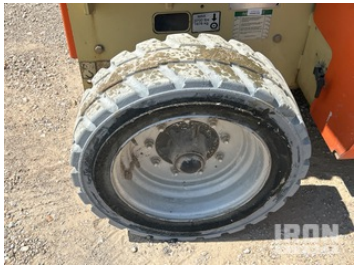
| Left Front Tire | Cracks, Chunks missing | |

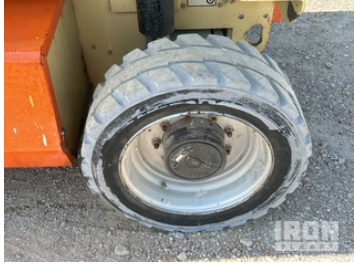
| Left Rear Tire | Cracks, Chunks missing | |

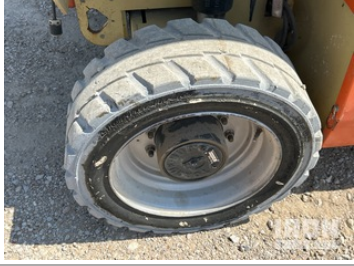
| Right Rear Tire | Cracks, Chunks missing | |

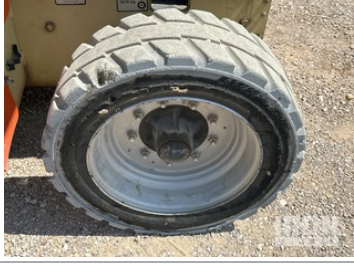
| Right Front Tire | Cracks, Chunks missing | |
