## Item #13810821 - 2016 Genie GS3232 Electric Scissor Lift

## Inspection Report

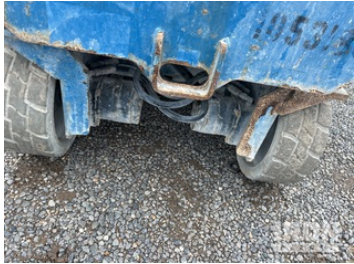
| Item | Assessment | Photo |
|---|---|---|
| Drive Motors | ★★★★ | |

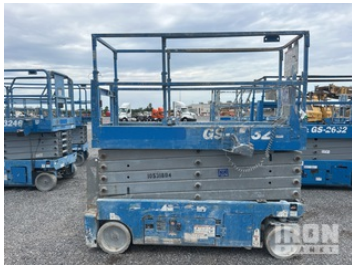
| Paint | Concrete residue And has rust on it | |

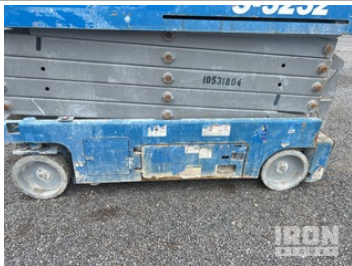
| Body Panels | Right door is bent. Bent panel on the back left | |

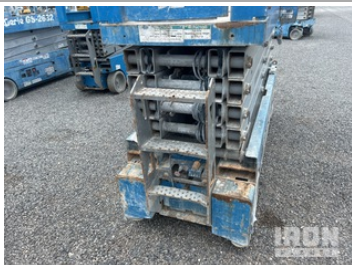
| Steps/Ladders | Bent | |

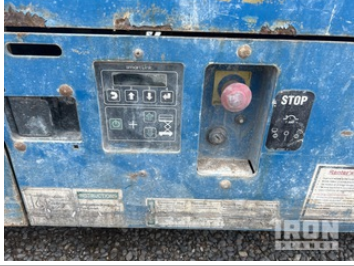
| Control Station Ground | | |
|---|---|---|
| Function Controls | ★★★★☆ | |

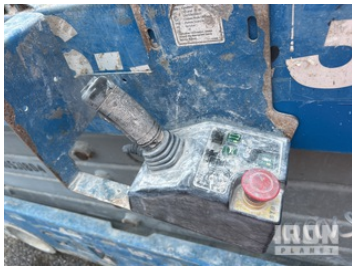
| Item | Assessment | Photo |
|---|---|---|
| Control Console | Screen is hard to see | |

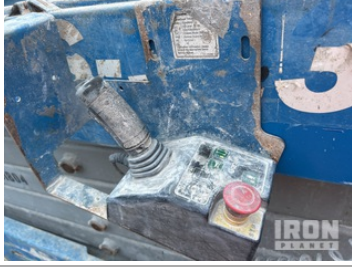
| Item | Assessment | Photo |
|---|---|---|
| Upper Function Controls | ☆☆☆☆ | |

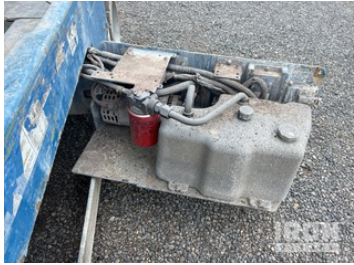
| Hydraulics | | |
|---|---|---|
| Pumps (Hydraulics) | ★★★★☆ | |

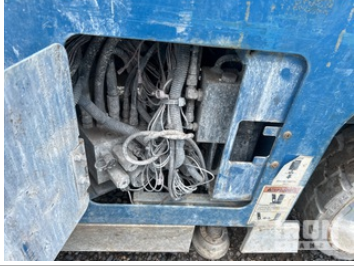
| Hydraulics | | |
|---|---|---|
| Valves | ★★★★☆ | |

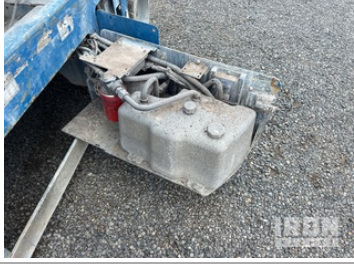
| Hydraulics | | |
|---|---|---|
| Hydraulic Tank | ★★★★☆ | |

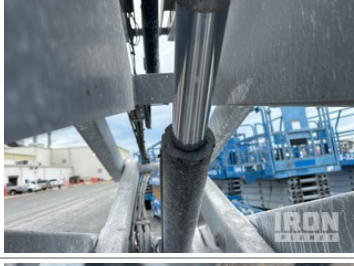
| Hydraulics | | |
|---|---|---|
| Lift Cylinders | ★★★★☆ | |

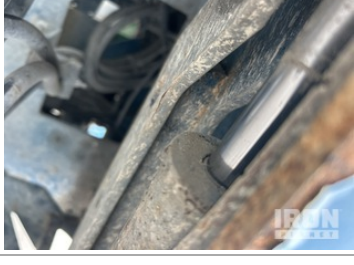
| Hydraulics | | |
|---|---|---|
| Steering Cylinder | ★★★★☆ | |

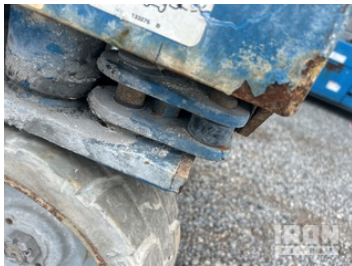
| Item | Assessment | Photo |
|---|---|---|
| Steering Linkage | ★★★★☆ | |

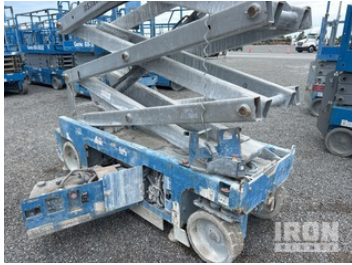
| Item | Assessment | Photo |
|---|---|---|
| Frame Condition | ★★★★☆ | |

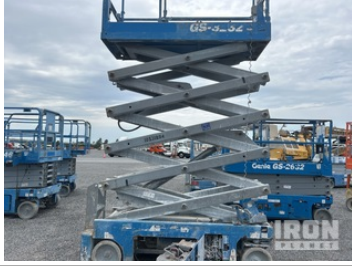
| Item | Assessment | Photo |
|---|---|---|
| Scissor Linkage | ★★★★☆ | |

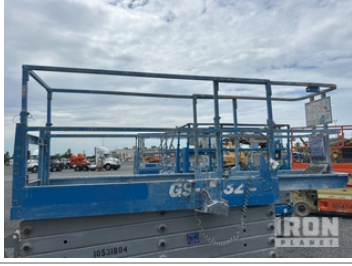
| Item | Assessment | Photo |
|---|---|---|
| Platform Condition | ★★★☆☆<br>Has some bent metal | |

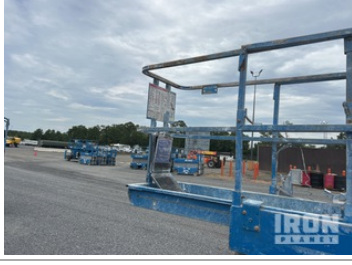
| Item | Assessment | Photo |
|---|---|---|
| Platform Extension | ★★★★☆ | |

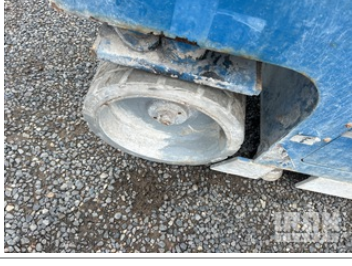
| Item | Assessment | Photo |
|---|---|---|
| Left Front Tire | Tears | |

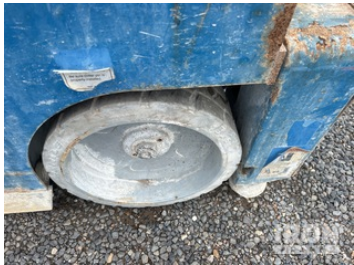
| Left Rear Tire | Tears | |

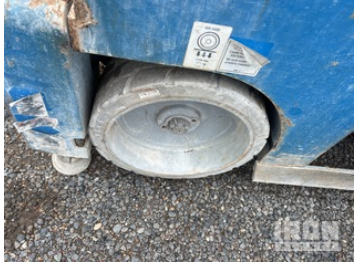
| Right Rear Tire | Tears | |

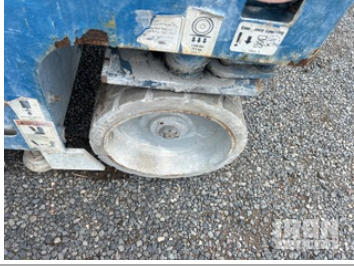
| Right Front Tire | Tears | |

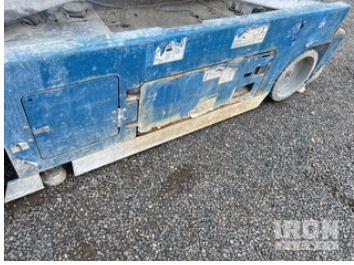
| Pothole Protection Bars | ★★★★☆<br>Functional | |

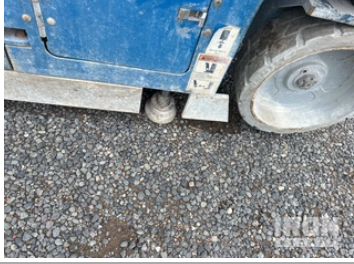
| Outriggers / Stabilizers | ★★★★☆ | |
