## Item #13811434 - 2016 JLG 4069LE Scissor Lift

# Inspection Report

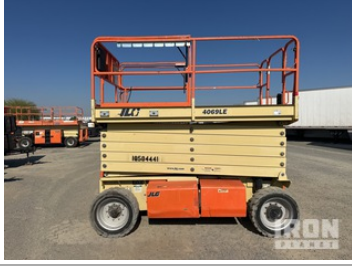
| Paint | No visible damage | |

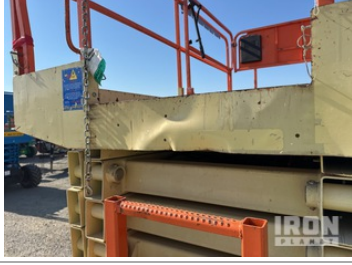
| Body Panels | No visible damage or missing components | |

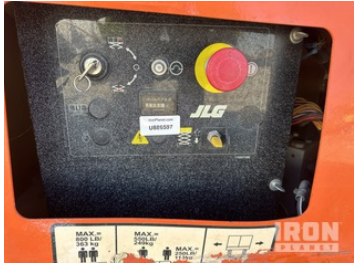
| Control Station Ground | | |
|---|---|---|
| Function Controls | ★★★★☆ | |

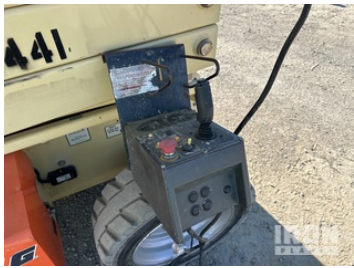
| Item | Assessment | Photo |
|---|---|---|
| Control Console | No visible damage or missing components | |

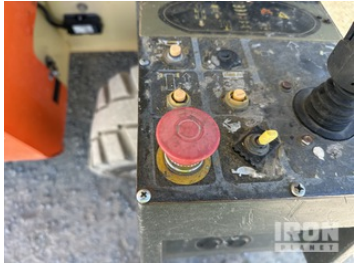
| Item | Assessment | Photo |
|---|---|---|
| Emergency Shut Off Switch | Operational | |

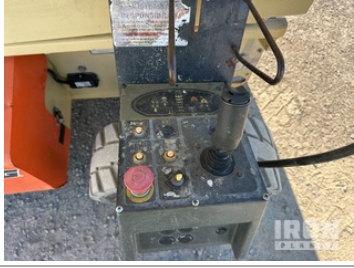
| Item | Assessment | Photo |
|---|---|---|
| Upper Function Controls | ☆☆☆☆ | |

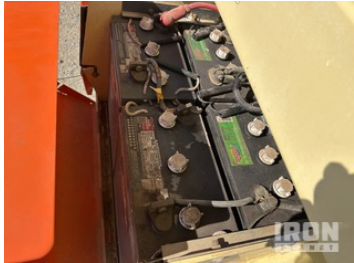
| Electrical Operating System | | |
|---|---|---|
| Cables and Connections | No visible damage or missing components | |

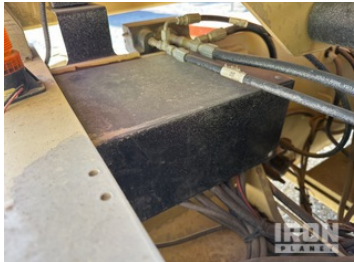
| Electrical Operating System | | |
|---|---|---|
| Battery Charger | Included Appears normal - Not operationally checked, 120 Volt, Single Phase | |

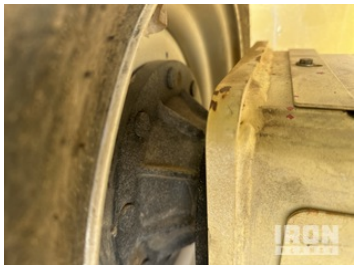
| Drivetrain | | |
|---|---|---|
| Drive Motors | ★★★★☆ | |

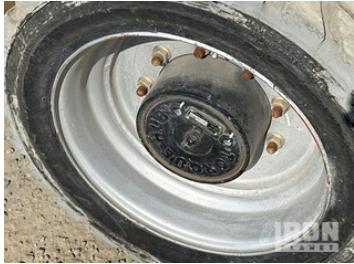
| Drivetrain | | |
|---|---|---|
| Final Drives | ★★★★☆ | |

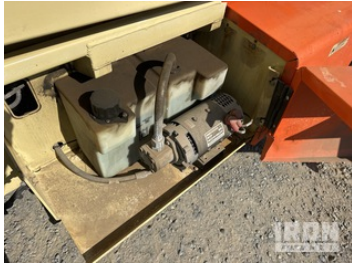
| Hydraulics | | |
|---|---|---|
| Pumps (Hydraulics) | ★★★★☆ | A close-up photograph of a hydraulic pump assembly mounted on a yellow metal frame. The pump is a white, rectangular unit with various hoses and electrical connections. An "IRON PLANET" watermark is visible in the bottom right corner. |

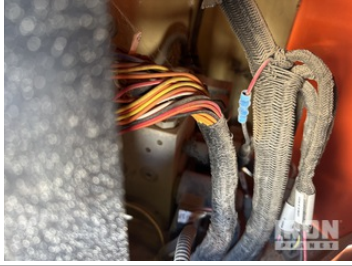
| Hydraulics | | |
|---|---|---|
| Valves | ★★★★☆ | A close-up photograph of hydraulic hoses and valves. The hoses are braided and connected to various components. An "IRON PLANET" watermark is visible in the bottom right corner. |

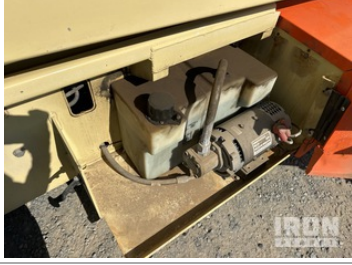
| Hydraulics | | |
|---|---|---|
| Hydraulic Tank | ★★★★☆ | A photograph showing a hydraulic tank and pump assembly. The tank is a large, dark, rectangular unit, and the pump is a white unit mounted on top. An "IRON PLANET" watermark is visible in the bottom right corner. |

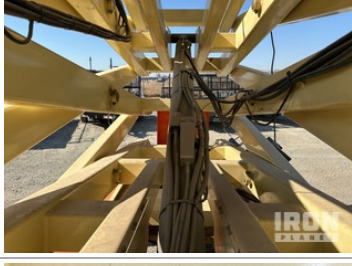
| Hydraulics | | |
|---|---|---|
| Lift Cylinders | ★★★★☆ | A photograph showing the lift cylinders of the scissor lift. The cylinders are yellow and extend upwards. An "IRON PLANET" watermark is visible in the bottom right corner. |

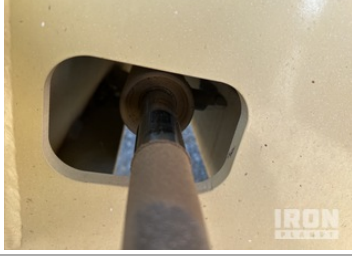
| Hydraulics | | |
|---|---|---|
| Steering Cylinder | ★★★★☆ | A close-up photograph of a steering cylinder. The cylinder is a dark, cylindrical unit with a metal rod extending from the top. An "IRON PLANET" watermark is visible in the bottom right corner. |

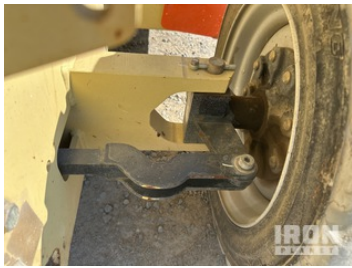
| Item | Assessment | Photo |
|---|---|---|
| Steering Linkage | ★★★★☆ | |

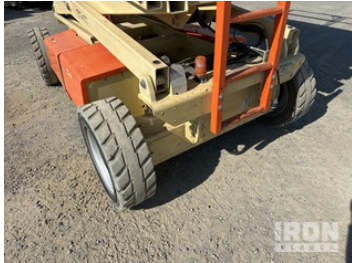
| Item | Assessment | Photo |
|---|---|---|
| Frame Condition | ★★★★☆ | |

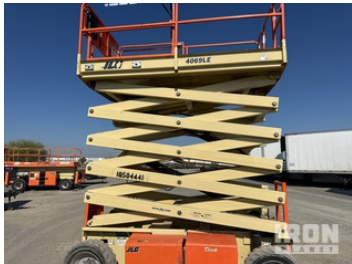
| Item | Assessment | Photo |
|---|---|---|
| Scissor Linkage | ★★★★☆ | |

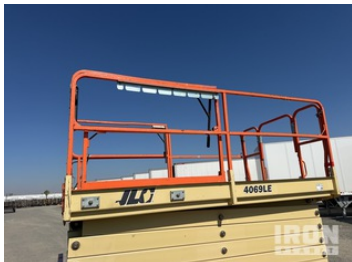
| Item | Assessment | Photo |
|---|---|---|
| Platform Condition | ★★★★☆ | |

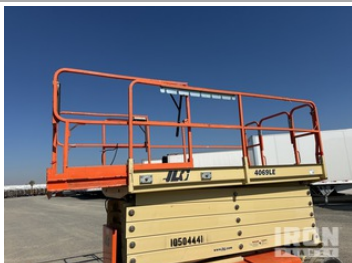
| Item | Assessment | Photo |
|---|---|---|
| Platform Extension | ★★★★☆ | |

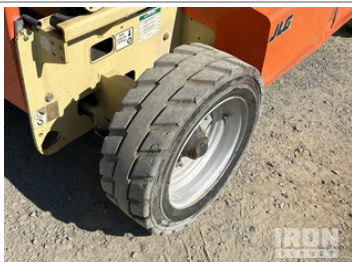
| Item | Assessment | Photo |
|---|---|---|
| Left Front Tire | No visible defects | |

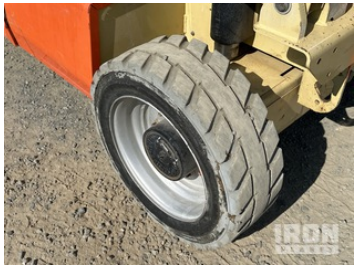
| Left Rear Tire | No visible defects | |

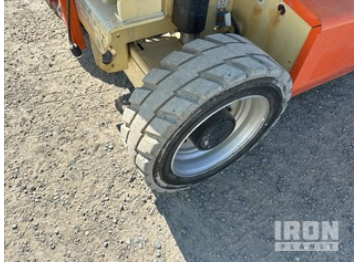
| Right Rear Tire | No visible defects | |

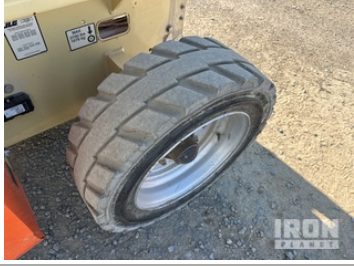
| Right Front Tire | No visible defects | |

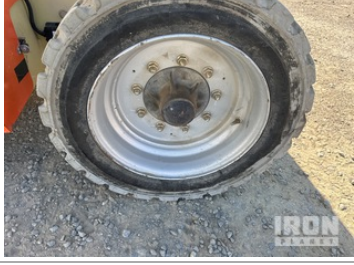
| Wheel Condition | No visible damage or missing components | |
