## Item #14340467 - 2015 Skyjack SJ7135RT Diesel 4x4 Scissor Lift

# Inspection Report

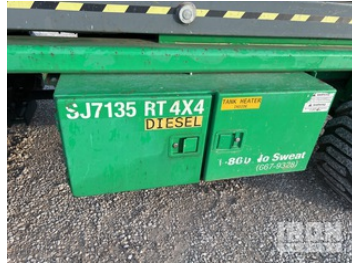
| Body Panels | Engine compartment door damaged,<br>Hydraulic compartment door damaged | |

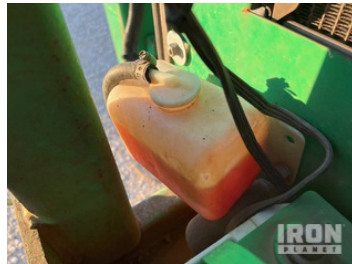
| Engine | | |
|---|---|---|
| Radiator | ★★★★☆ | |

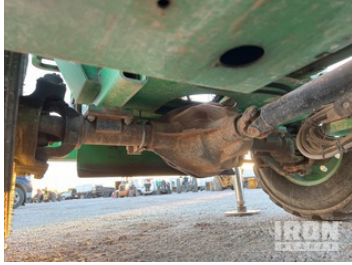
| Item | Assessment | Photo |
|---|---|---|
| Front Drive Axle | ★★★★☆ | A close-up photograph of the front drive axle assembly of a green scissor lift. The axle is a heavy-duty metal shaft with a differential housing in the center. The surrounding components are painted green, matching the lift's body. The ground is a light-colored gravel or dirt surface. |

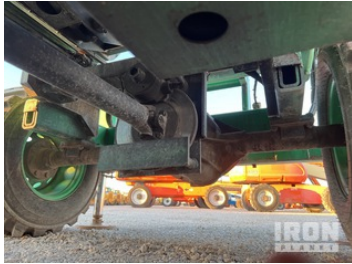
| Item | Assessment | Photo |
|---|---|---|
| Rear Drive Axle | ★★★★☆ | A photograph of the rear drive axle assembly. This view shows the axle from a slightly different angle, highlighting the rear differential and the connection to the lift's frame. A yellow and orange vehicle is visible in the background, parked on the same gravel surface. |

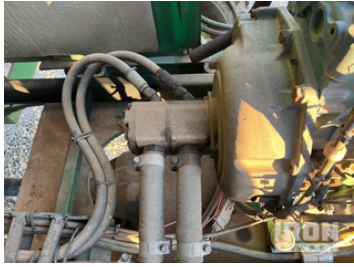
| Hydraulics | | |
|---|---|---|
| Pumps (Hydraulics) | ★★★★☆ | |

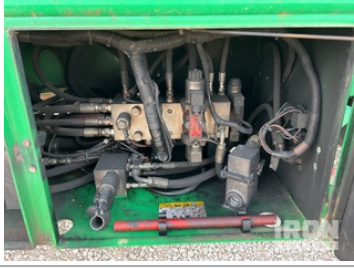
| Hydraulics | | |
|---|---|---|
| Valves | ★★★★☆ | |

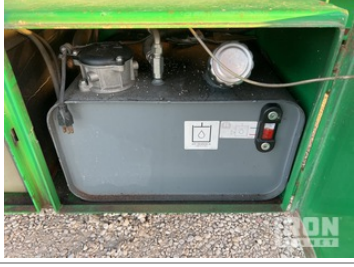
| Hydraulics | | |
|---|---|---|
| Hydraulic Tank | ★★★★☆ | |

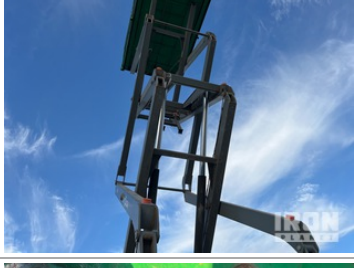
| Hydraulics | | |
|---|---|---|
| Lift Cylinders | ★★★★☆ | |

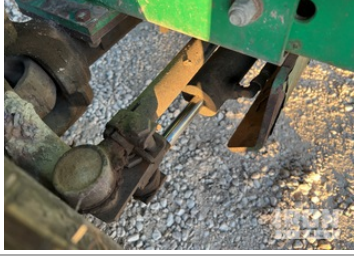
| Hydraulics | | |
|---|---|---|
| Steering Cylinder | ★★★★☆ | |

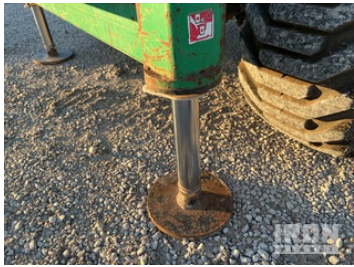
| Outrigger Cylinders | ★★★★☆ | |

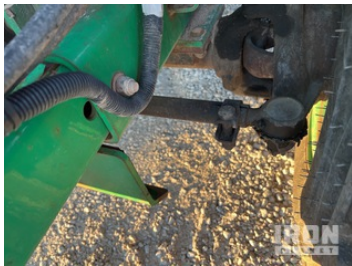
| Item | Assessment | Photo |
|---|---|---|
| Steering Linkage | ★★★★☆ | |

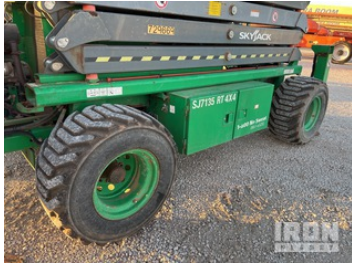
| Item | Assessment | Photo |
|---|---|---|
| Frame Condition | ★★★★☆ | |

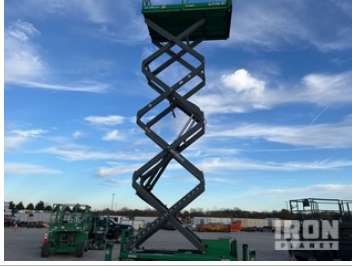
| Item | Assessment | Photo |
|---|---|---|
| Scissor Linkage | ★★★★☆ | |

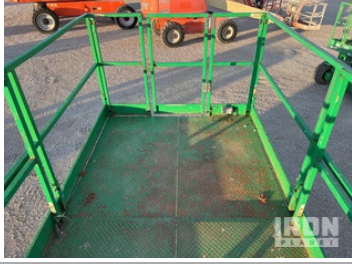
| Item | Assessment | Photo |
|---|---|---|
| Platform Condition | ★★★★☆ | |

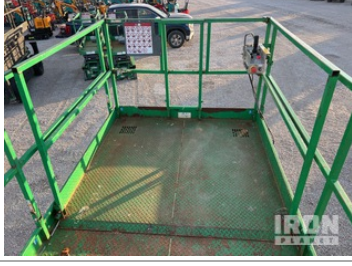
| Item | Assessment | Photo |
|---|---|---|
| Platform Extension | ★★★★☆ | |

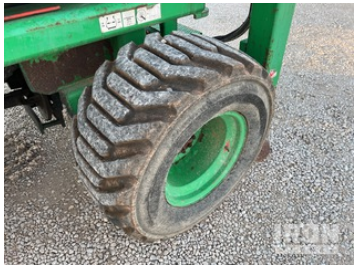
| Left Rear Tire | Cracks, Chunks missing, Tears | |

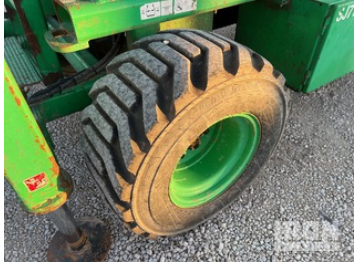
| Right Rear Tire | Cracks, Chunks missing, Tears | |

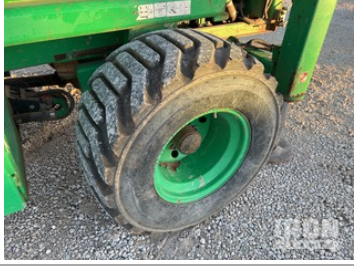
| Right Front Tire | Cracks, Chunks missing, Tears | |

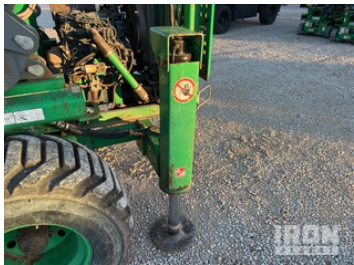
| Outriggers / Stabilizers | ★★★★☆ | |
