## Item #13811482 - 2016 JLG 4069LE Electric Scissor Lift

## Inspection Report

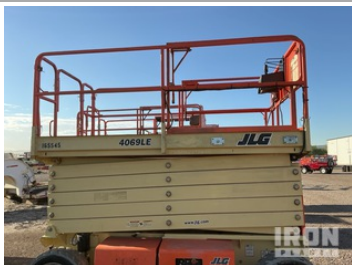
| Paint | No visible damage | |

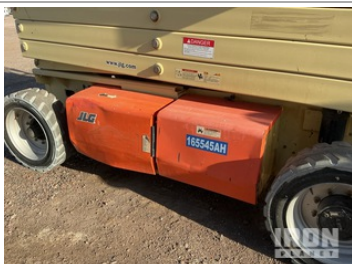
| Body Panels | Hydraulic compartment door damaged | |

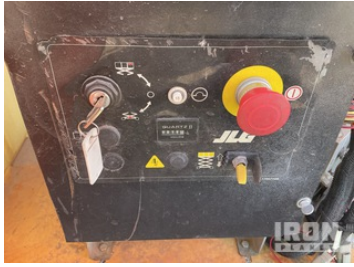
| Control Station Ground | | |
|---|---|---|
| Gauges | Operational | |

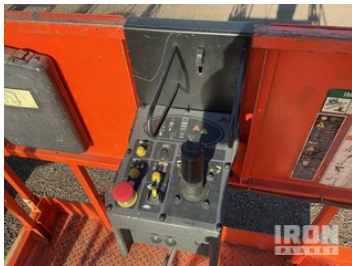
| Item | Assessment | Photo |
|---|---|---|
| Control Console | No visible damage or missing components | |

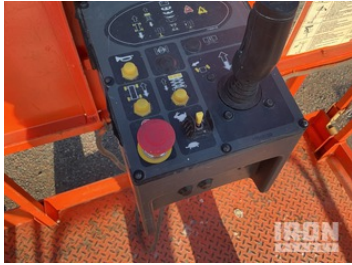
| Item | Assessment | Photo |
|---|---|---|
| Emergency Shut Off Switch | Operational | |

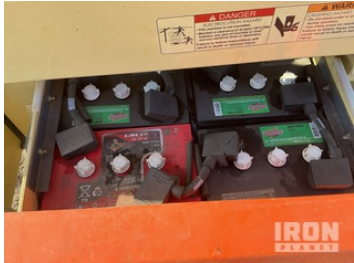
| Electrical Operating System | | |
|---|---|---|
| Cables and Connections | No visible damage or missing components | |

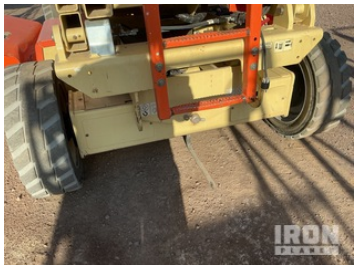
| Item | Assessment | Photo |
|---|---|---|
| Drive Motors | ★★★★☆ | |

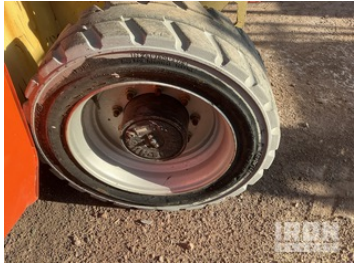
| Item | Assessment | Photo |
|---|---|---|
| Final Drives | ★★★★☆ | |

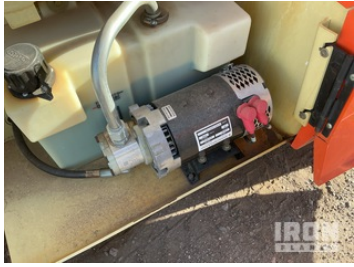
| Hydraulics | | |
|---|---|---|
| Pumps (Hydraulics) | ★★★★☆ | A close-up photograph of a hydraulic pump assembly mounted on a yellow metal frame. The pump is a black and silver unit with various hoses and electrical connections. An "IRON PLANET" watermark is visible in the bottom right corner. |

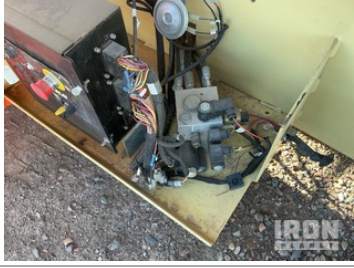
| Hydraulics | | |
|---|---|---|
| Valves | ★★★★☆ | A photograph showing a hydraulic valve assembly with multiple colored hoses (red, blue, yellow) connected to a metal block. The assembly is mounted on a yellow frame. An "IRON PLANET" watermark is visible in the bottom right corner. |

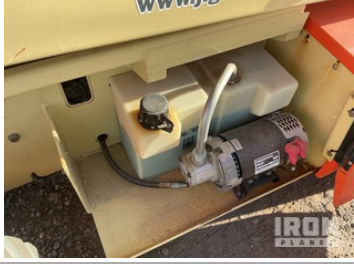
| Hydraulics | | |
|---|---|---|
| Hydraulic Tank | ★★★★☆ | A photograph of a hydraulic tank and pump assembly. The tank is a white plastic container with a black pump motor on top. It is mounted on a yellow frame. An "IRON PLANET" watermark is visible in the bottom right corner. |

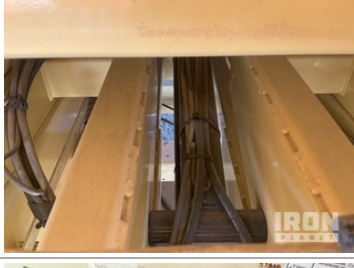
| Hydraulics | | |
|---|---|---|
| Lift Cylinders | ★★★★☆ | A photograph showing the internal structure of a scissor lift, specifically the lift cylinders. The cylinders are yellow and are arranged in a parallel fashion. An "IRON PLANET" watermark is visible in the bottom right corner. |

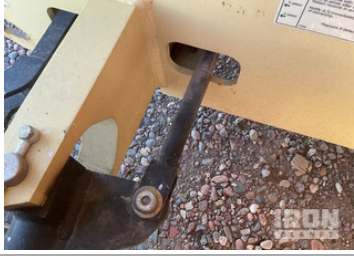
| Hydraulics | | |
|---|---|---|
| Steering Cylinder | ★★★★☆ | A photograph of a steering cylinder, which is a black metal component with a hydraulic hose attached. It is mounted on a yellow metal frame. An "IRON PLANET" watermark is visible in the bottom right corner. |

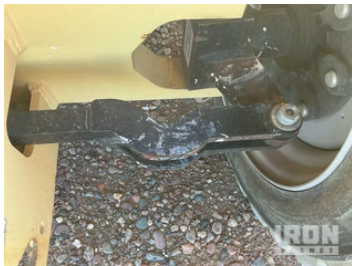
| Item | Assessment | Photo |
|---|---|---|
| Steering Linkage | ★★★★☆ | |

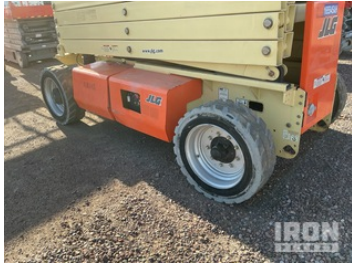
| Item | Assessment | Photo |
|---|---|---|
| Frame Condition | ★★★★☆ | |

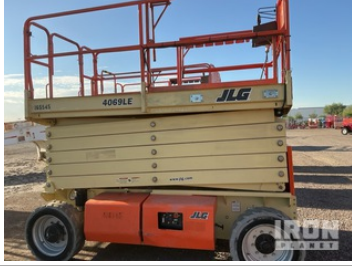
| Item | Assessment | Photo |
|---|---|---|
| Scissor Linkage | ★★★★☆ | |

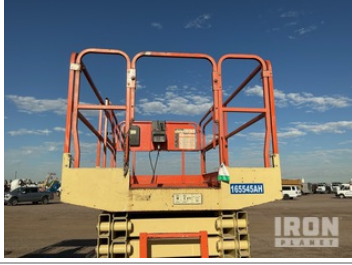
| Item | Assessment | Photo |
|---|---|---|
| Platform Condition | ★★★★☆ | |

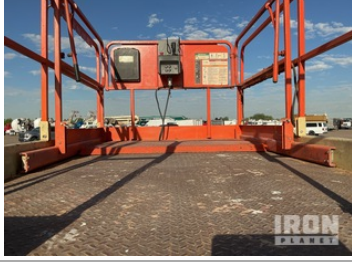
| Item | Assessment | Photo |
|---|---|---|
| Platform Extension | ★★★★☆ | |

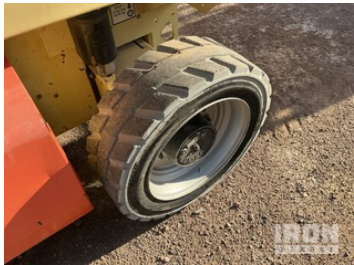
| Left Rear Tire | Cracks | |

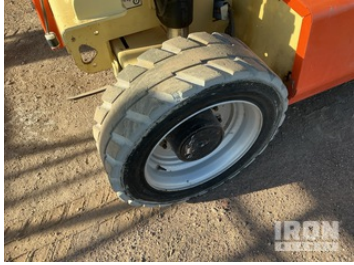
| Right Rear Tire | Cracks | |

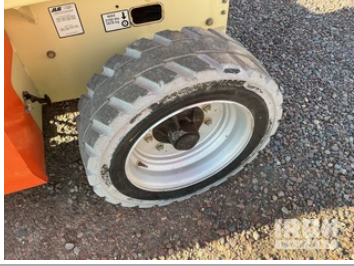
| Right Front Tire | Chunks missing | |

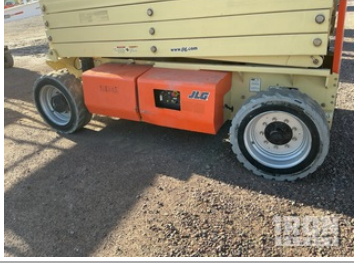
| Wheel Condition | No visible damage or missing components | |
