Item #14301889 - 2017 JLG 4069LE Electric Scissor Lift

Inspection Report

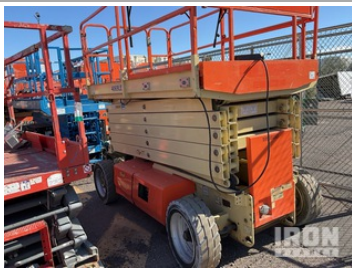
Paint	No visible damage

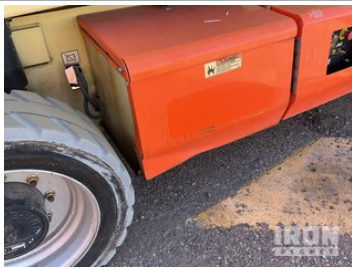
Body Panels	Hydraulic compartment door damaged

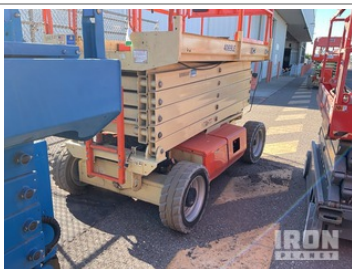
Basket / Safety Railing	No visible damage or missing components	
General Appearance #1

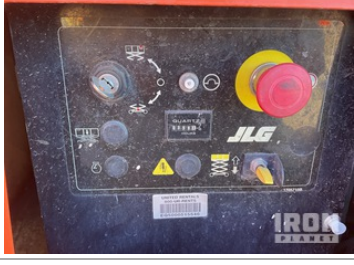
Function Controls	★★★★☆

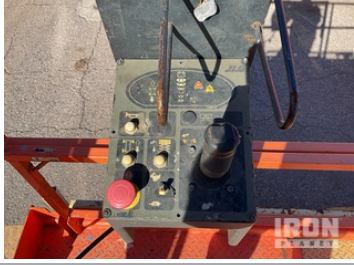
Control Station Upper		
Pin connection pivot point wear inspections are limited to sound, sight and feel observations. Dial indicator testing is not performed.		
Item	Assessment	Photo
Control Console	No visible damage or missing components

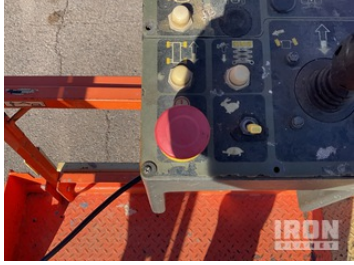
Emergency Shut Off Switch	Operational

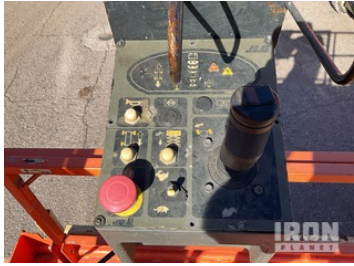
Upper Function Controls	☆☆☆☆

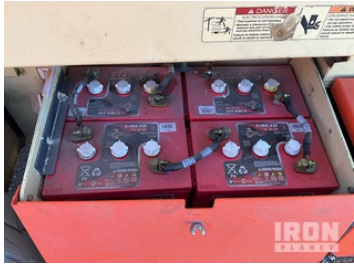
Electrical Operating System		
Item	Assessment	Photo
Operating Voltage	48 Volts	
Battery Condition	Functioned during the inspection	
Cables and Connections	No visible damage or missing components

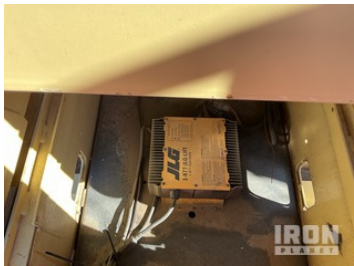
Battery Charger	Included Appears normal - Not operationally checked, 110 Volt, Single Phase

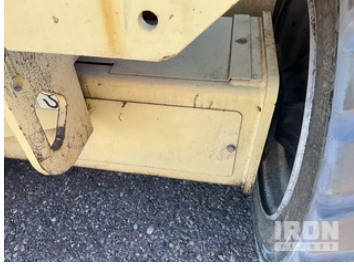
Drivetrain		
Operational test is limited to low speed in a confined flat area without load. Differential interlocks, full transmission shifting and functionality of all drive axles cannot be fully verified. Inspector listens for abnormal noises, observes leaks and notes physical damage.		
Item	Assessment	Photo
Drive Motors	★ ★ ★ ☆

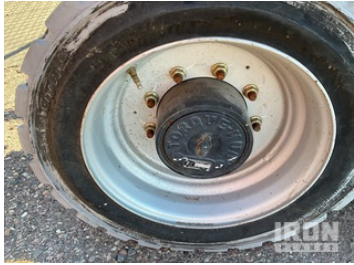
Final Drives	★ ★ ★ ☆

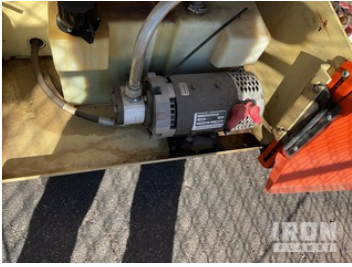
Hydraulics		
Item	Assessment	Photo
Pumps (Hydraulics)	★★★★☆

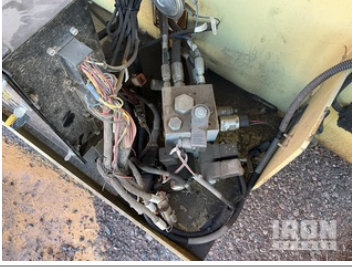
Valves	★★★★☆

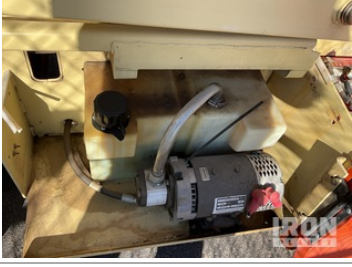
Hydraulic Tank	★★★★☆

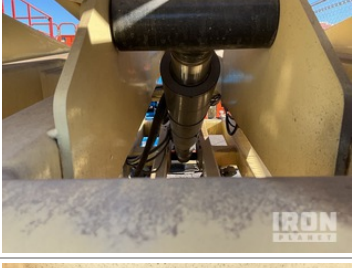
Lift Cylinders	★★★★☆

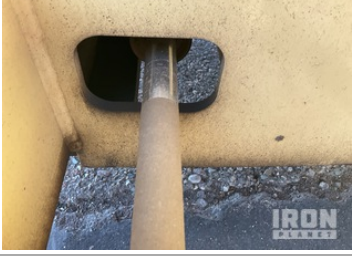
Steering Cylinder	★★★★☆

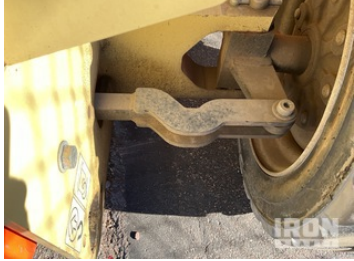
Chassis		
IronPlanet pin connection pivot point wear inspections are limited to sound, sight and feel observations. Dial indicator testing is not performed.		
Item	Assessment	Photo
Steering Linkage	★★★★☆

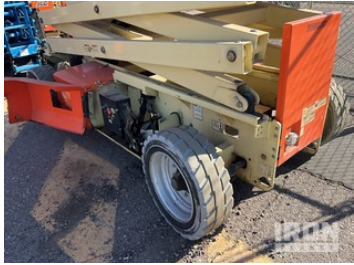
Frame Condition	★★★★☆

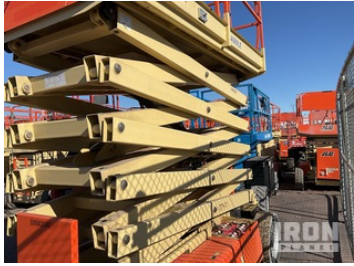
Scissor Linkage	★★★★☆

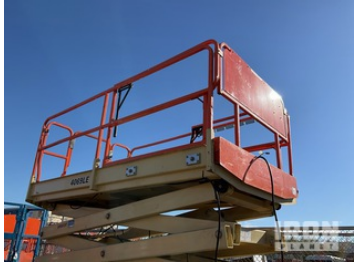
Platform Condition	★★★★☆

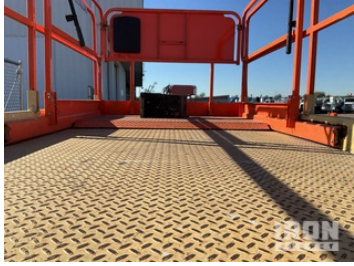
Platform Extension	★★★★☆

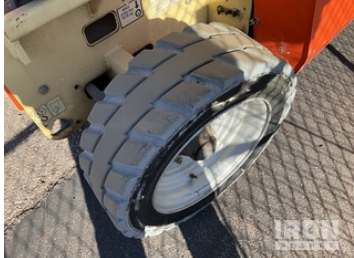
Left Front Tire	No visible defects

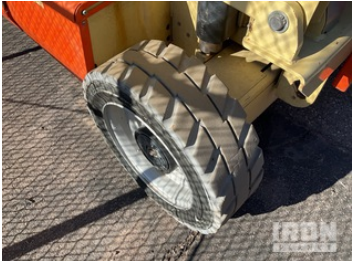
Left Rear Tire	No visible defects

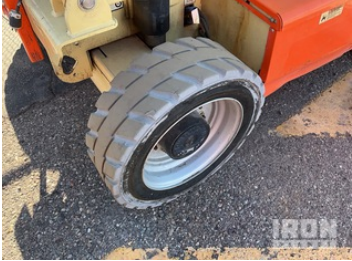
Right Rear Tire	No visible defects

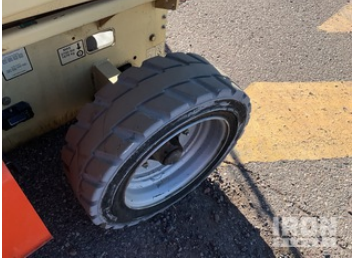
Right Front Tire	No visible defects

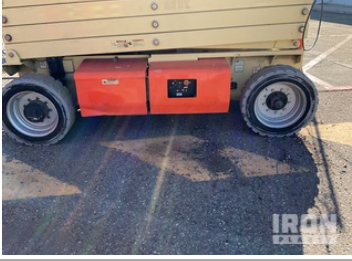
Wheel Condition	No visible damage or missing components

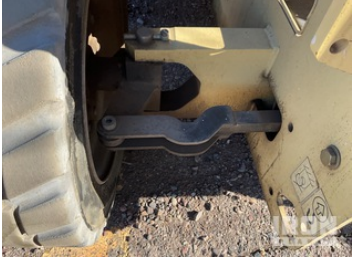
Wheel Studs	★★★★☆	
Limited Function Check (Scissor-lift)	The main components appear to be in place and operational.	
Chassis #1
