Item #13811437 - 2016 JLG 4069LE Scissor Lift

Inspection Report

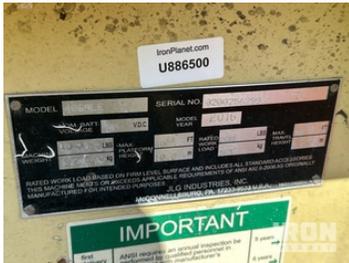
Serial Number / VIN	0200256299

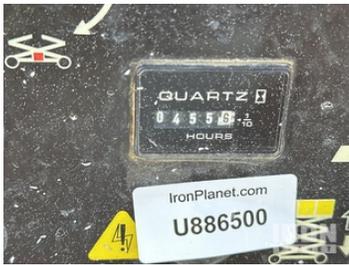
CE Mark	No CE mark found	
Hour Meter / Odometer	455 hrs

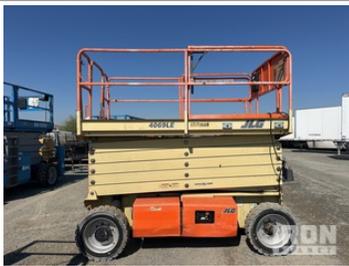
Paint	No visible damage

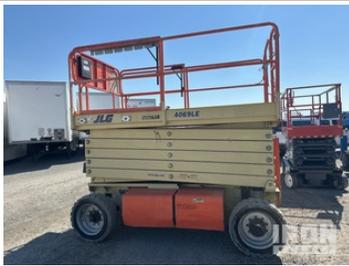
Body Panels	No visible damage or missing components

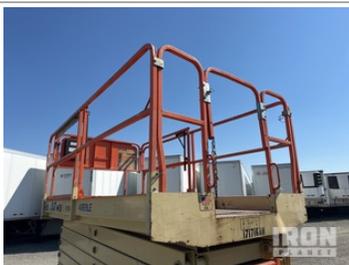
Basket / Safety Railing	No visible damage or missing components	
General Appearance #1

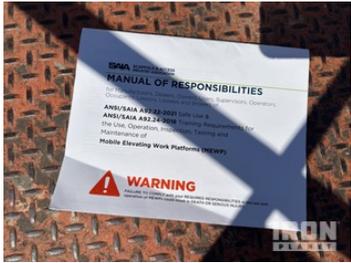
Safety		
Item	Assessment	Photo
Travel Alarm	Operational	
Horn	Operational	
Current Safety Manual	Yes	
Current Operator/Maintenance Manual	Yes	
ANSI Guidelines	Yes

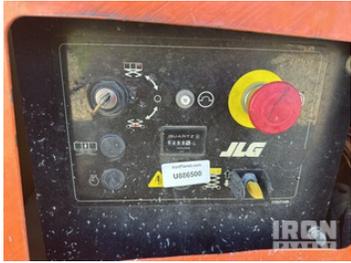
Control Station Ground		
Item	Assessment	Photo
Function Controls	★ ★ ★ ☆

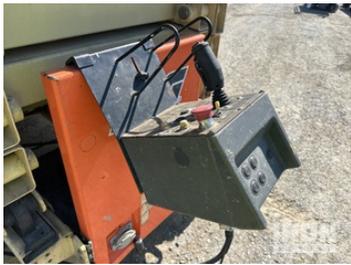
Control Station Upper		
Pin connection pivot point wear inspections are limited to sound, sight and feel observations. Dial indicator testing is not performed.		
Item	Assessment	Photo
Control Console	No visible damage or missing components

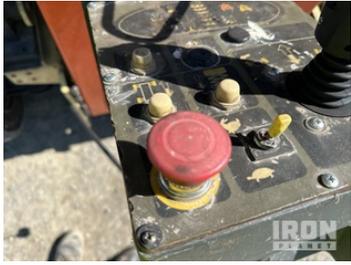
Emergency Shut Off Switch	Operational

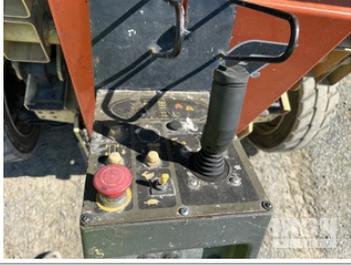
Upper Function Controls	☆☆☆☆

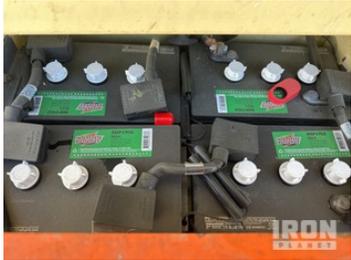
Electrical Operating System		
Item	Assessment	Photo
Operating Voltage	48 Volts	
Battery Condition	Functioned during the inspection	
Cables and Connections	No visible damage or missing components

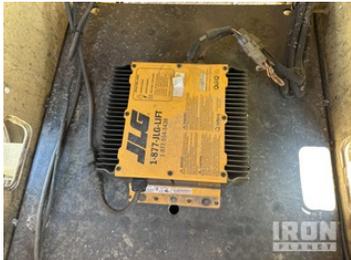
Battery Charger	Included Appears normal - Not operationally checked, 120 Volt, Single Phase

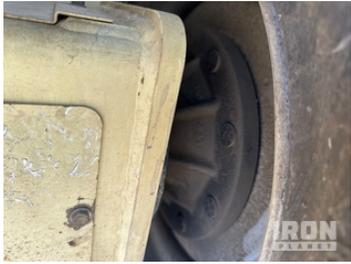
Drivetrain		
Operational test is limited to low speed in a confined flat area without load. Differential interlocks, full transmission shifting and functionality of all drive axles cannot be fully verified. Inspector listens for abnormal noises, observes leaks and notes physical damage.		
Item	Assessment	Photo
Drive Motors	★★★☆☆

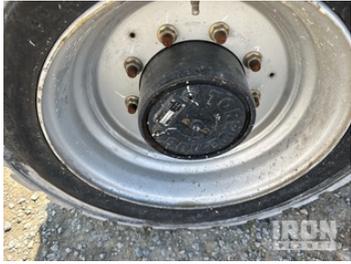
Final Drives	★★★☆☆

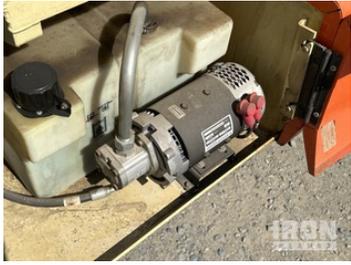
Hydraulics		
Item	Assessment	Photo
Pumps (Hydraulics)	★★★★☆

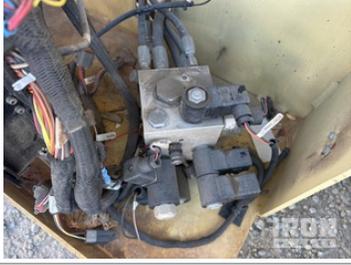
A close-up photograph of a hydraulic pump assembly mounted on a yellow scissor lift. The pump is connected to various hoses and has a red emergency stop button nearby. An "IRON PLANET" watermark is visible in the bottom right corner.
Valves	★★★★☆

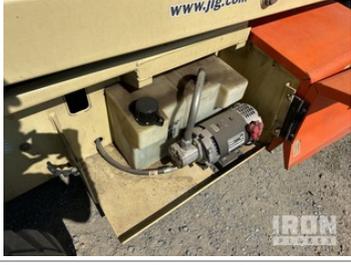
A photograph showing a hydraulic valve manifold with several ports and hoses connected. The manifold is mounted on the yellow frame of the lift. An "IRON PLANET" watermark is visible in the bottom right corner.
Hydraulic Tank	★★★★☆

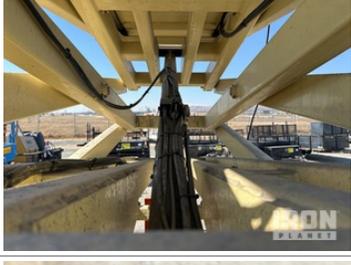
Lift Cylinders	★★★★☆

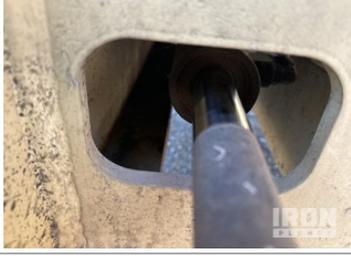
A photograph looking down into the scissor lift mechanism, showing the hydraulic cylinders and the scissor arms. The cylinders are black and the arms are yellow. An "IRON PLANET" watermark is visible in the bottom right corner.
Steering Cylinder	★★★★☆

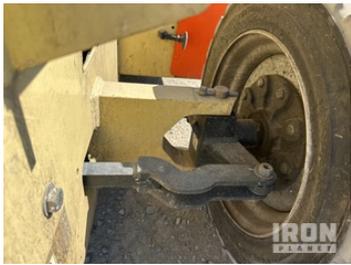
Chassis		
IronPlanet pin connection pivot point wear inspections are limited to sound, sight and feel observations. Dial indicator testing is not performed.		
Item	Assessment	Photo
Steering Linkage	★★★☆☆

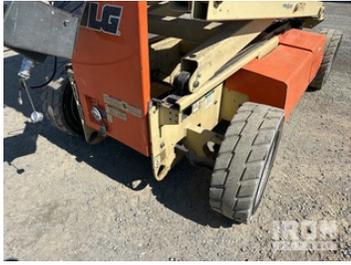
Frame Condition	★★★☆☆

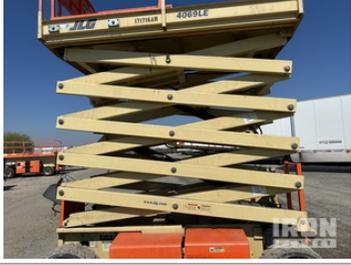
Scissor Linkage	★★★☆☆

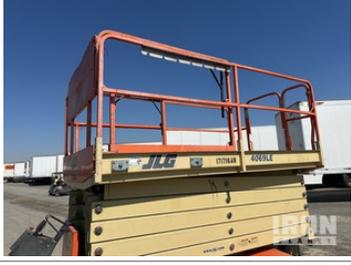
Platform Condition	★★★☆☆

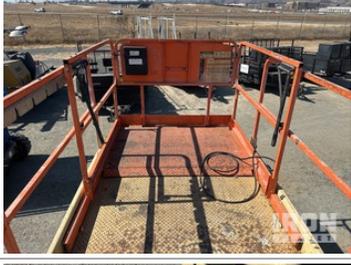
Platform Extension	★★★☆☆

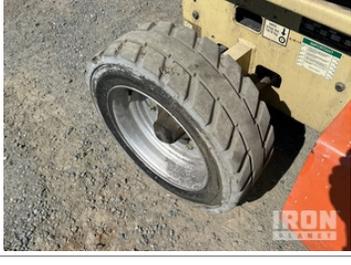
Left Front Tire	No visible defects

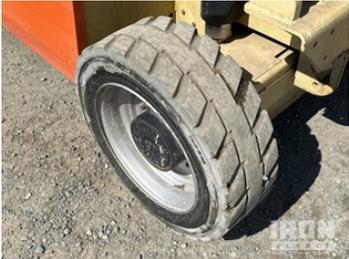
Left Rear Tire	No visible defects

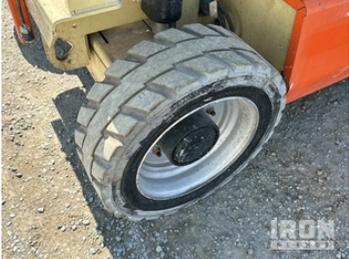
Right Rear Tire	No visible defects

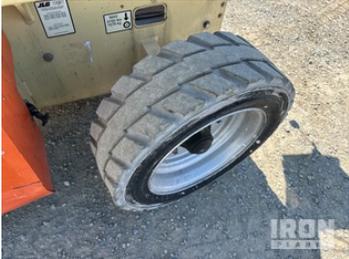
Right Front Tire	No visible defects

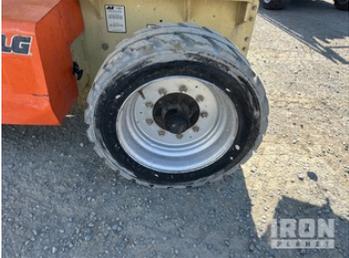
Wheel Condition	No visible damage or missing components

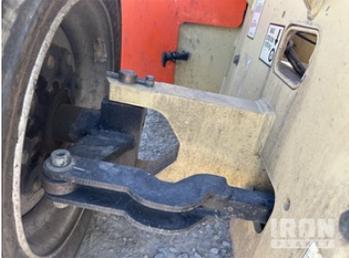
Wheel Studs	★★★★☆	
Limited Function Check (Scissor-lift)	The main components appear to be in place and operational.	
Chassis #1
