## Item #14339927 - 2019 Skyjack SJ 3226 Electric Scissor Lift

# Inspection Report

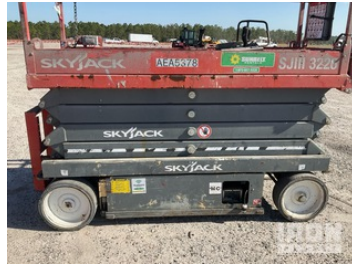
| Paint | No visible damage | |

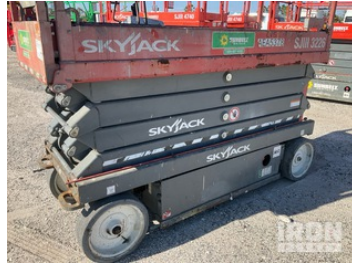
| Body Panels | No visible damage or missing components | |

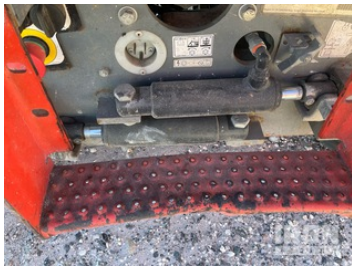
| Item | Assessment | Photo |
|---|---|---|
| Brake System | ★★☆☆<br>The brake system functioned, stopping and holding the machine. | |

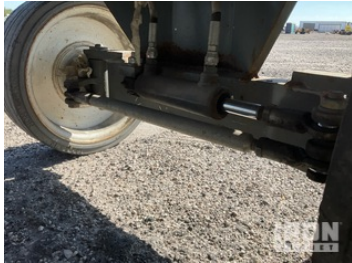
| Item | Assessment | Photo |
|---|---|---|
| Steering Linkage | ★★☆☆ | |

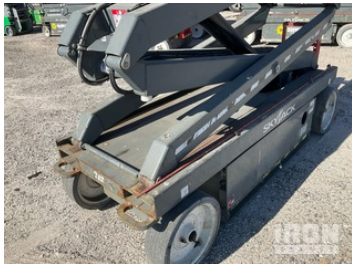
| Item | Assessment | Photo |
|---|---|---|
| Frame Condition | ★★☆☆ | |

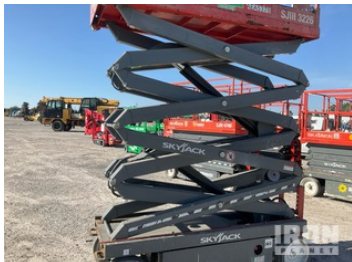
| Item | Assessment | Photo |
|---|---|---|
| Scissor Linkage | ★★☆☆ | |

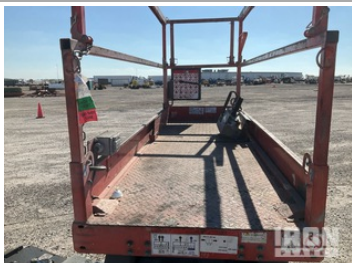
| Item | Assessment | Photo |
|---|---|---|
| Platform Condition | ★★☆☆ | |

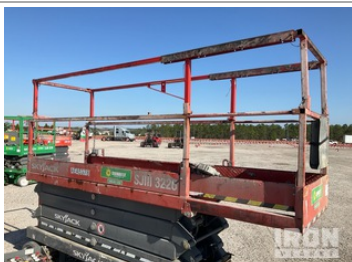
| Item | Assessment | Photo |
|---|---|---|
| Platform Extension | ★★☆☆ | |

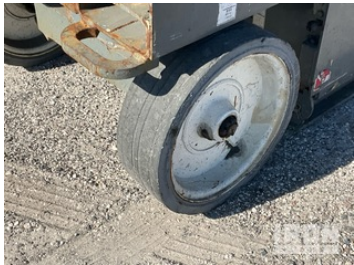
| Left Front Tire | Cracks | |

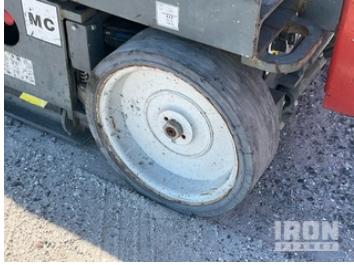
| Left Rear Tire | Cracks | |

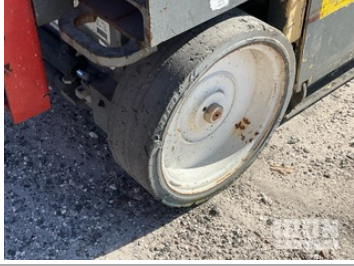
| Right Rear Tire | Cracks | |

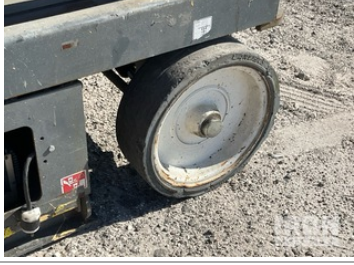
| Right Front Tire | Cracks | |
