## Item #13810819 - 2016 Genie GS3232 Electric Scissor Lift

- Features: 32 ft Max Platform Height, 500 lb Max Weight Capacity, Platform Extension, Power to Platform, Stabilizers, Solid Non-Marking Tires, Upper Control Box
- Meter Reading: 393 Hours
- Serial # : GS3216P-146544
- Inspection Completed: 8/4/25

## Inspection Report

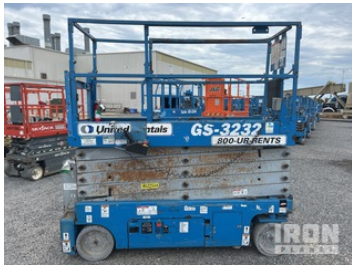
| Paint | Has a lot of rust | |

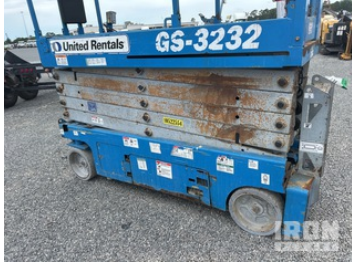
| Body Panels | Top rails are bent. Bottom part of the frame on the left side front of left rear tire is bent. | |

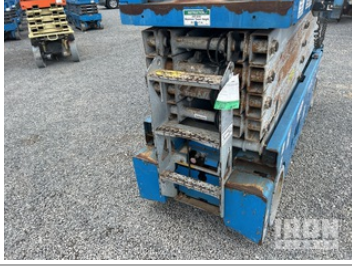
| Steps/Ladders | Bent | |

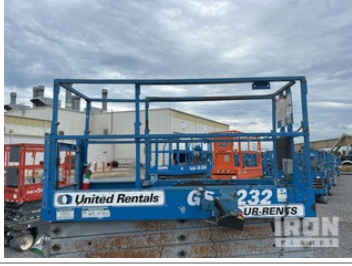
| Item | Assessment | Photo |
|---|---|---|
| Platform Condition | ★★★☆☆<br>Top rails are bent | |

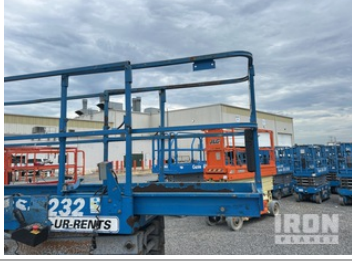
| Item | Assessment | Photo |
|---|---|---|
| Platform Extension | ★★★☆☆<br>Front piece is bent | |

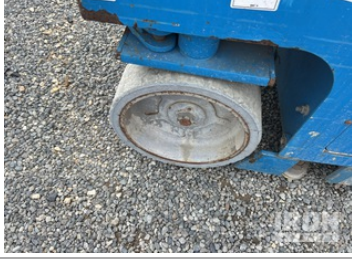
| Item | Assessment | Photo |
|---|---|---|
| Left Front Tire | Chunks missing, Tears | |

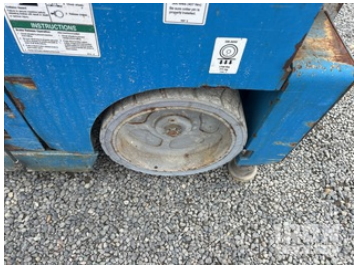
| Left Rear Tire | Cracks, Chunks missing, Tears | |

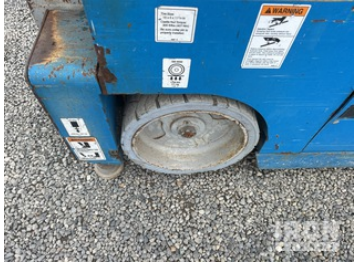
| Right Rear Tire | Cracks, Chunks missing, Tears | |

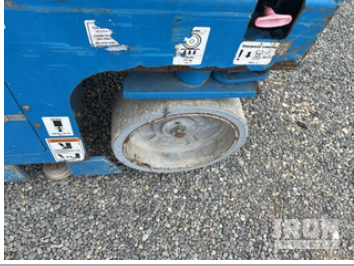
| Right Front Tire | Cracks, Chunks missing, Tears | |
