## Item #14097125 - 2018 Skyjack SJIII4740 Electric Scissor Lift

# Inspection Report

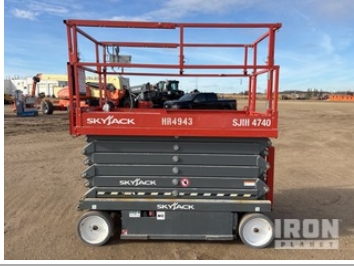
| Paint | No visible damage | |

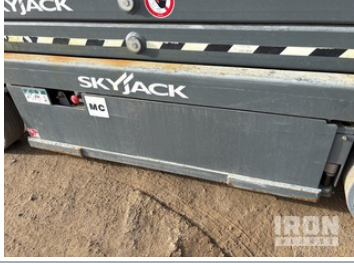
| Body Panels | No visible damage or missing components | |

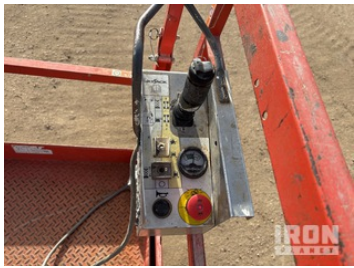
| Item | Assessment | Photo |
|---|---|---|
| Control Console | No visible damage or missing components | |

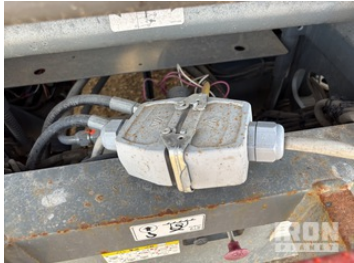
| Electrical Operating System | | |
|---|---|---|
| Cables and Connections | No visible damage or missing components | |

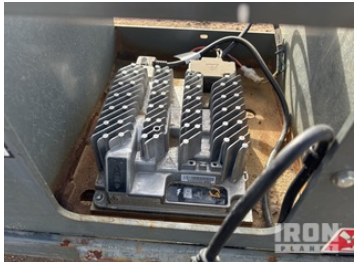
| Electrical Operating System | | |
|---|---|---|
| Battery Charger | Included Appears normal - Not operationally checked, Damaged cord, 100-240 Volt | |

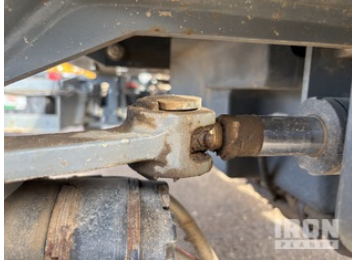
| Item | Assessment | Photo |
|---|---|---|
| Steering Linkage | ★★☆☆ | |

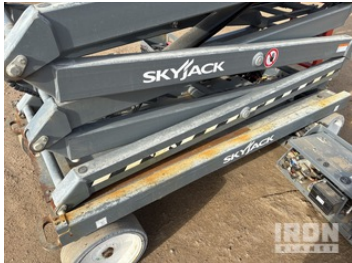
| Item | Assessment | Photo |
|---|---|---|
| Frame Condition | ★★☆☆ | |

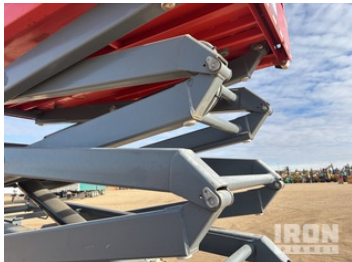
| Item | Assessment | Photo |
|---|---|---|
| Scissor Linkage | ★★☆☆ | |

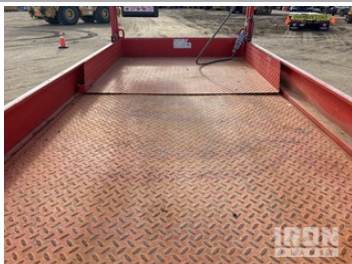
| Item | Assessment | Photo |
|---|---|---|
| Platform Condition | ★★☆☆ | |

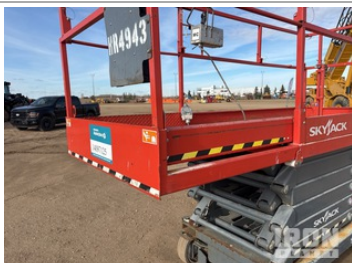
| Item | Assessment | Photo |
|---|---|---|
| Platform Extension | ★★☆☆ | |

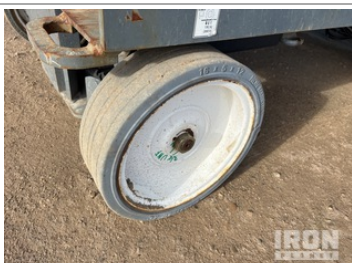
| Item | Assessment | Photo |
|---|---|---|
| Left Front Tire | Tears | |

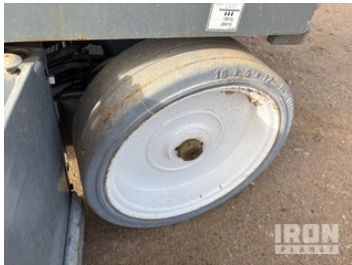
| Left Rear Tire | No visible defects | |

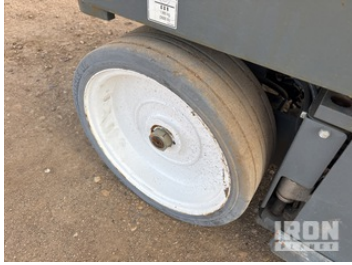
| Right Rear Tire | No visible defects | |

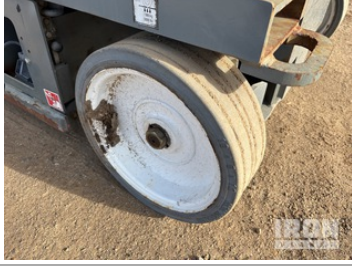
| Right Front Tire | No visible defects | |

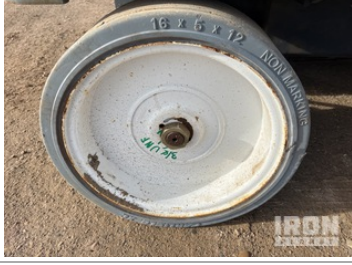
| Wheel Condition | No visible damage or missing components | |
