## Item #13811300 - 2016 JLG 4069LE Electric Scissor Lift

# Inspection Report

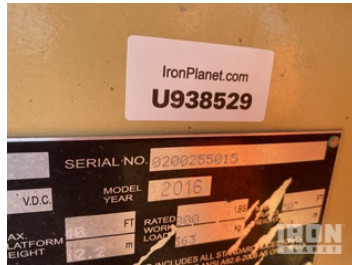
| Serial Number / VIN | 0200255015 | |

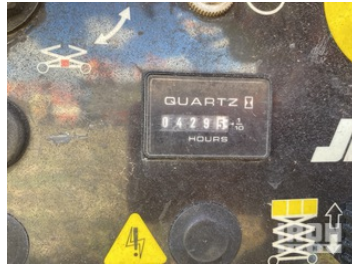
| Hour Meter / Odometer | 429 hrs | |

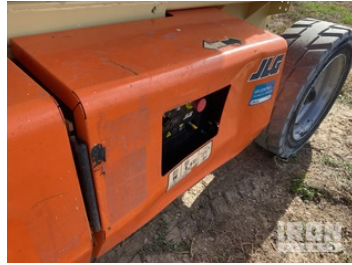
| Body Panels | No visible damage or missing components | |

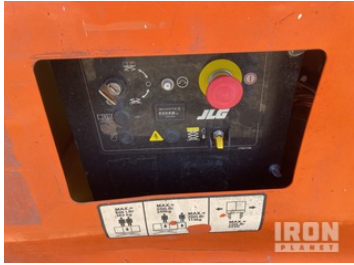
| Control Station Ground | | |
|---|---|---|
| Function Controls | ☆☆☆☆ | |

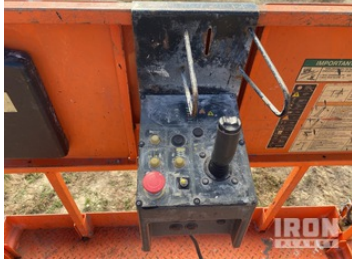
| Item | Assessment | Photo |
|---|---|---|
| Control Console | No visible damage or missing components | A photograph of the control console, showing a black panel with various buttons and a joystick. The console is mounted on an orange frame. A watermark "IRON PLANET" is visible in the bottom right corner. |

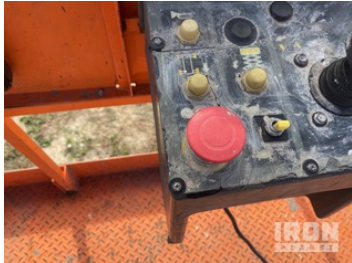
| Item | Assessment | Photo |
|---|---|---|
| Emergency Shut Off Switch | Operational | A close-up photograph of the emergency shut off switch, which is a large red button. It is located on the control console. A watermark "IRON PLANET" is visible in the bottom right corner. |

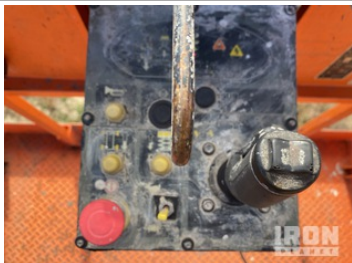
| Item | Assessment | Photo |
|---|---|---|
| Upper Function Controls | ☆☆☆☆ | A photograph of the upper function controls, showing a black panel with various buttons and a joystick. The console is mounted on an orange frame. A watermark "IRON PLANET" is visible in the bottom right corner. |

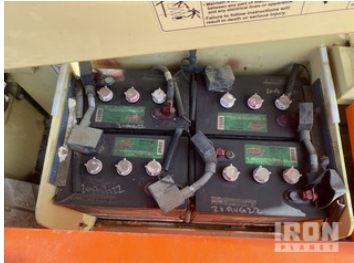
| Electrical Operating System | | |
|---|---|---|
| Cables and Connections | No visible damage or missing components | |

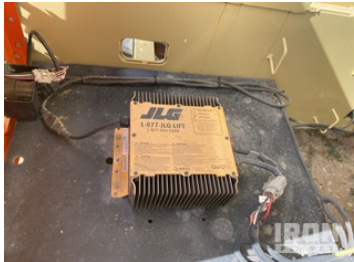
| Electrical Operating System | | |
|---|---|---|
| Battery Charger | Included Appears normal - Not operationally checked, 120 Volt, Single Phase | |

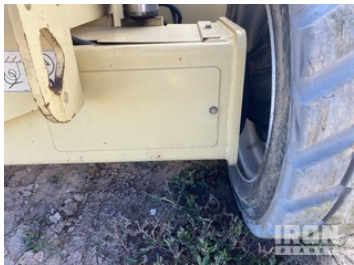
| Item | Assessment | Photo |
|---|---|---|
| Drive Motors | ★★★★☆ | |

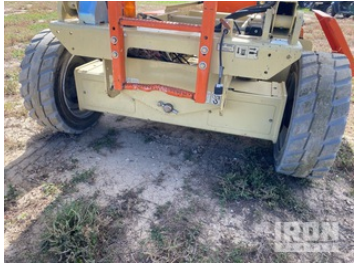
| Item | Assessment | Photo |
|---|---|---|
| Rear Drive Axle | ★★★★☆ | |

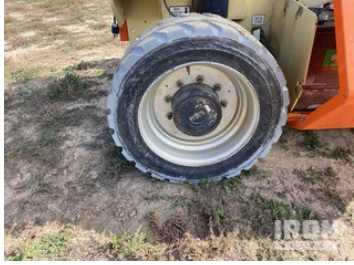
| Item | Assessment | Photo |
|---|---|---|
| Final Drives | ★★★★☆ | |

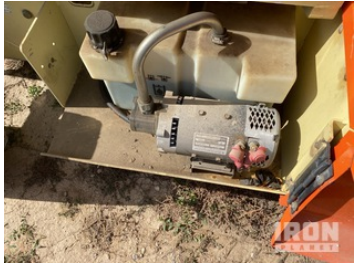
| Hydraulics | | |
|---|---|---|
| Pumps (Hydraulics) | ★★★★☆ | |

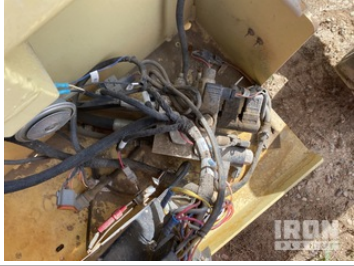
| Hydraulics | | |
|---|---|---|
| Valves | ★★★★☆ | |

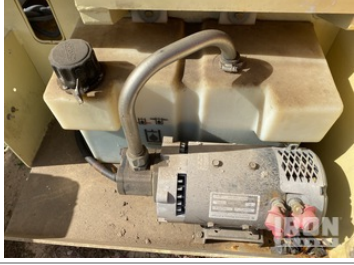
| Hydraulics | | |
|---|---|---|
| Hydraulic Tank | ★★★★☆ | |

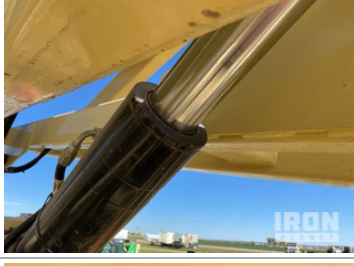
| Hydraulics | | |
|---|---|---|
| Lift Cylinders | ★★★★☆ | |

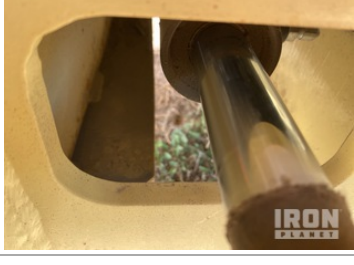
| Hydraulics | | |
|---|---|---|
| Steering Cylinder | ★★★★☆ | |

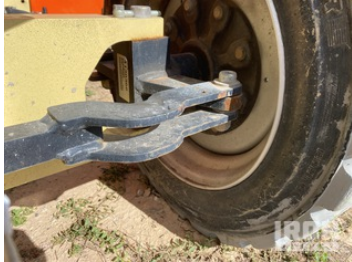
| Item | Assessment | Photo |
|---|---|---|
| Steering Linkage | ★★★★☆ | |

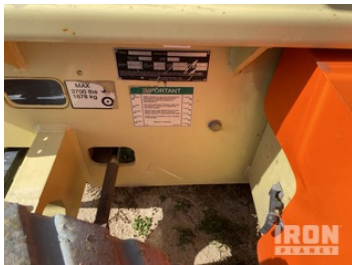
| Item | Assessment | Photo |
|---|---|---|
| Frame Condition | ★★★★☆ | |

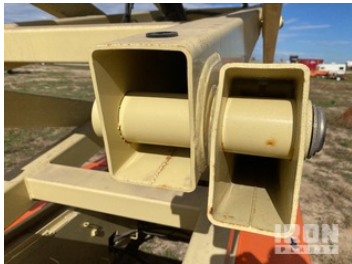
| Item | Assessment | Photo |
|---|---|---|
| Scissor Linkage | ★★★★☆ | |

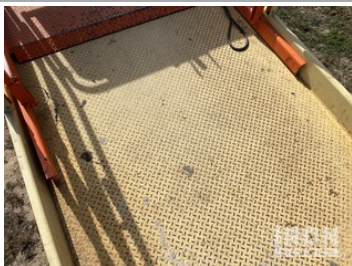
| Item | Assessment | Photo |
|---|---|---|
| Platform Condition | ★★★★☆ | |

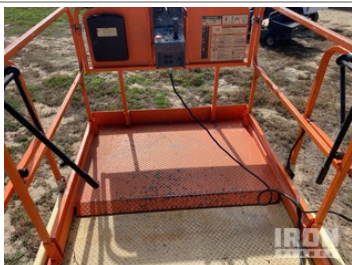
| Item | Assessment | Photo |
|---|---|---|
| Platform Extension | ★★★★☆ | |

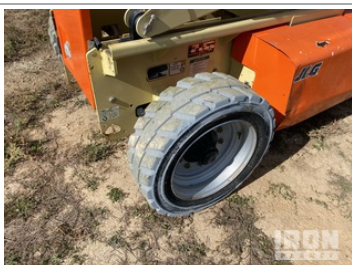
| Item | Assessment | Photo |
|---|---|---|
| Left Front Tire | Tears, No visible defects | |

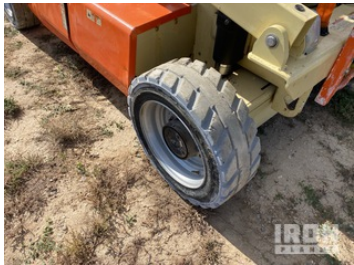
| Left Rear Tire | Cracks, Tears | |

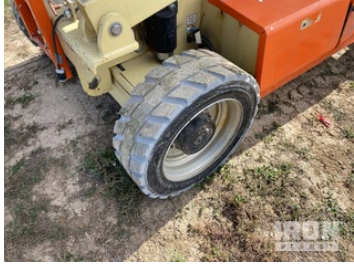
| Right Rear Tire | Cracks, Tears | |

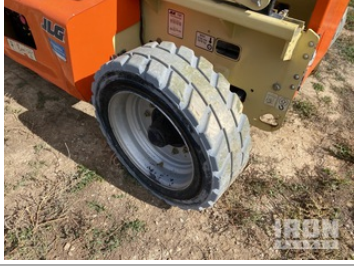
| Right Front Tire | Cracks, Tears | |

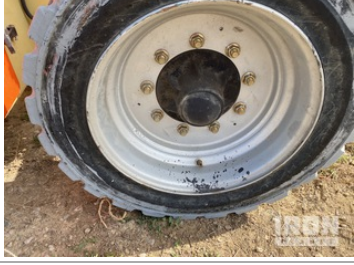
| Wheel Condition | No visible damage or missing components | |
